**STAFF REPORT ON THE WELL CONTROL INCIDENT
ON OUTER CONTINENTAL SHELF PLATFORM GAIL ON
NOVEMBER 18, 2004, SOCKEYE FIELD,
CHANNEL ISLANDS BLOCK 4661,
LEASE OCS-P 0205,
VENTURA COUNTY**

OCS Report
MMS 2005-017

Investigation of Loss of Well Control and Oil Spill, Platform Gail, Channel Islands Block 4661, Lease OCS-P 0205, November 18, 2004

U.S. Department of the Interior
Minerals Management Service
Pacific OCS Region

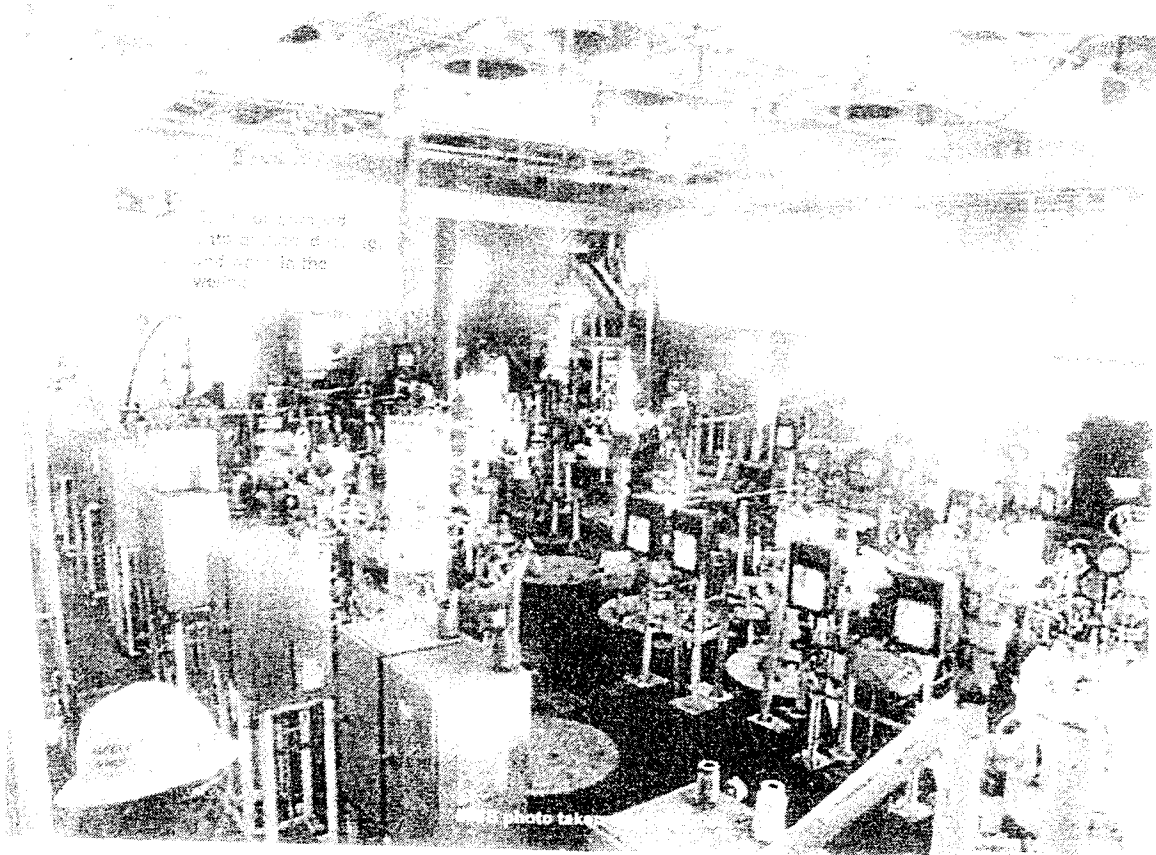
that were subjected to the oily discharge from the well. All surfaces in the immediate area of the well were covered with a thick, oily residue, but no actual damage to any of these components was found.

MMS offshore platform showing crude oil sprayed onto grating, decking, and walls in the wellbay.

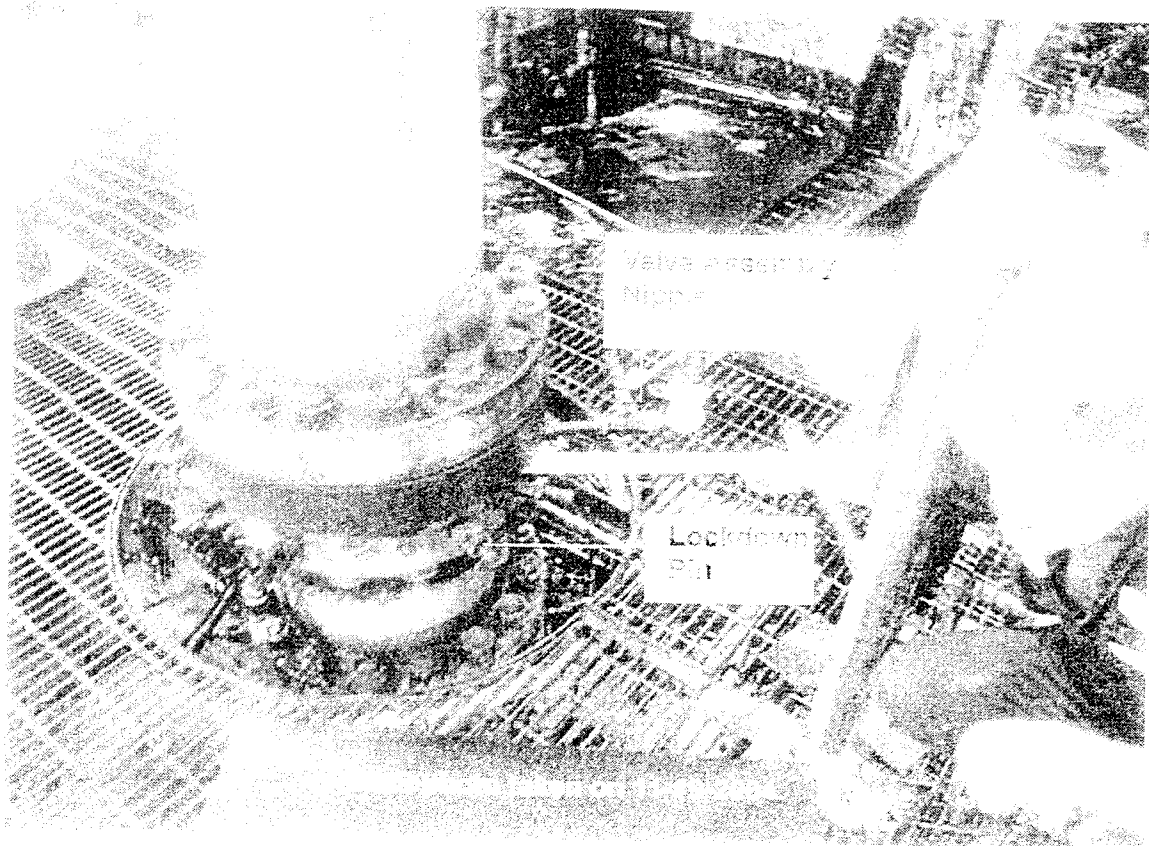
Lockdown Pin

2. The tubing hanger lockdown pin was completely removed from the wellhead assembly. Removal of this pin circumvented the blowout preventer system and provided an exit point for the wellbore fluids.

The procedure of pulling the lockdown pin had been used in the past on some workovers associated with dual-string completions without incident. It should be noted that the lockdown pin was not designed for this purpose nor does the manufacturer of the wellhead, FMC Technologies, recommend it. The pin was designed to be backed in and out of the wellhead to secure the tubing hanger without breaching the pressure integrity of the wellhead.

Photo showing valve assembly nipple and lockdown pin on offshore oil platform.

1. Lessees and operators develop specific procedures or revise existing procedures for landing dual string casing hangers so that circumvention of the well-control system is eliminated.
2. Well-control training and safety meetings cover potential consequences of well-control system circumvention.
3. Operators review and/or provide detailed work procedures to be used by company and contract employees.
4. Rig crews and third-party personnel be instructed to conform to approved Applications for Permit to Modify and field rules.
5. Job Safety Analyses be conducted for all tasks involving potential hazards.

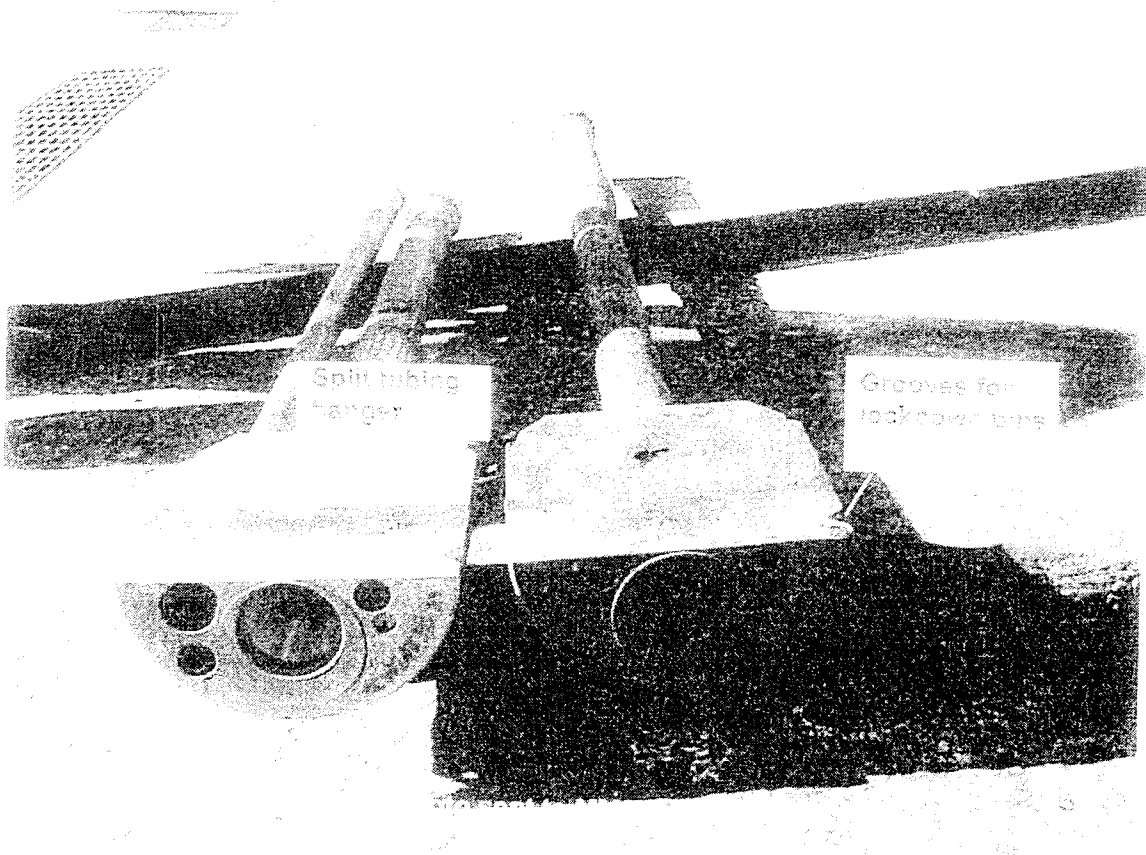
Design Factors: A further cause not explicitly named in the MMS investigation is the tubing head and split hanger design, which results in a landing procedure

Apparently, the pin pulling procedure evolved to assist in aligning the split hanger, to verify that the hanger was set in the correct position. If the split tubing hanger is slightly misaligned, it could cause critical damage and added expense for additional rig time to correct problems. Prior to use of the lockdown pin pulling procedure, a mechanical finesse and measurement system was used to set dual string tubing completions.

Photo showing split tubing hanger and grooves for lockdown pins on offshore oil platform.
