MINUTE ITEM

STAFF REPORT ON HEARINGS  
CONCERNING THE NUMBER OF MOORINGS  
UNDER BID SOLICITATION WP 3639.1

DIAGRAMS OF TYPICAL MOORINGS

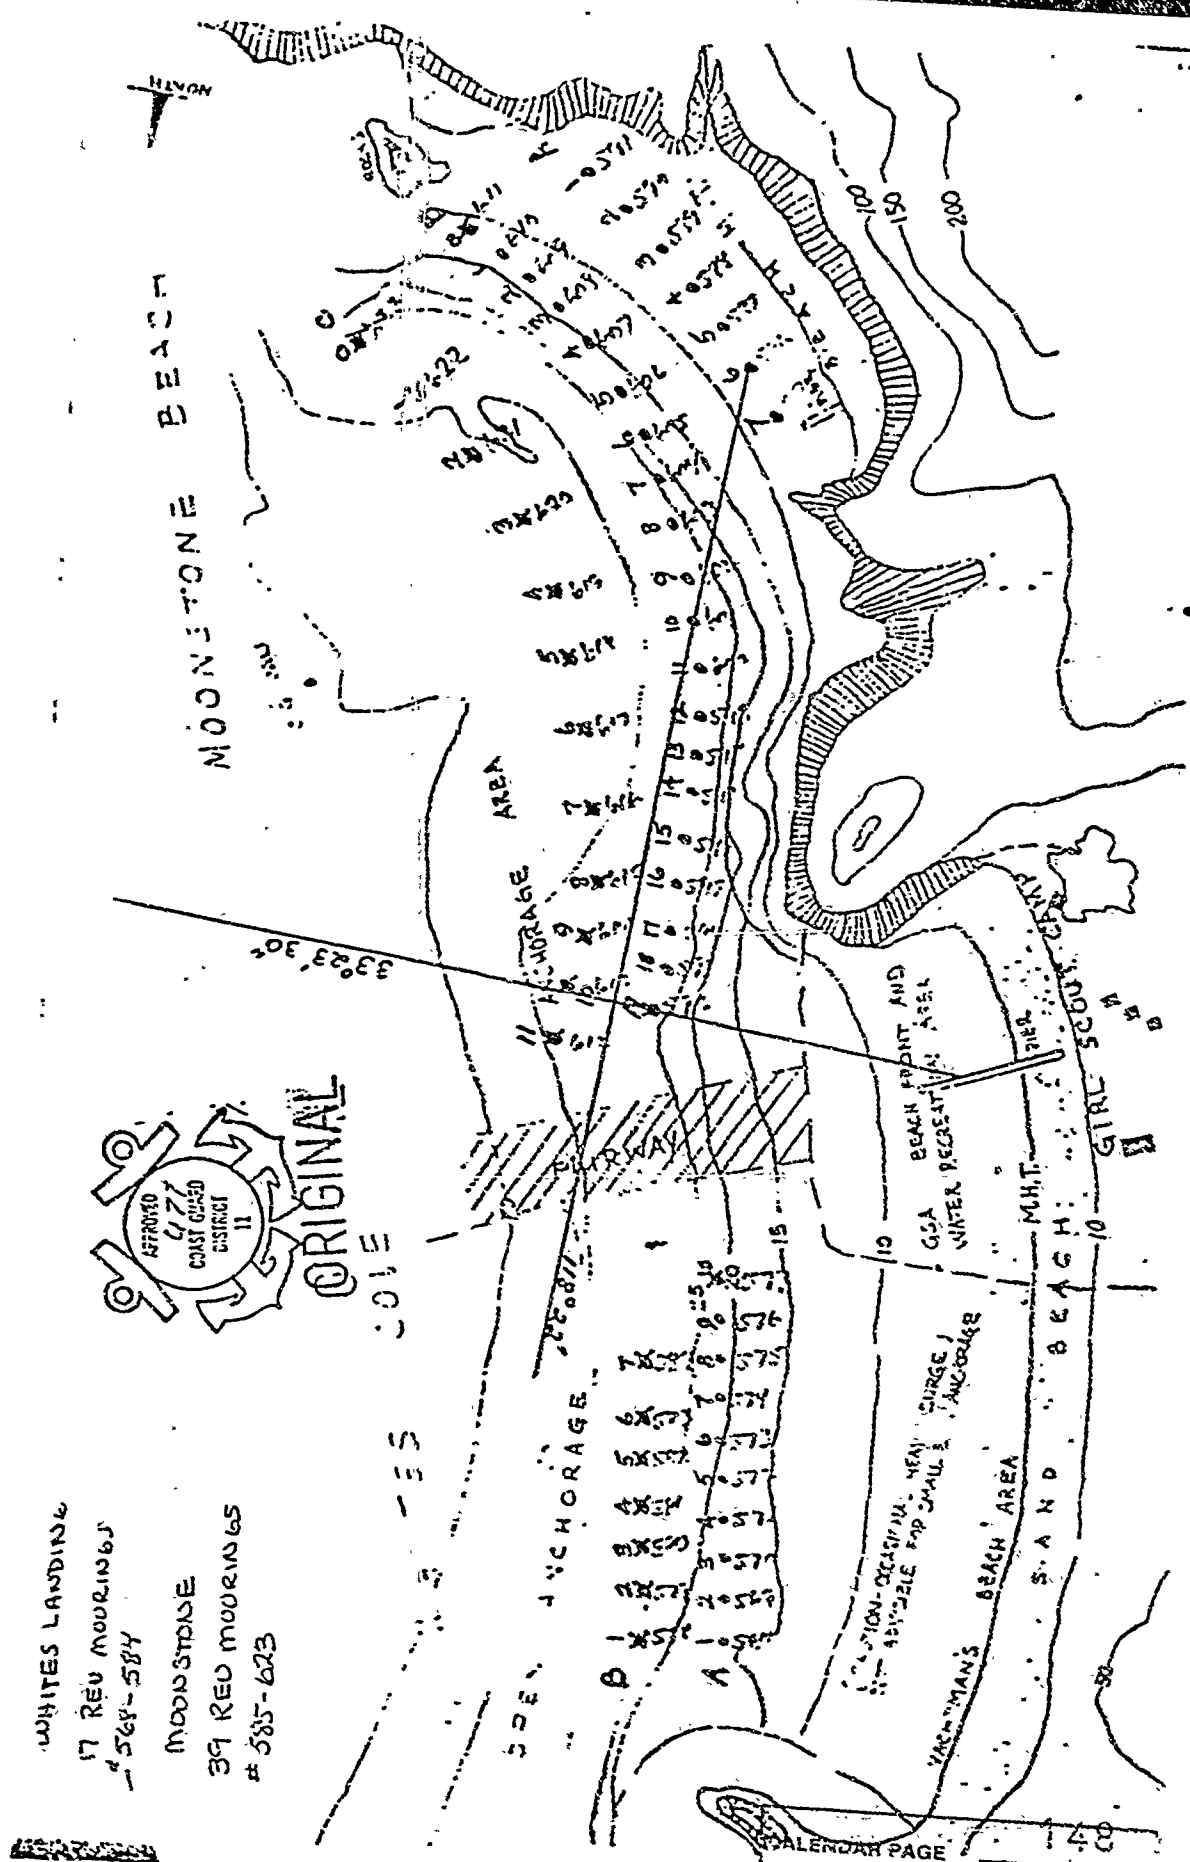
WHITES LANDING  
17 RED MOORINGS  
# 568-584
