**CALENDAR ITEM
C50**

AS TRUSTEE OF THE KAPILOFF LAND BANK FUND, AUTHORIZE EXPENDITURE OF UP TO \$17,000 TO COMPLETE A PREVIOUSLY APPROVED DEMONSTRATION PROJECT FOR HAND-REMOVAL OF A NON-NATIVE, INVASIVE AQUATIC PLANT, EURASIAN WATERMILFOIL (*MYRIOPHYLLUM SPICATUM*), FROM EMERALD BAY, LAKE TAHOE, AND INITIATE ANOTHER SMALL PILOT STUDY USING A BARRIER CONTROL TECHNIQUE ON SOVEREIGN LANDS IN LAKE TAHOE, EL DORADO COUNTY

PILOT PROJECT
EURASIAN WATER MILFOIL REMOVAL FROM EMERALD BAY
CALIFORNIA STATE LANDS COMMISSION
MAY 22-25, 2005

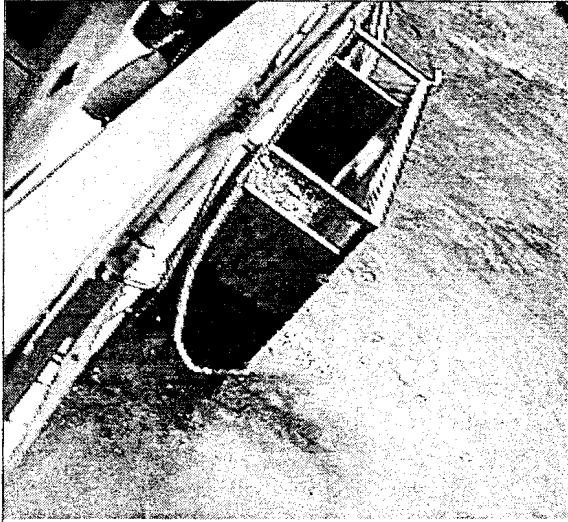
Fig. 8. Day 1 Screen Box No Silt Curtain

ACE fastened an 8-foot wide sheet of black plastic around the screen box. Figures 8 and 9 show the demonstrable differences in silt movement observed from water surface, without and with the silt curtain, within 5 feet from the screen box. With such measurable benefit, the CSLC believes the use of a silt curtain should be required when vacuum assist dredging is used in Lake Tahoe.

- 2. Turbidity Standards** The applicable turbidity standards are uncertain, as guidelines for monitoring varied between TRPA and Lahontan. The most important effect measured was the improvement documented with the addition, on the second Day, of a silt curtain. For removal involving suction assist on over 100
