**HYDROGRAPHIC & GEOPHYSICAL SURVEY REPORT**

**HKA CABLE ROUTE SURVEY**

**HERMOSA, CALIFORNIA**

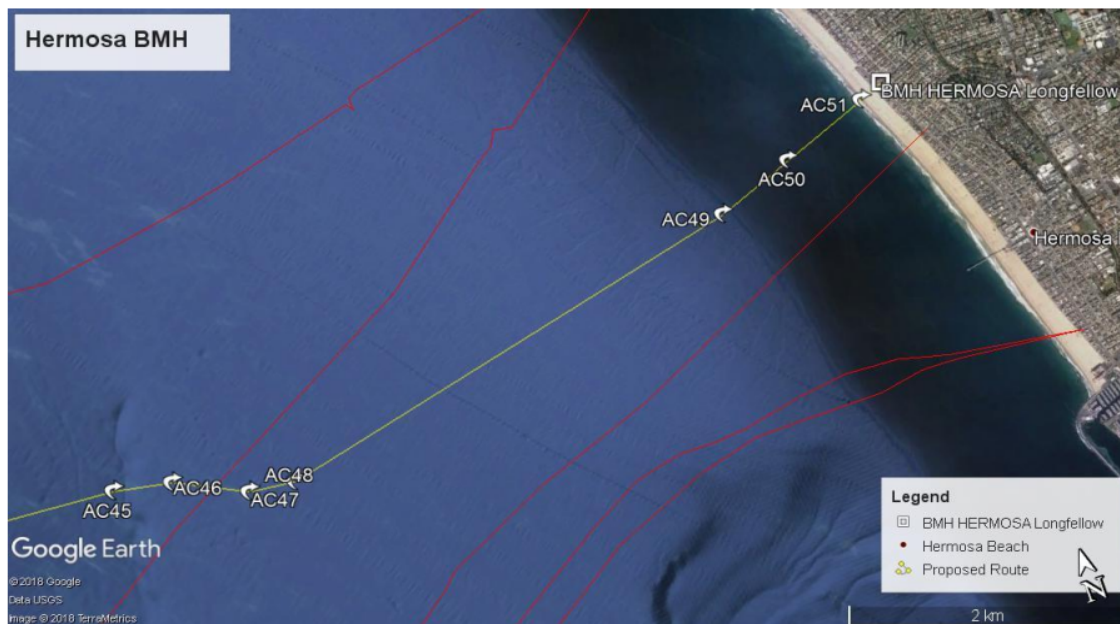
Figure 1: Survey Area Location

The survey area is defined as a polygon using the Route Point List (RPL) for the Hermosa Longfellow Beach Manhole (BMH) landing site. This site is located in Los Angeles, CA on Hermosa Beach. The area includes a topographic survey of the beach area in the vicinity of the BMH (Details of this survey can be found in document "2018\_Hermosa\_Topographic\_Survey\_Report\_Final.pdf" ) and a nearshore area bounded by a buffer of 250 meters to either side of the RPL and 500 meters offshore of the 3nm state waters boundary. The landfall point for the inshore geophysical survey work is defined as up to the 3m contour below LAT.

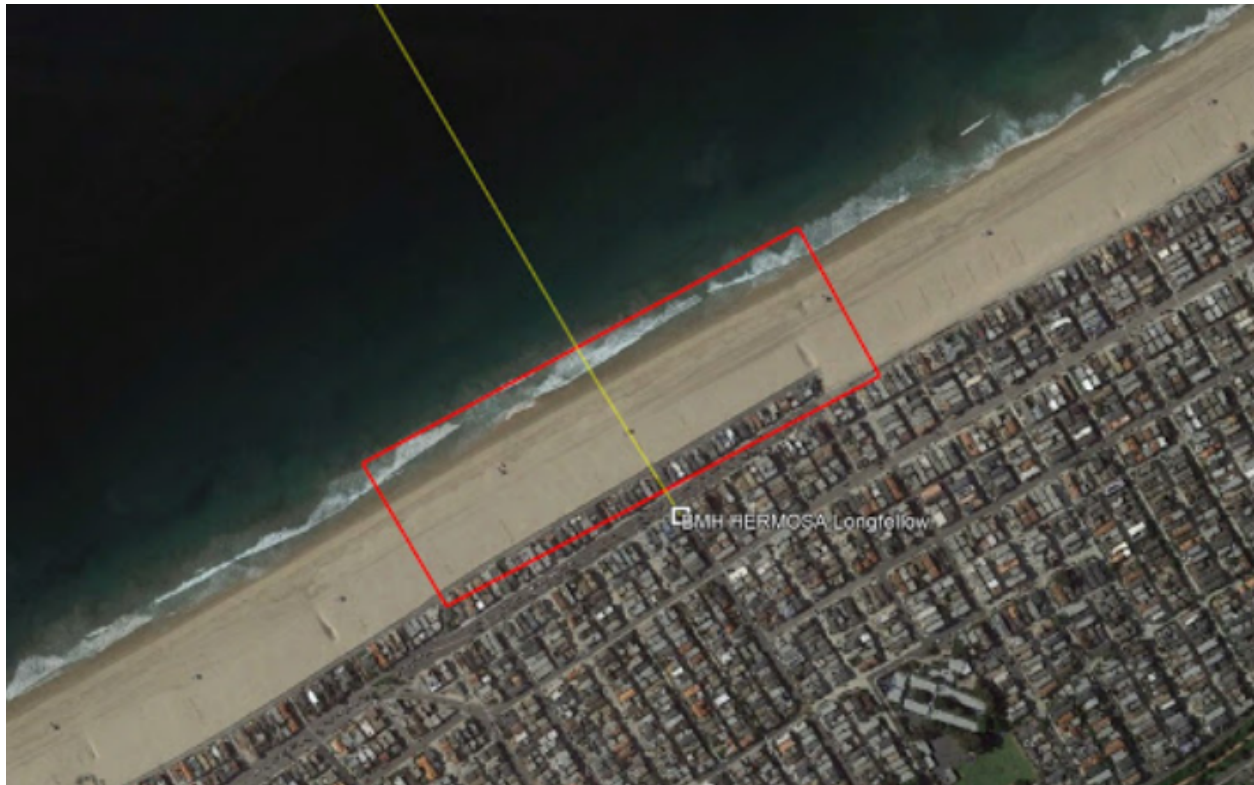
Figure 2: Topographic Survey Area

A topographic survey was conducted in a 500 meter wide corridor centered about the BMH HERMOSA Longfellow Avenue Manhole Site (see below Figure 2). The topographic landing survey identified access points and infrastructure in the survey area. Topographic features were located from the concrete boardwalk abutting the beach down to the waterline at low tide. Other permanent features such as utility locations were also mapped within the 500m beach corridor.

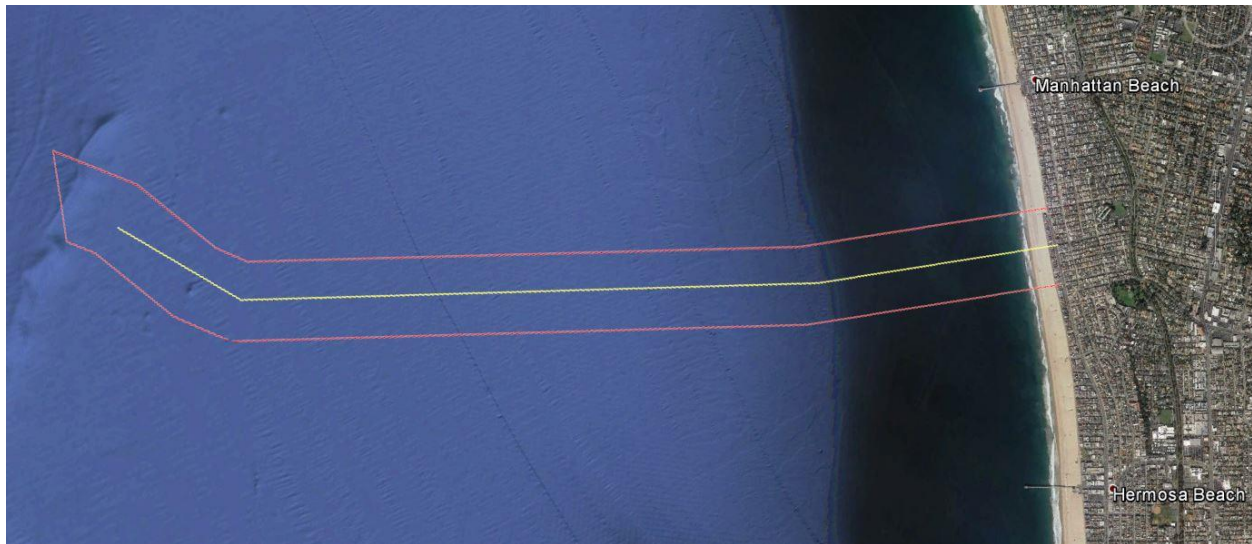
**Figure 3: Nearshore Survey Area**

The nearshore survey consists of a polygon bounded by a buffer of 250 meters to either side of the cable alignment and 500 meters offshore of the 3nm state waters boundary (see Figure 3). The nearshore extents of the survey area for all bathymetric and geophysical operations is defined as the 3m contour in reference to LAT. All operations required in the nearshore survey area will support the measurement, study, and investigation of the bathymetry, seabed features, shallow geology, and potential hazards along the cable route.

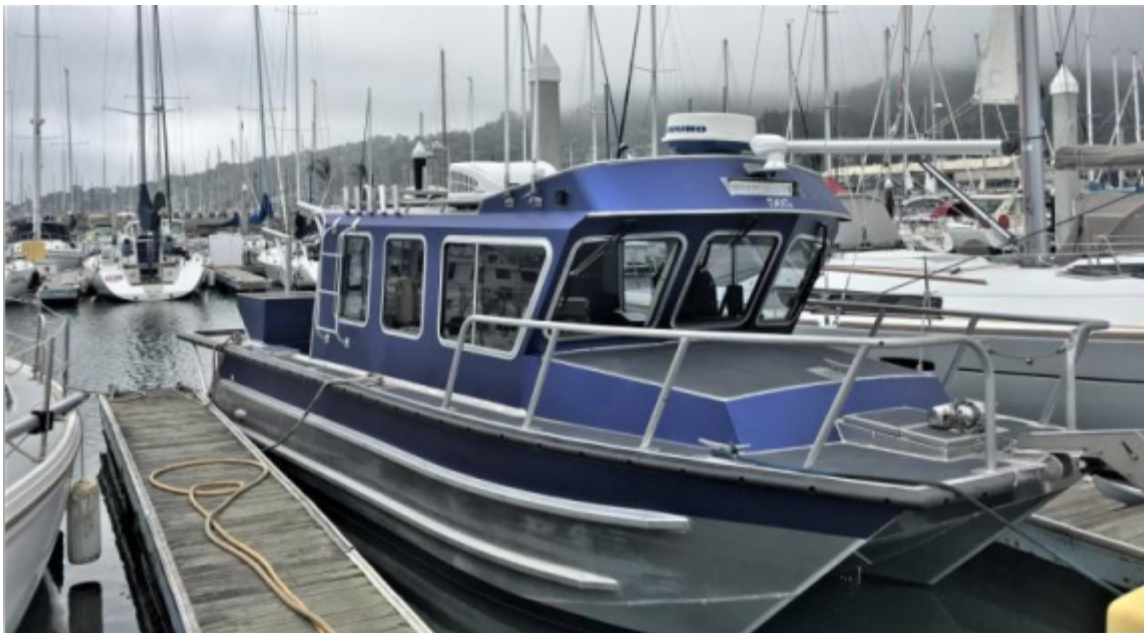
Figure 4: R/V 505

On R/V 505 a positioning and motion detection system was installed on the vessel with a long antenna base allowing maximum heading accuracy. A multibeam system was mounted with a Universal Sonar Mount (USM). The sediment sampler was deployed and retrieved via the onboard electric winch. The sidescan sonar and sub-bottom system were towed using a sheave with a block and winch off the stern of the vessel. The magnetometer was towed in tandem with the sidescan sonar.

As detailed in the mobilization report R/V 505 (Figure 4) and the WAV-V 20 (Figure 5) were used for hydrographic survey operations for this project. R/V 505 was also used for all geophysical survey operations for this project.

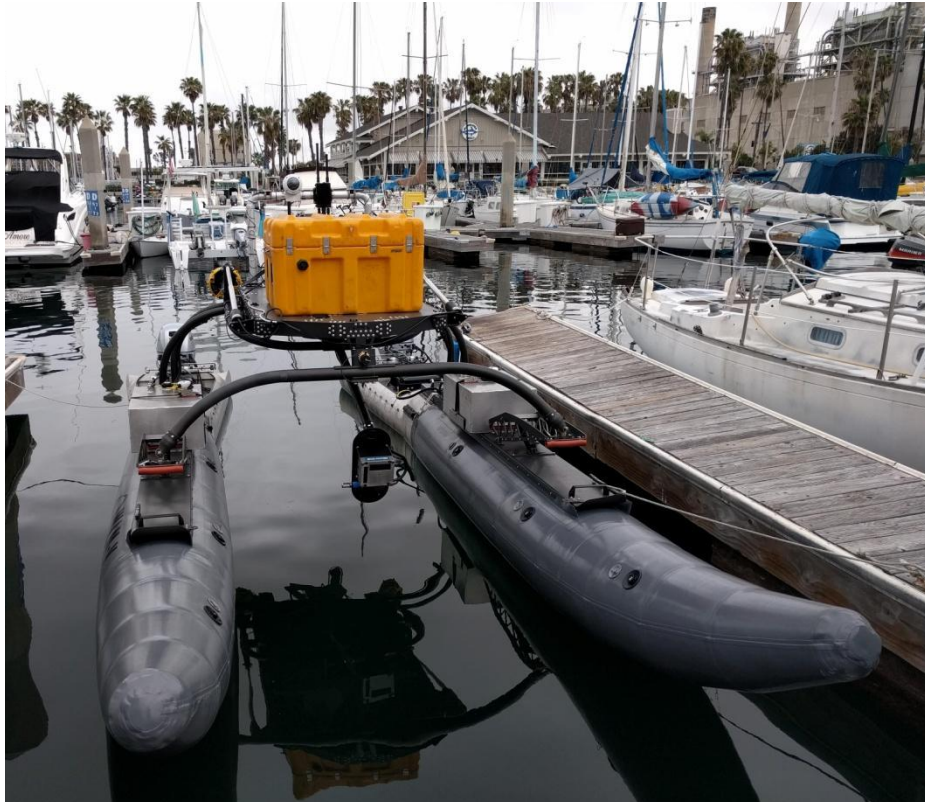
Figure 5: WAM-V 20

On the WAM-V 20 a positioning and motion detection system was installed on the vessel with a long antenna base allowing maximum heading accuracy. A multibeam system was mounted with a custom sonar mount.

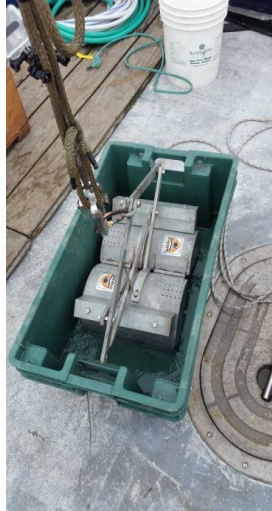
Figure 11: WILDCO Ponar Grab Sampler

A WILDSCO Ponar grab sediment sampler system was used for all sediment collection( Figure 11). The Ponar grab is a self closing stainless steel grab sampler and has a sample volume of 500 Cubic Inches and measures 9'Wx9'L. Further details of the grab sampler can be found in the Mobilization Report.

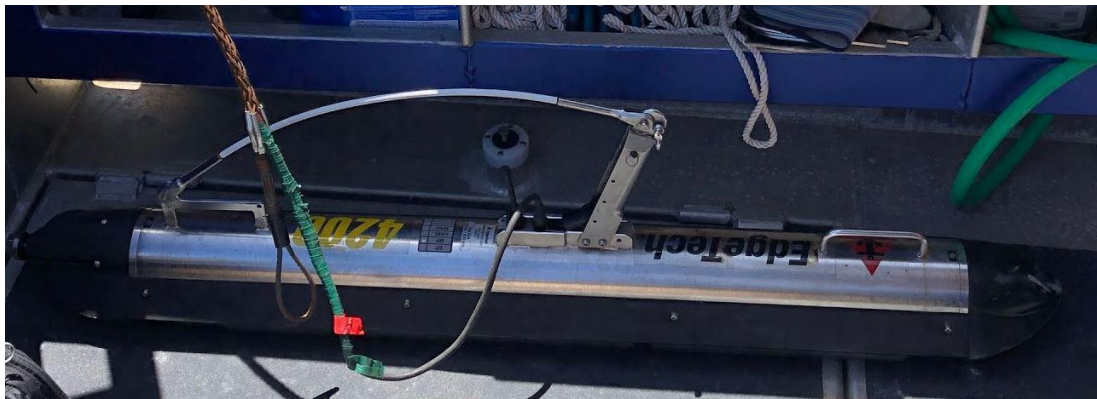
Figure 12: EdgeTech 4200 Sidescan Sonar

Layback of the tow fish was computed in SonarWiz software (catenary and cable incl.) using both physical measurements from the cable (alternating 2 and 3 meter markings) as well as an electronic hall effect sensor-based cable counter on a dedicated sheave. The sheave was suspended from a davit towed from a point on the centerline of the stern of the vessel. Electronic cable payout information was input in real-time via serial data to the acquisition computer and applied in the SonarWiz software.

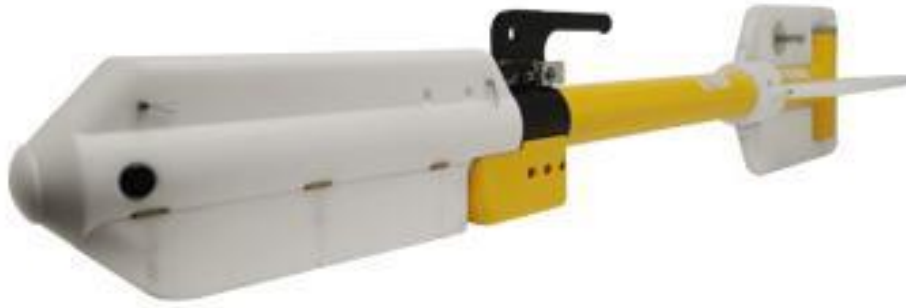
**Figure 14: Geometrics G-822 Cesium Magnetometer**

As discussed in the mobilization report R/V 505 was mobilized with a Geometrics G-882 cesium marine magnetometer (Figure 14) to detect cable crossings. This system detects ferrous objects below and at the surface of the seabed.

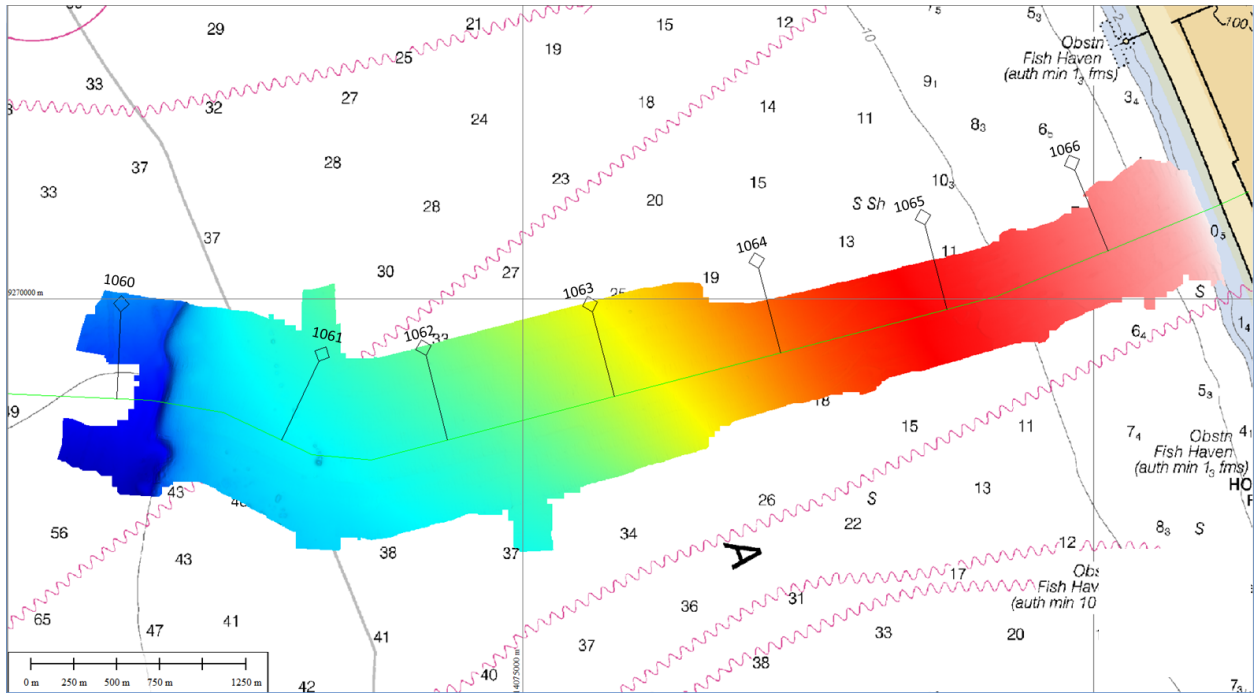
Figure 16: Multibeam Coverage

100% multibeam coverage with 20% overlap was achieved through the entire survey area. Multibeam data was collected over the 500m wide corridor centered about the HKA Cable RPL to the BMH Hermosa landing site. Depths ranged from approximately 1m LAT on the landward end (KP 1066.60000) to 99m LAT on the seaward extents (KP 1060.20000) of the survey area. Additional coverage was run at the deeper end of the corridor near the elbow. The purpose was to provide possible alternative routes due to observed gas seeps near the elbow. The additional wing lines expanded the multibeam coverage to approximately 1000 meters in width at the seaward end of the corridor.

The average density was eight (8) soundings per node and a maximum of forty (40) soundings in a grid cell was achieved in parts of the survey area. Spurious soundings were identified where two soundings from different passes were not in agreement. All position data was successfully collected and applied in processing. Data was successfully aligned to the LAT vertical datum using a continuous tide file and offset to LAT. MBES depth coverage through the entire survey corridor is displayed in the image below in Figure 16.

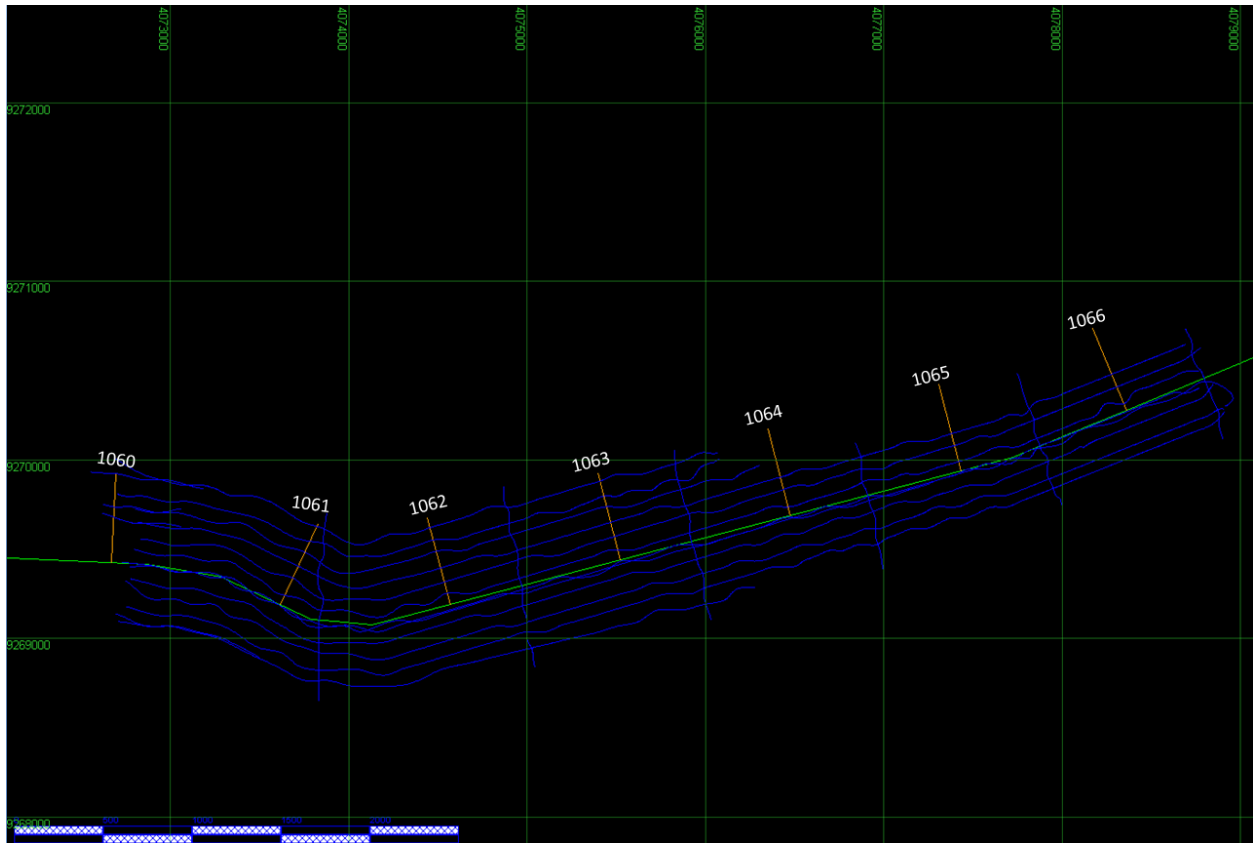
Figure 20: Sub-Bottom Acquired Lines

100% of planned survey lines were run. Twenty-two (22) sub-bottom lines were acquired along 18 planned lines. The lines covered the entire survey area. 80m spaced lines were run parallel to the Route Plan Line, with two (2) 100m spaced lines and Six (6) cross lines at equal spacing where run perpendicular to the RPL. The sub-bottom line coverage is shown below in Figure 20 with the survey area displayed as a white polygon and the bathymetry grid in background.

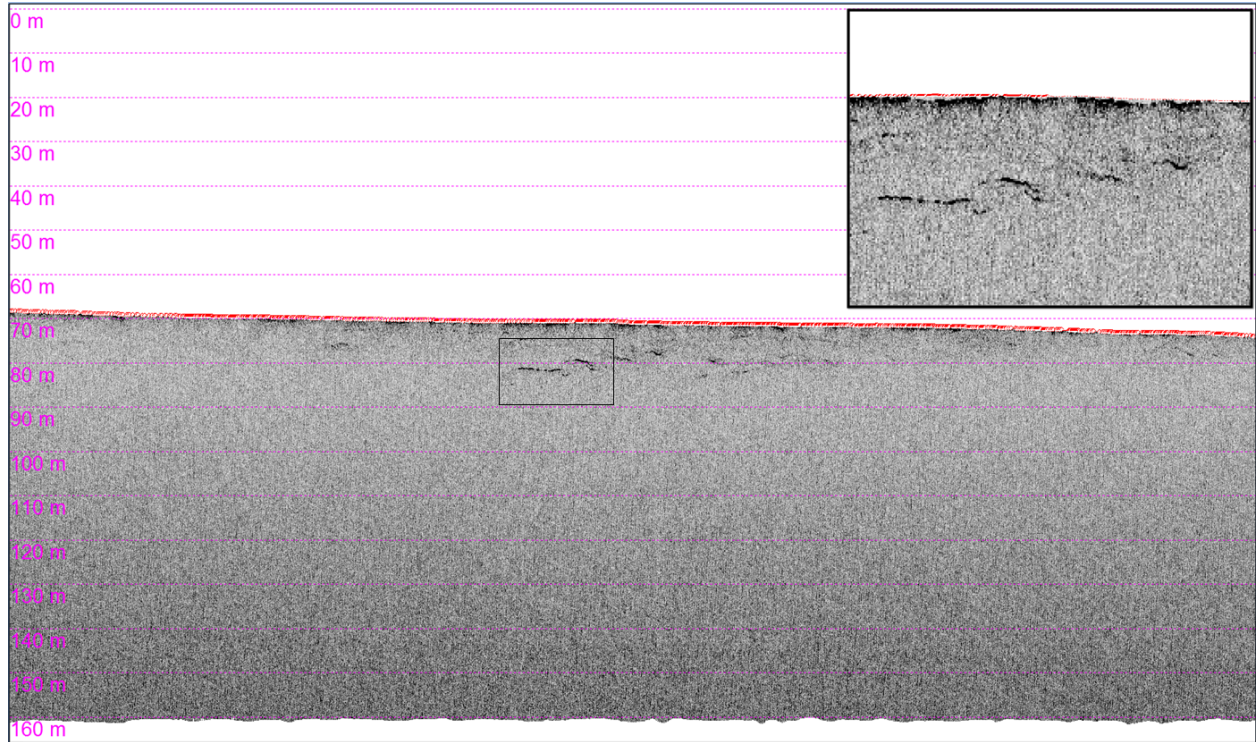
Figure 21: Subsurface Sediment Facies in Sub-bottom Data

Figure 21 below shows an example of subsurface sediment facies identified in Chirp sub-bottom data.

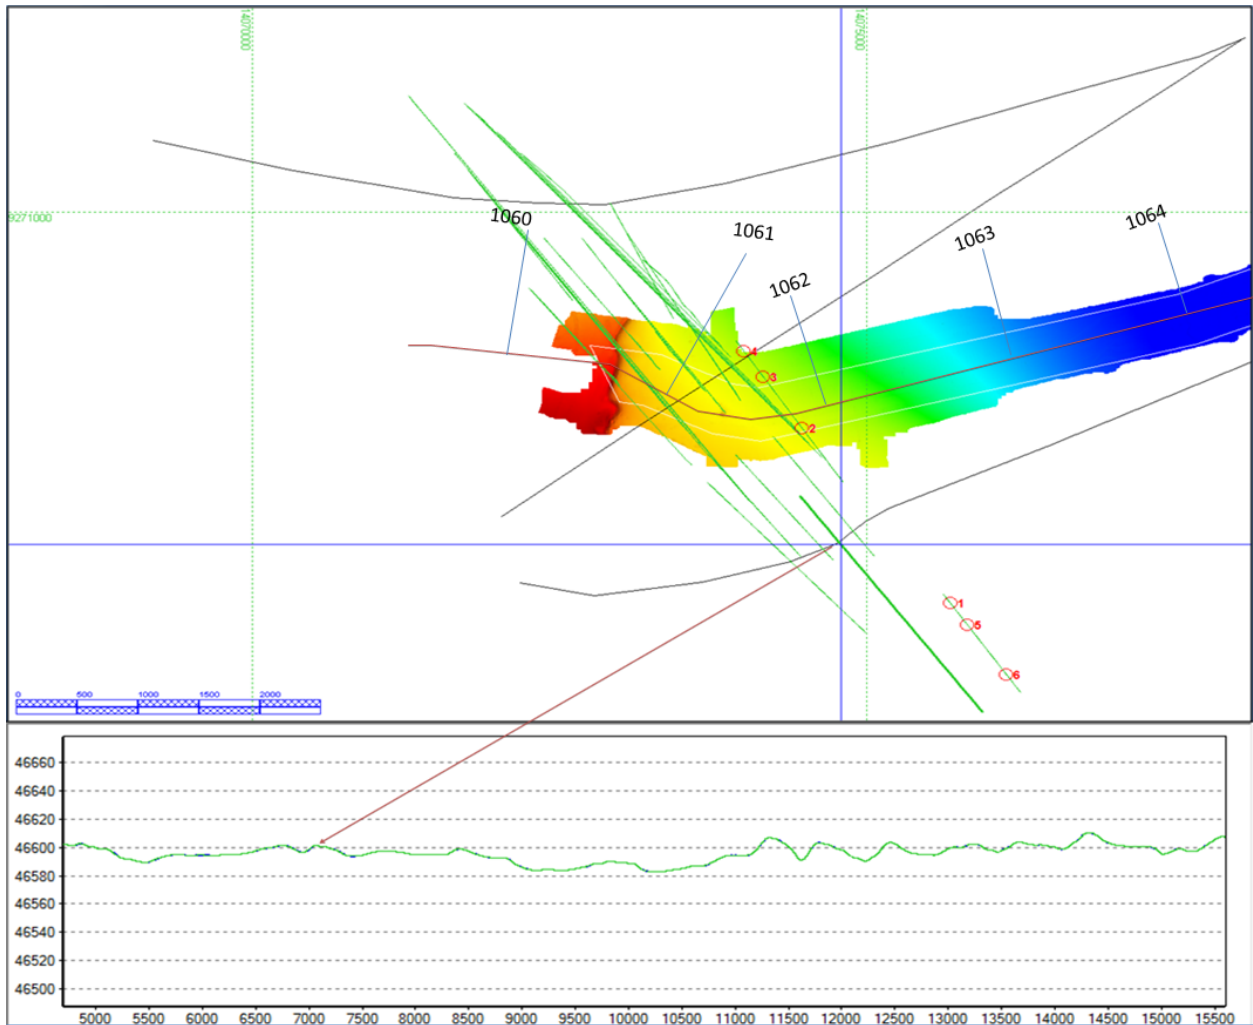
Figure 25: Profile of Magnetometer Data over the Charted Cable Route with no Return

Data across the cables showed no obvious return aside from the ambient magnetism of the survey area. The point in the profile, the magnetometer crosses a charted cable route is shown below in Figure 25.

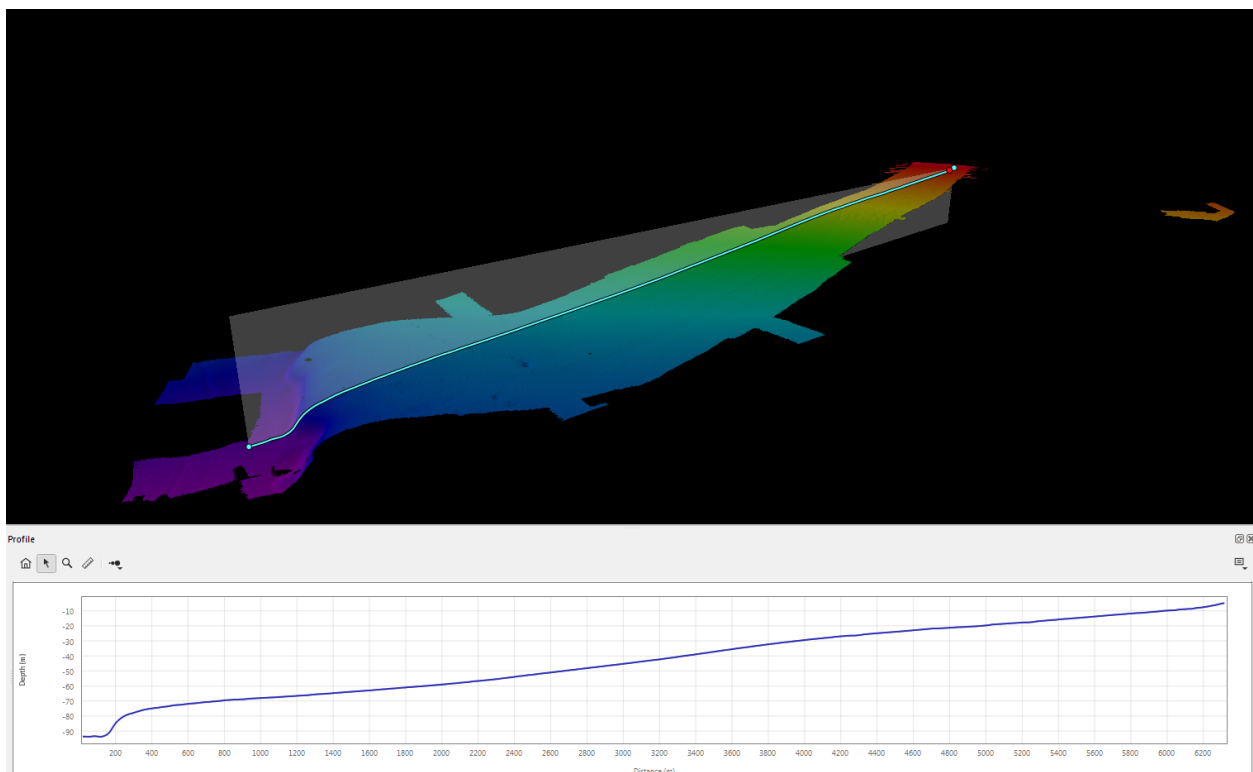
Figure 26 Overview of the bathymetry across the survey area with profile (vertical exaggeration x 6)

The bathymetry in the area ranges from 0m below LAT at shore to a maximum depth of 98m offshore. The bathymetry undulates downward from shore to offshore. The slope is an average of  $0.8^\circ$  and consistently between  $0.5^\circ$  and  $1^\circ$  aside from between KP1066.50 to 1060.50 with only a slight change between KP1064.00 and KP1063.00 where the slope flattens slightly from KP1064.00 to 1064.40 to less than  $0.5^\circ$  and becomes steeper to  $1.5^\circ$  between KP1064.40 to 1063.00 before returning to the consistent shallow slopes at 1063.00 towards offshore. An overview of the bathymetry is shown below in Figure 26.

Generally, the seabed gradient in the survey area is shallow, with the exception of a shelf that was observed at the western end of the survey area with an approximately 14% grade slope. Depths in the survey area range from approximately 1m LAT to 99m LAT.

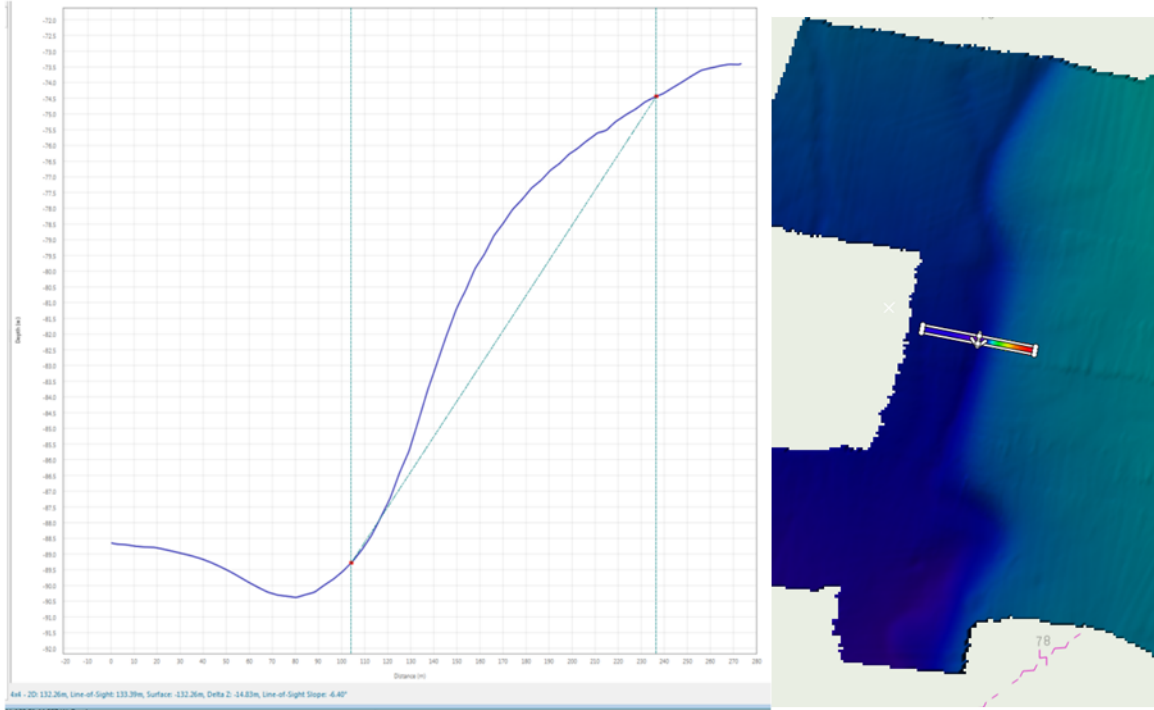
Figure 27: Shelf Observed in MBES Data

At KP 1060.3 a large shelf was observed at the western end of the survey area (see Figure 27 below). The toe of slope appears to intersect the RPL alignment around 33°51'53.30"N, 118°28'31.14"W (14072916.58E 9269441.854N ; KP 1060.32424). Depths drop from approximately 78m down to approximately 92m over a 100m range (approximately 14% grade slope).

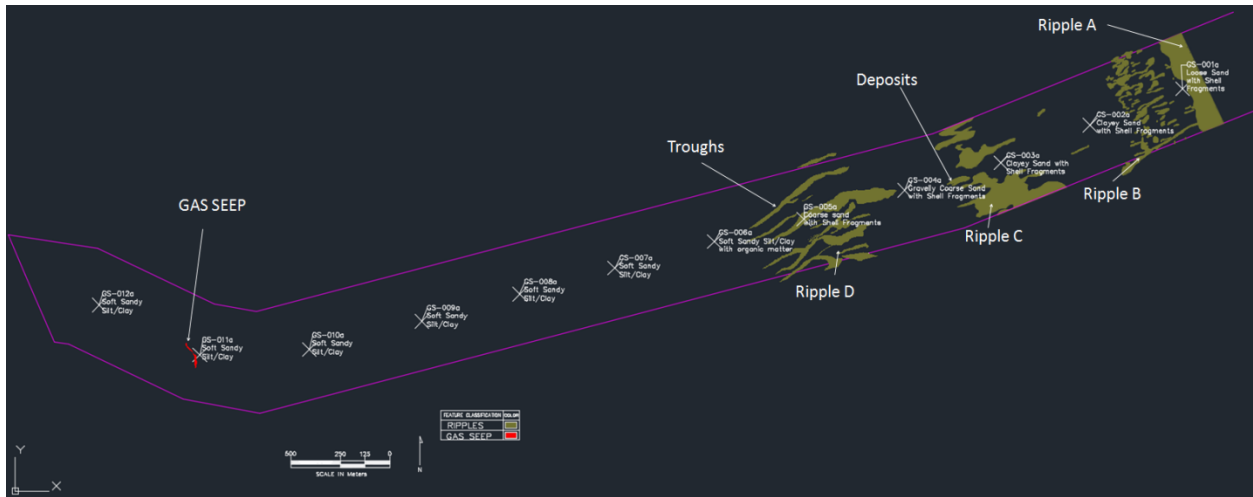
Figure 37: Surface Geological Features across the survey area

Four (4) different classes of geologic features were found within the sidescan sonar data. Firstly, a gas seep with associated pock marks was found during data collection in the field. The seep was clear in the multibeam, sidescan sonar as well as the sub-bottom chirp. Secondly, four different areas of sand ripples were distinguished throughout the survey area. Thirdly, troughs and finally, deposit features were identified at the surface in the survey area. These surface geological features are described below. Figure 37 shows the location of the surface geological features.

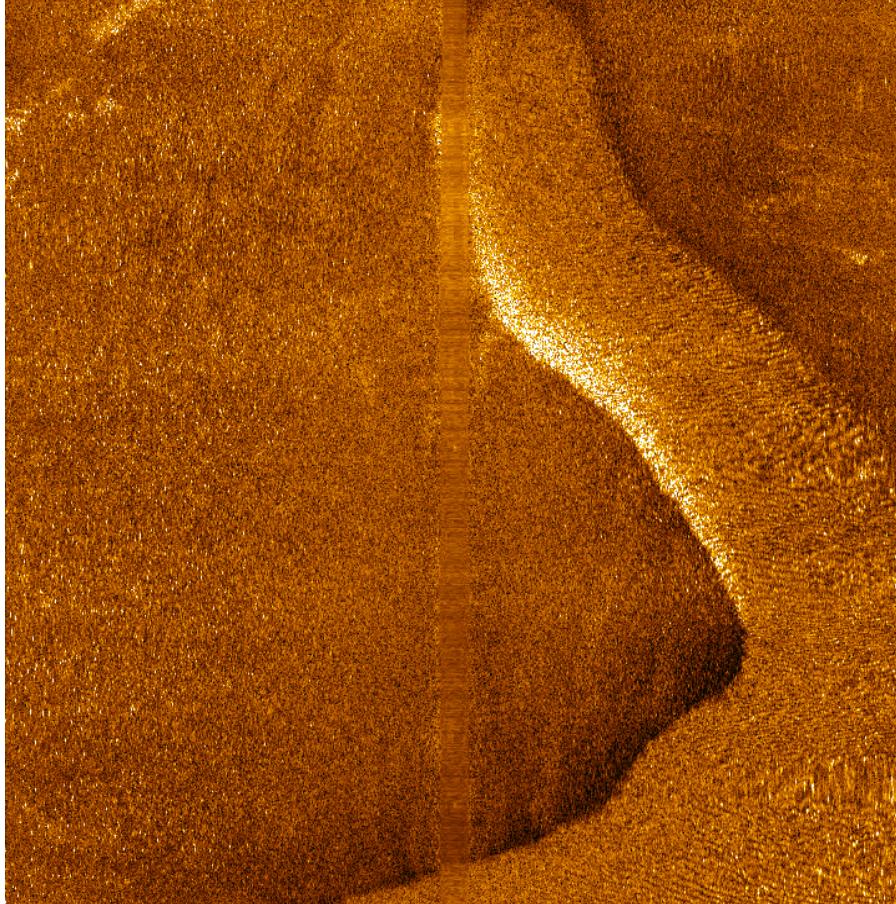
An area of ripples (Ripple C) occurs at a depth range of approximately 15m to 20m in an area where the seafloor has been categorized as “clayey sand” (KP 1065.66000 to KP 1065.19000). These ripples are within between the deposit features described below. The ripples are in a transitional zone between clayey sand and gravelly coarse sand where mounds of soft sandy silt-clay begin to appear. The ripples are straight and sinuous which is indicative of a low energy environment. They have small wavelengths of between 0.3 and 0.4m and heights less than 0.2m.

Figure 46: Ripple C area in Low Relief Depressions (Example 1)

**Figure 47: Ripple C in Low Relief Depressions (Example 2)**

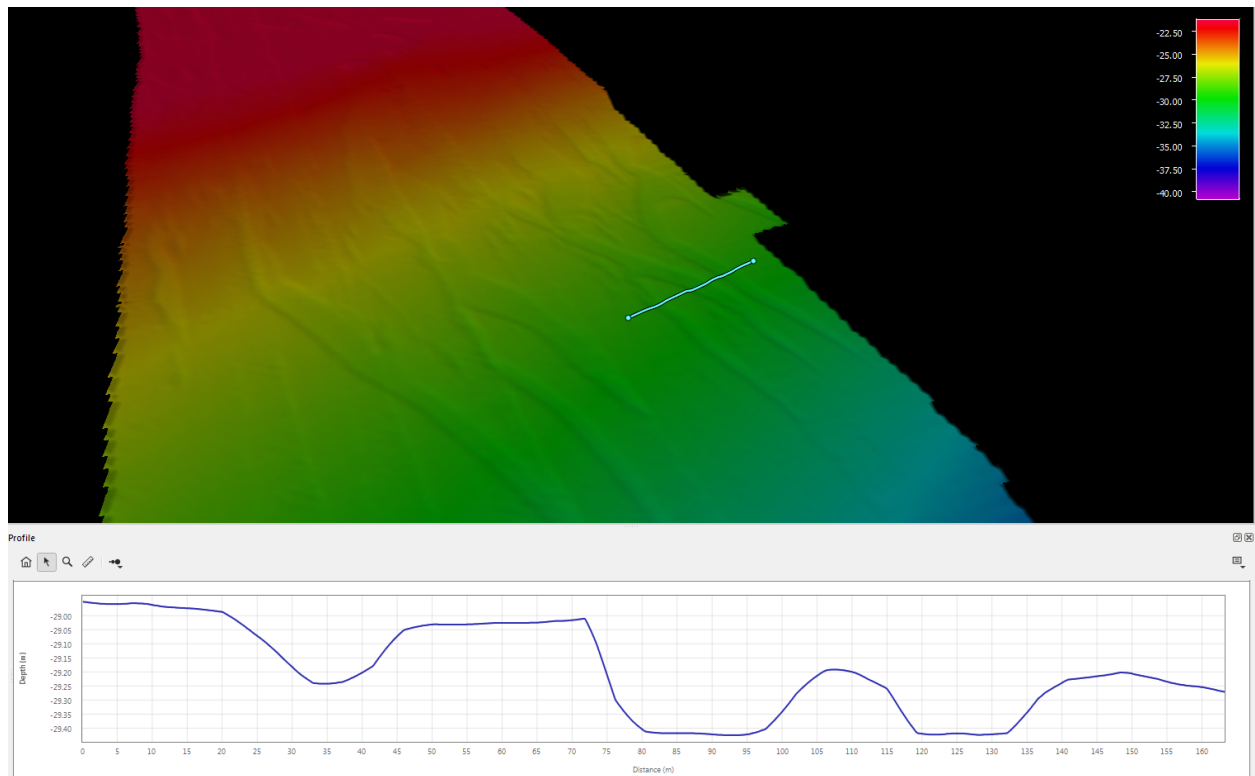
400m offshore from the deposit features between KP1063.8 and 1063 are a series of troughs. These are perpendicular to the shore line and up to 600m long. Widths of the features range from 40m to 60m. The troughs are found at 30m depth and within them are sand ripple deposits (Ripple D). The trough features as imaged in the multibeam echosounder data are shown below in Figure 53 and Figure 54.

**Figure 53 Trough features**

Figure 54 Profile across trough features showing dimensions

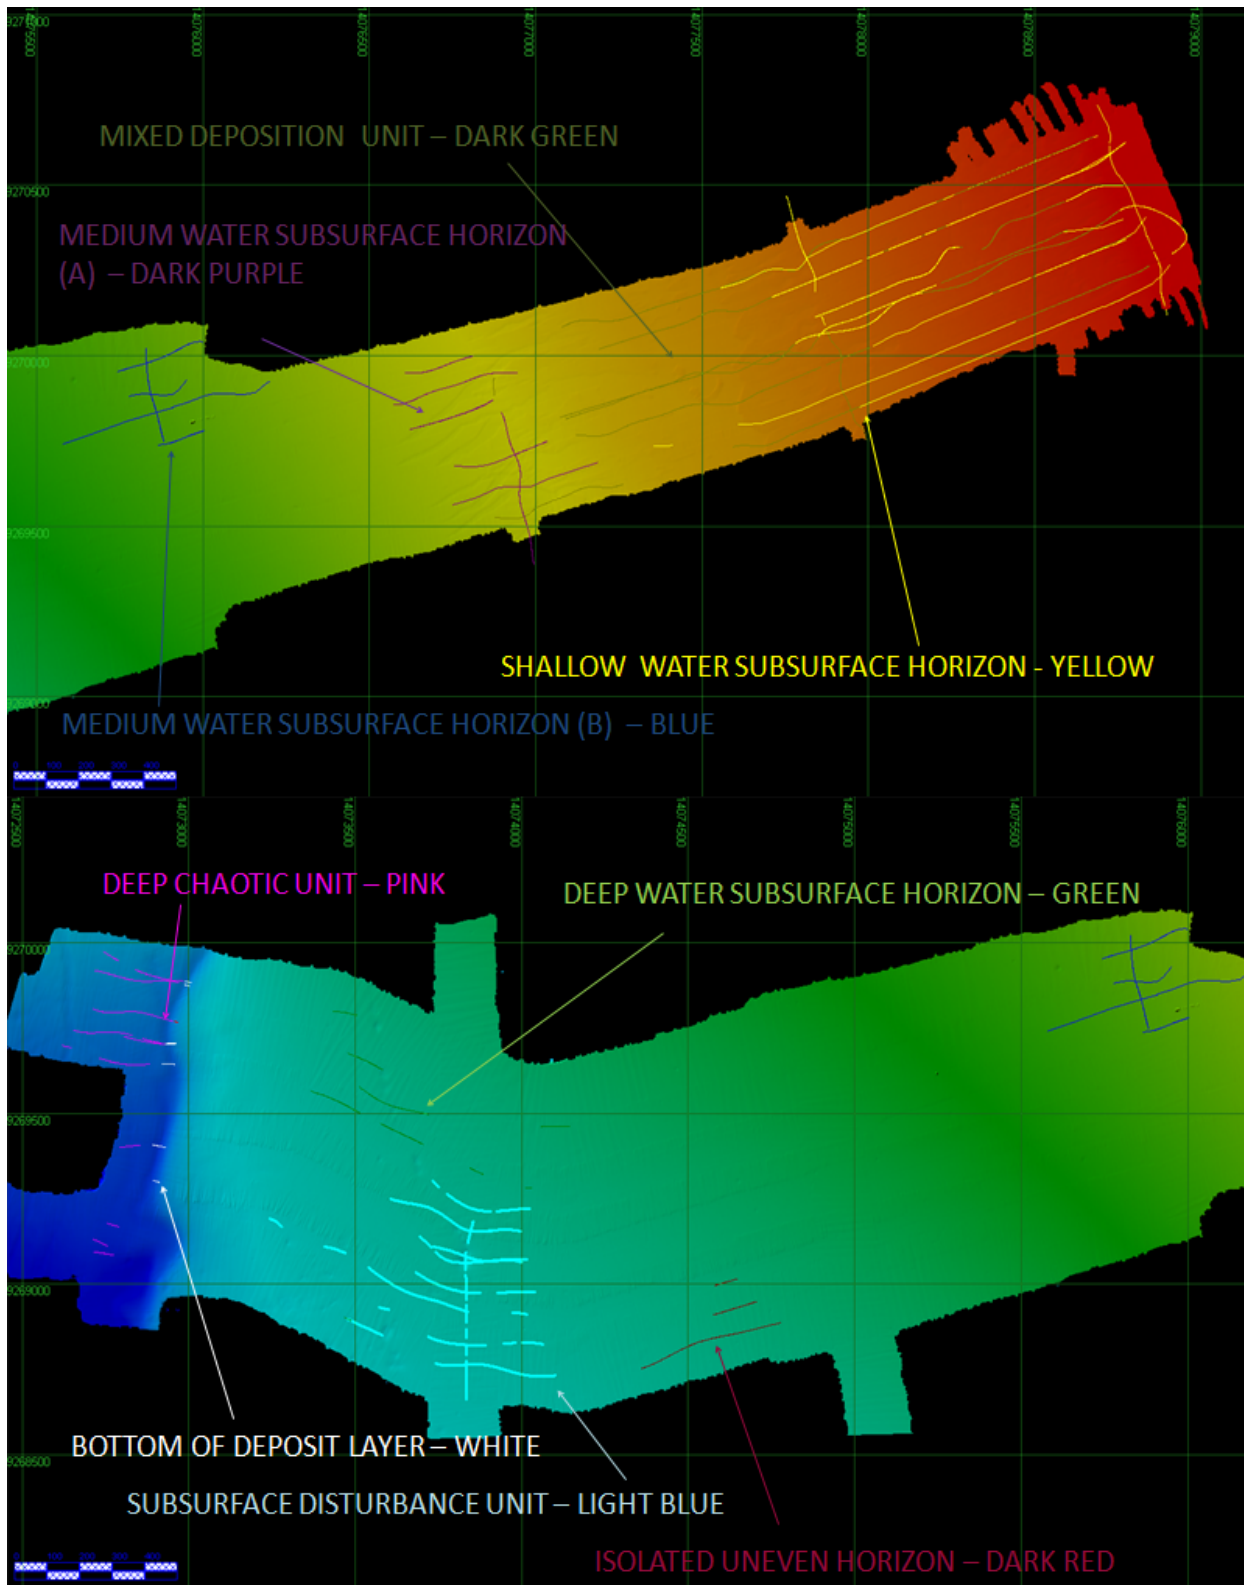
Figure 55: Subsurface Facies Identified Across the Survey Area

No core sample information was obtained or could be found within the survey area. Therefore, no attempt has been made to classify the sub-surface soil types. The surface sediment type is identified for each unit which can be assumed to be the sediment type from the surface to the first horizon.

Single, subsurface horizons suggesting a change in deposited, sediment from the surface were identified across the area. These horizons were identified across adjacent profiles to determine contiguous areas with subsurface change. The subsurface horizons were categorized based on the water depth at which they were identified. Four (4) categories of horizon were created; shallow water subsurface horizon (horizon found in the shallow water depths from 0-20m), two medium water depth horizons (located in water depths of 25-50m) were identified and divided as (A) and (B). A final deep water depth horizon was identified (below depths of 65m).

Nine (9) categories of horizon or subsurface sediment unit were created; shallow water subsurface horizon (horizon found in the shallow water depths from 0-20m), two medium water depth horizons (located in water depths of 25-50m) were identified and divided as A and B. A final deep water depth horizon was identified (below depths of 65m). In addition, the bottom of the deposit layer horizon, a deep chaotic unit, a mixed deposit unit, isolated uneven horizon and subsurface disturbance unit were identified.

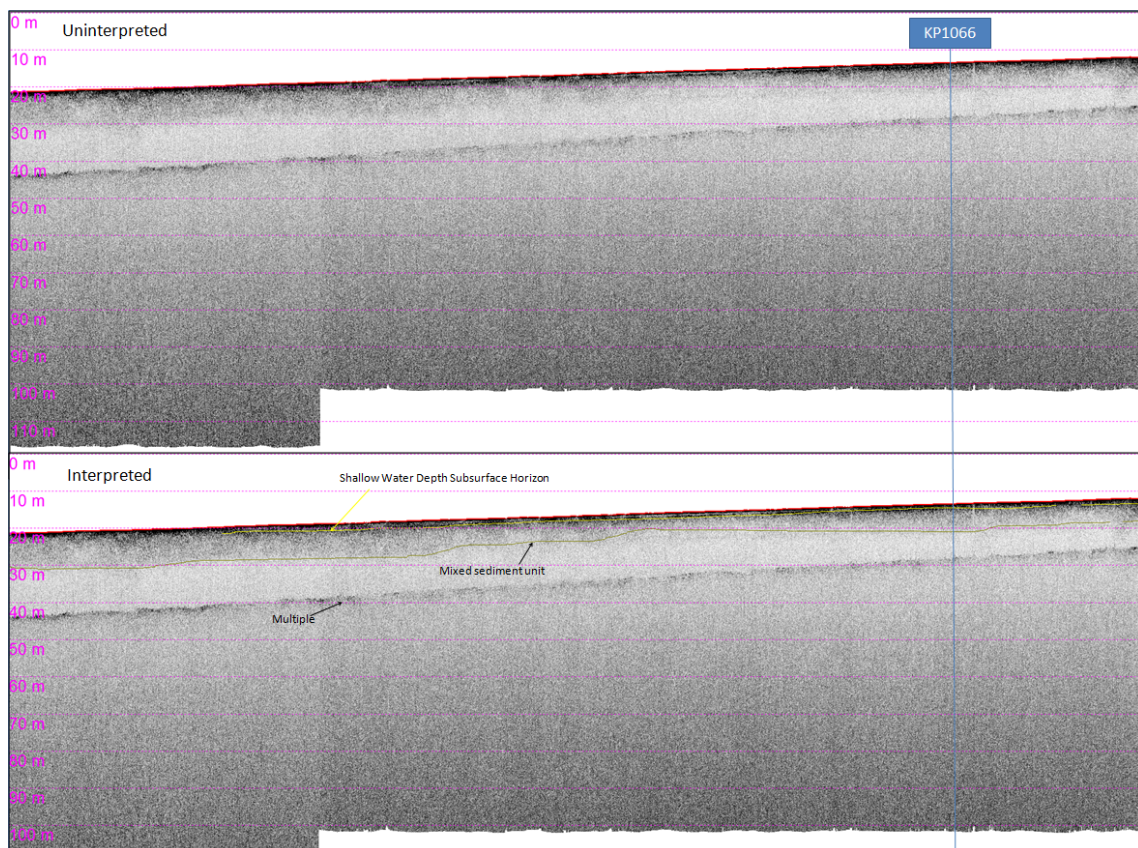
These horizons are observed at different depths below the seabed. The shallow water horizon is near the seabed surface at depths below the seabed averaging between 1 and 3m. The subsurface horizon medium water (A) is at similar depths below the surface at 1 to 3m. Depths below the surface for medium water unit (B) were between 4 and 6m. The subsurface horizon in deep water is at similar depths below the seabed. Examples of these horizons are shown below in Figure 56, Figure 57, Figure 58, and Figure 59.

Figure 56: Example of Shallow Water Subsurface Horizon

Figure 57: Example of Medium Water Depth Horizon (A) Subsurface Horizon

Figure 58: Example of Medium Water Depth Horizon (B) Subsurface Horizon

**Figure 59: Example of Deep Water Depth Subsurface Horizon**

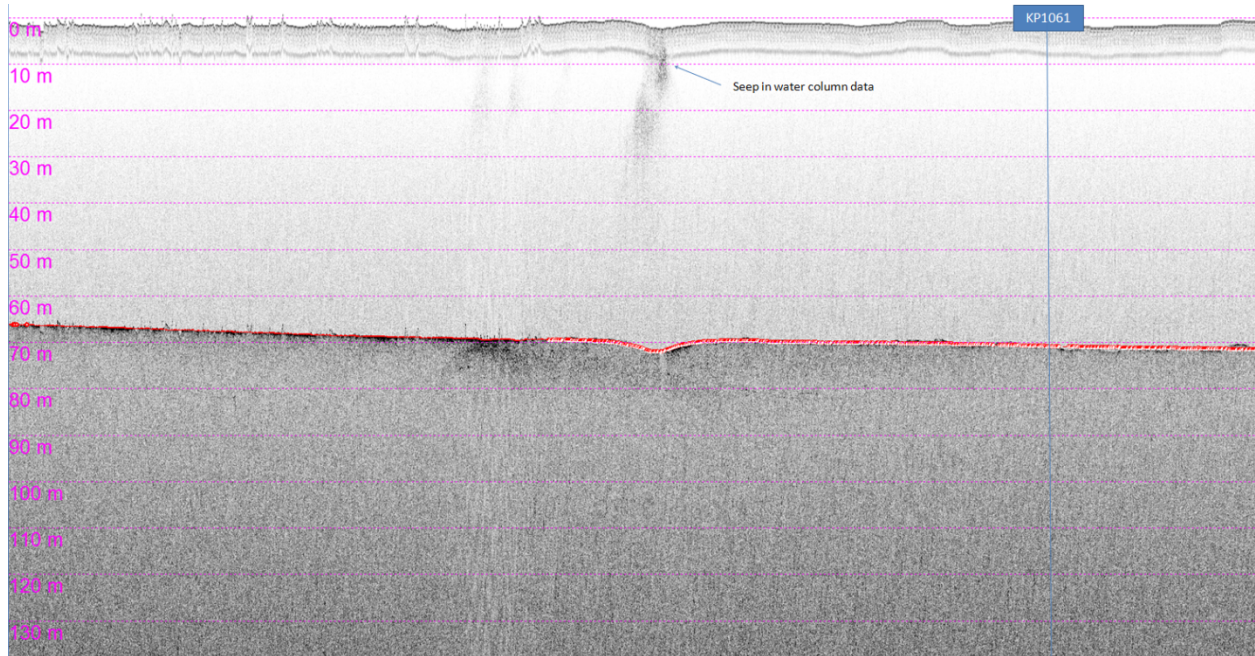
**Figure 61 Sub-bottom Profile with water column data included showing the seep detected within the dataset**

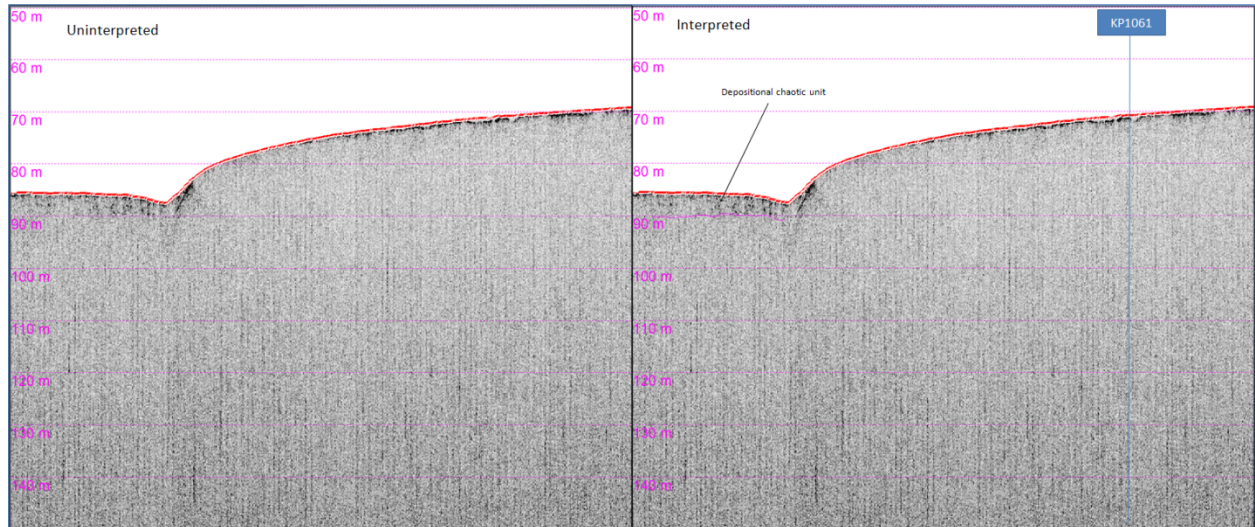
Figure 67: Profile from the CHIRP Sub-bottom Profiler Showing the Chaotic Unit at the Foot of the Slope Offshore in the Survey Area

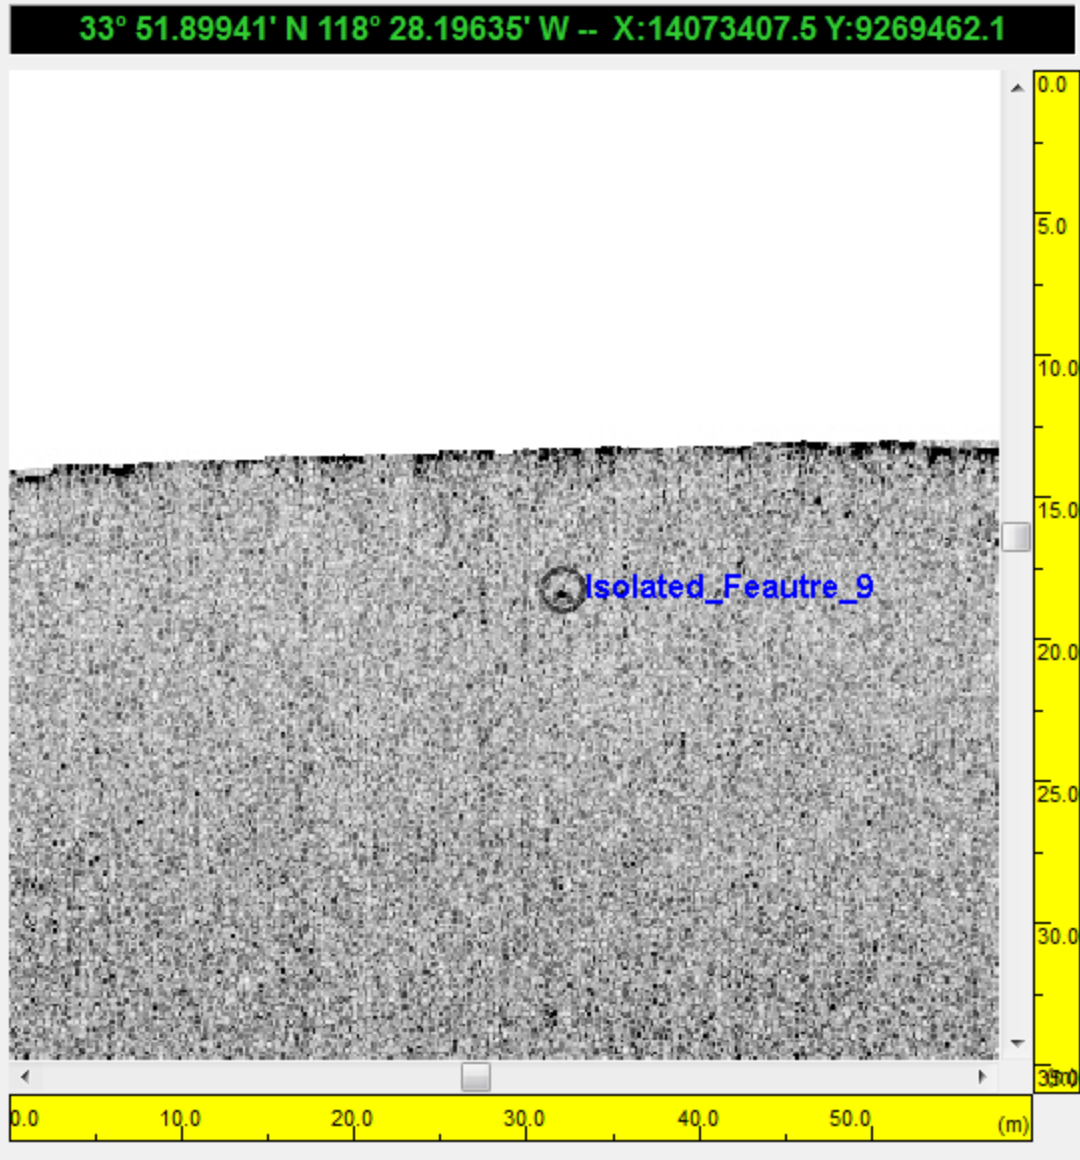
Figure 71: Isolated Feature 9 (SBP\_9) - An Unknown Subsurface Anomaly 5.5m below the Seabed
