Hydrographic Survey

Dynegy Morro Bay, LLC. Morro Bay Power Plant Marine
Terminal Decommissioning Project
Morro Bay, CA

Report of Survey

Pre Decommissioning
July 23, 2018

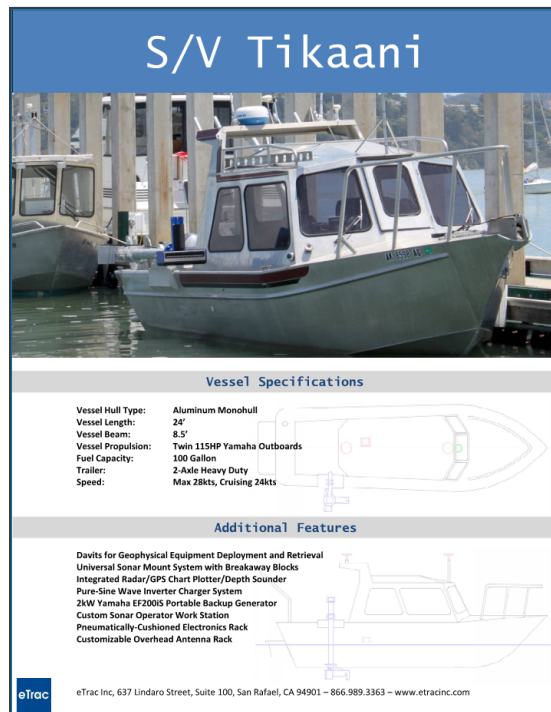
Figure 2 SV Tikaani specifications

All work was completed onboard survey vessel *S/V Tikaani*. *S/V Tikaani* is an aluminum monohull, hydrographic survey vessel of 24ft. *S/V Tikaani* is field proven, having conducted numerous hydrographic and geophysical surveys throughout Southern California with towed and mounted sensors. It is easily transported and can be mobilized for survey rapidly.

A positioning and motion detection system was installed on the vessel with a long antenna base allowing maximum heading accuracy and better results in areas with low GNSS coverage. *Tikaani* had all offsets on the vessel measured while on a trailer to ensure that measurements to and from the positioning equipment are accurate to less than 3cms. The vessel is equipped with a Universal Sonar Mount (USM) for side-mounted multibeam. The multibeam system was mounted on this specially engineered side mount. This mount positions the system with 100% repeatability and allows for surveying in shallow water due to a specifically designed break away block (see Figure 2 for *Tikaani* specifications)

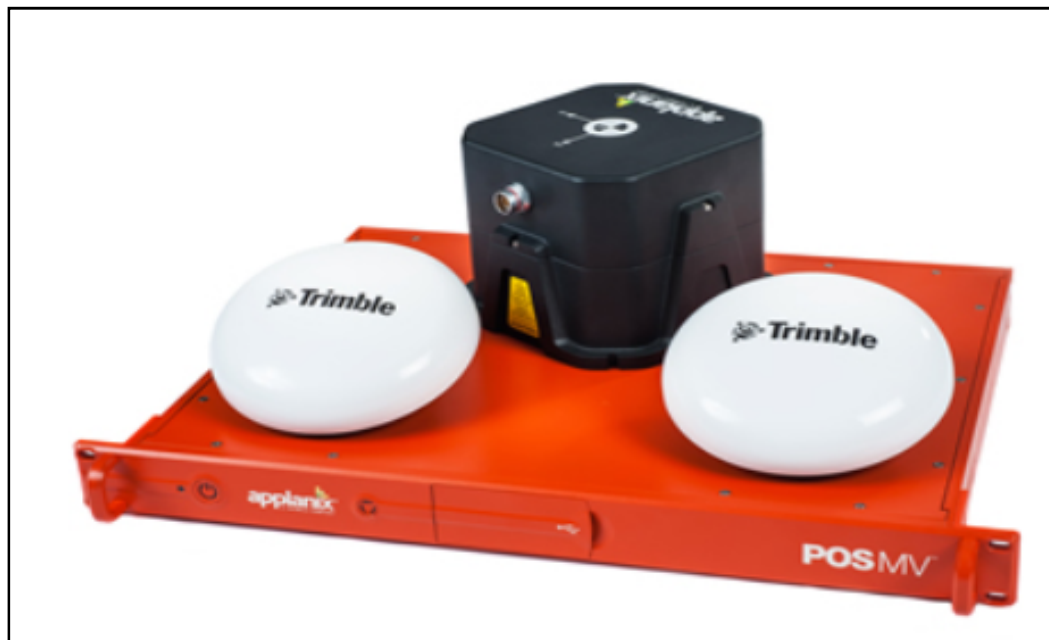
Figure 3 Applanix POS MV Oceanmaster

An advanced position and motion system was mobilized on Tikaani to accurately position the vessel and account of all motion on the water. The POS MV5 Wavemaster is market leading system with highly accurate positioning down to 3cms uncertainty. During field operation, the system received differential corrections from the WAAS network to operated in DGPS mode. All position, timing, and motion data was also logged to allow the creation of a post-processed position for highly accurate results.

Applanix POS MV V5 Wavemaster

- Position Accuracies PPK: Horizontal: +/- (8 mm + 1 ppm x baseline length)³
Vertical: +/- (15 mm + 1 ppm x baseline length)
- Motion Accuracies, Roll and Pitch: 0.015° in PPK
- Heading Accuracies: 0.03° (2 m baseline)
- Real time Heave 5cms and Trueheave Solutions available increasing to 3cms
- With POSpac Processing allows PPK solution with GLONASS AND GPS satellites.

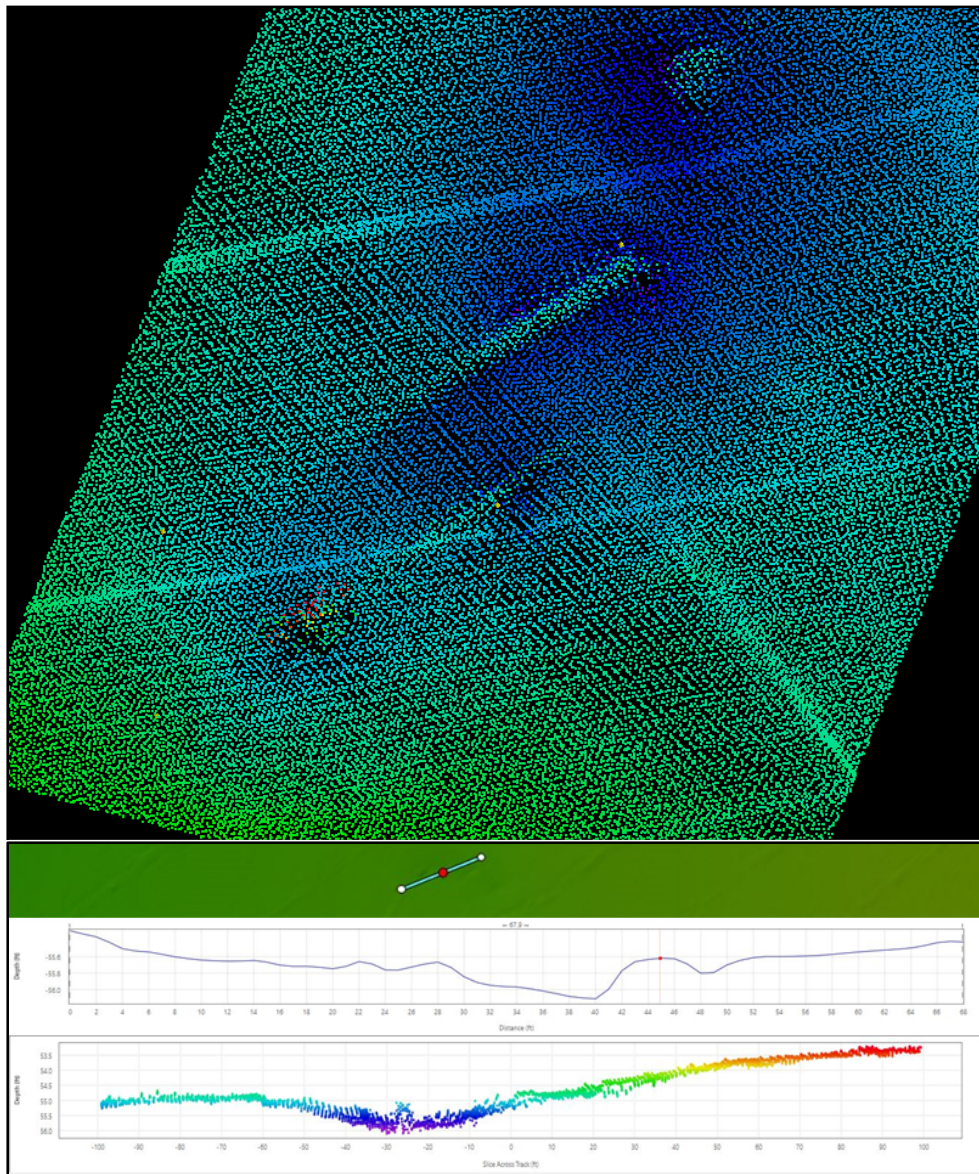
The pipeline was able to be identified when exposed above the seabed. The point definition on the pipeline was such that the top of the pipe was able to be determined for an accurate determination of alignment. Figure 14 shows the pipeline in the sounding data and the gridded data.

Figure 14 Pipeline as visible in the gridded multibeam data, profile data and 2D slide of sounding data

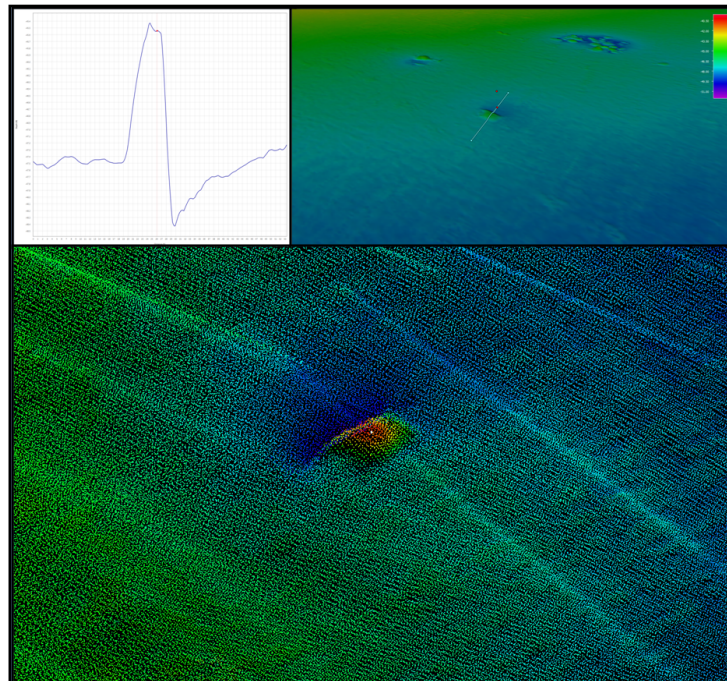
Figure 27 Rock objects

The rock objects were all similar dimensions (2-10ft diameter). An example of a rock in the survey area is below.

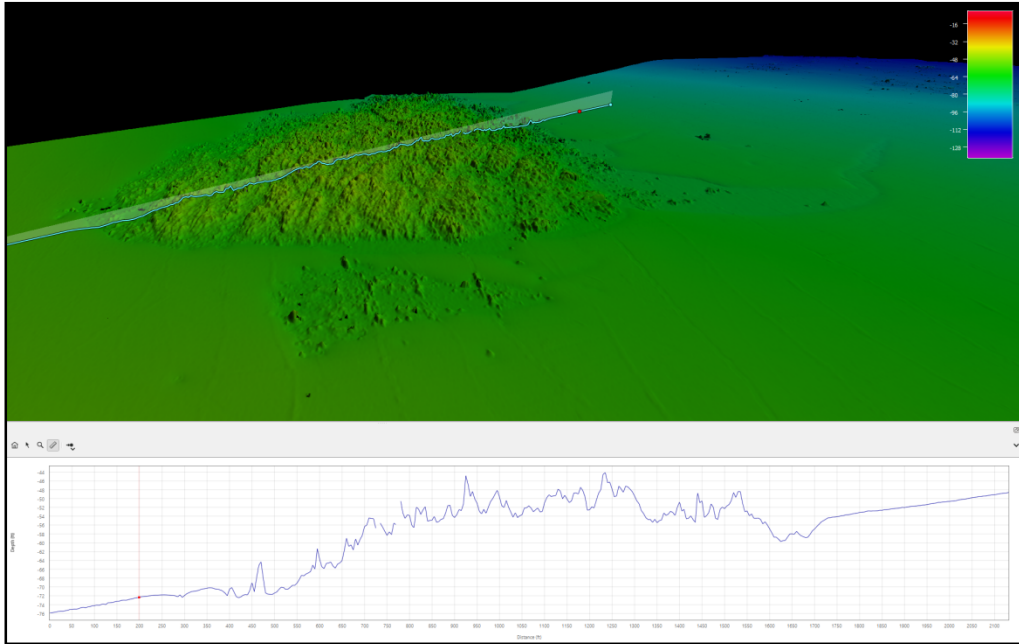
Another large rocky outcropping area is in the southern corner of the survey area. This is made up of one larger section (25 acres) and a smaller area (1 acre). This area can be seen below in Figure 27.

Figure 29 Southern Rocky Outcropping

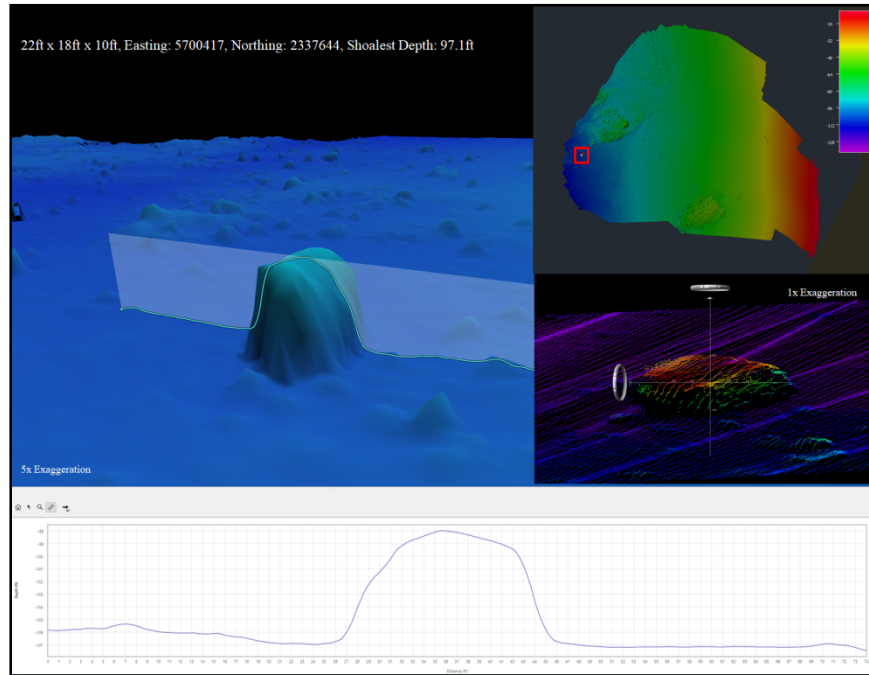
Also identified below is a boulder field located near the western limits just south of the rocky outcroppings. This field covers approximately 50 acres and contains over two hundred fifty boulders ranging in 2ft-22ft diameter. One of the larger boulders can be seen in the image below. This boulder has dimensions 22ft x 18ft x 10ft with a shoalest depth of 97.1ft MLLW.

Figure 31 22ft diameter boulder in boulder field
