**Hydrographic Survey
Encina Marine Oil Terminal
Decommissioning Project
Carlsbad, CA**

Report of Survey

September 27th 2018

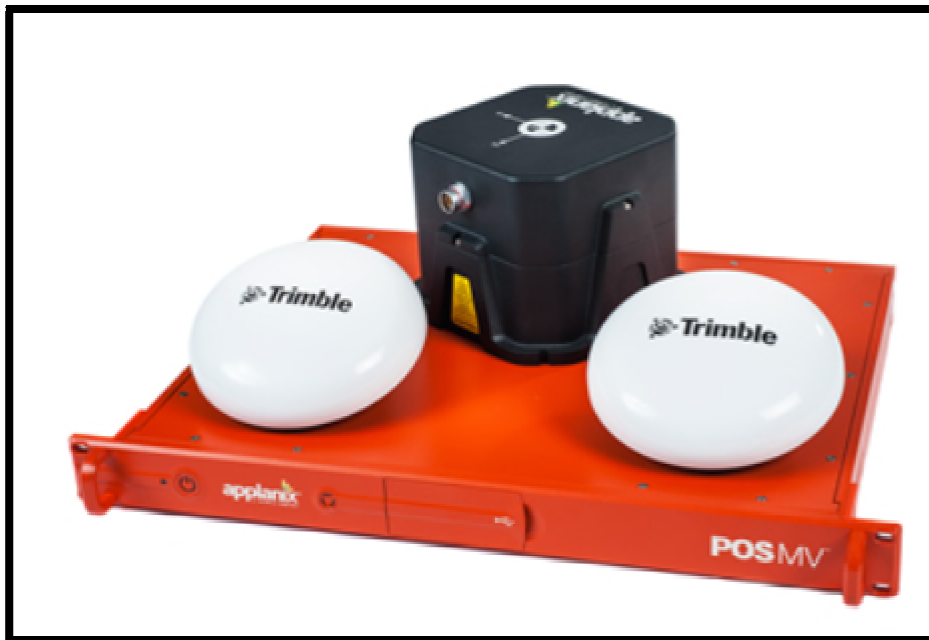
Applanix POS MV V5 Wavemaster

- Position Accuracies PPK: Horizontal: +/- (8 mm + 1 ppm x baseline length)³
Vertical: +/- (15 mm + 1 ppm x baseline length)
- Motion Accuracies, Roll and Pitch: 0.015° in PPK
- Heading Accuracies: 0.03° (2 m baseline)
- Real time Heave 5cms and Trueheave Solutions available increasing to 3cms
- With POSpac Processing allows PPK solution with GLONASS AND GPS satellites.

Figure 3 Applanix POS MV Oceanmaster

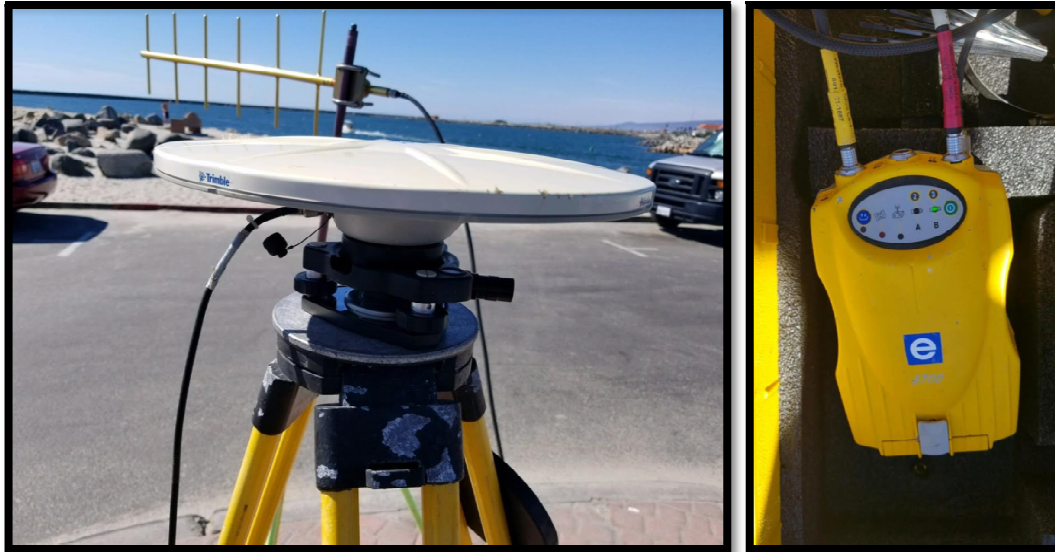
- Broadcasting RTK CMR+ and CMR 94 corrections
- Logging data with NetR5
- GPS and GLONASS

Figure 4 Trimble SP 5700 RTK base station set up for the project

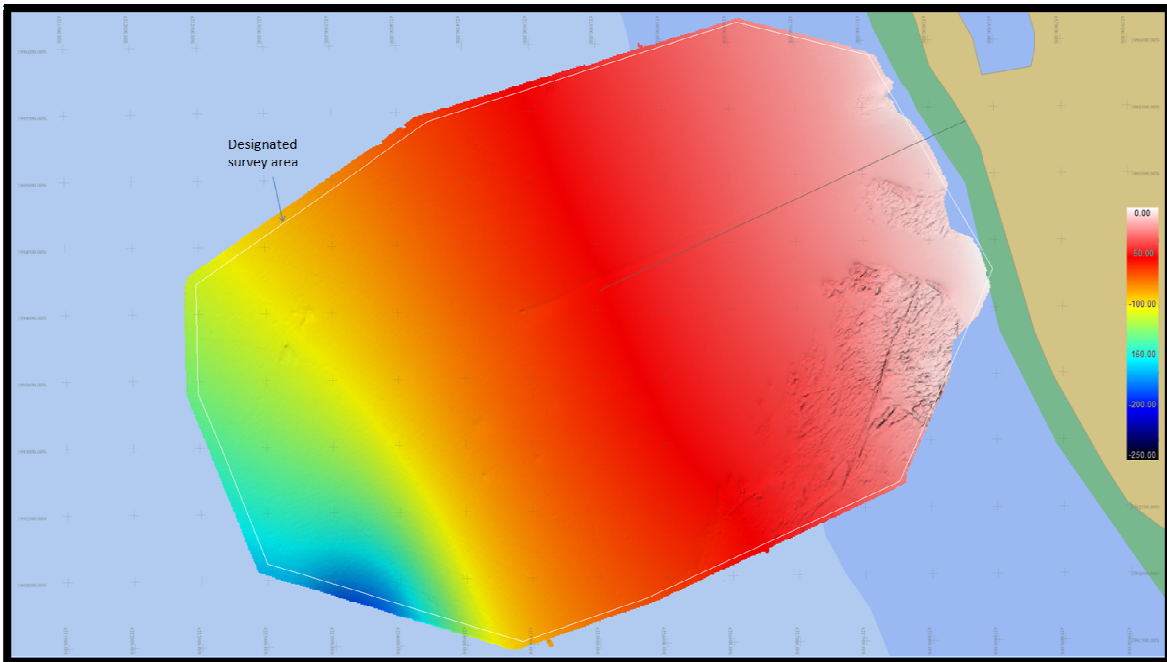
Multibeam coverage was achieved in entire survey area. All the position data was successfully post processed so that up to 100% of the data was post processed kinematic where accuracies of 0.1ft were achieved.

Figure 13 Multibeam coverage

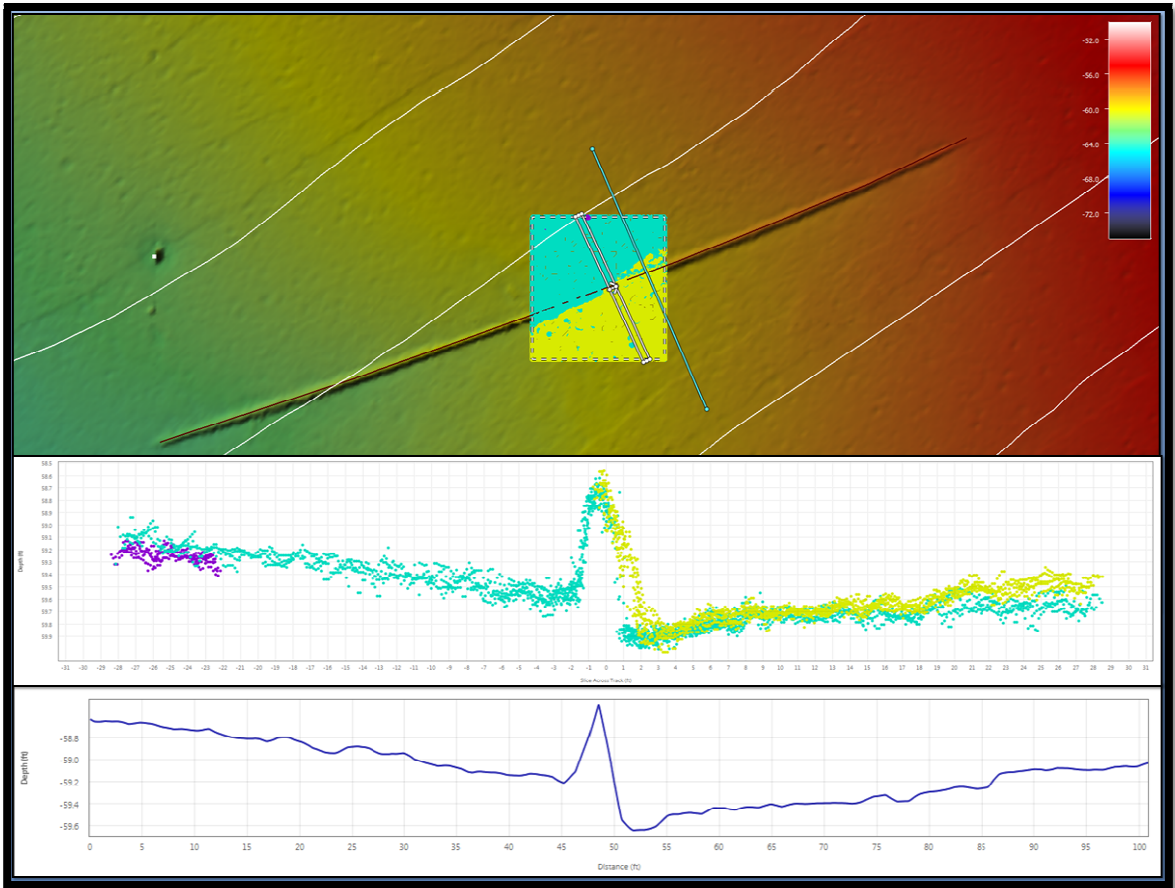
The pipeline was clearly able to be identified when exposed above the seabed. The point definition on the pipeline was such that the top of the pipe was able to be determined for an accurate determination of alignment. Figure 14 shows the pipeline in the sounding data and the gridded data.

Figure 14 Pipeline as visible in the gridded multibeam data, profile data and 2D slide of sounding data

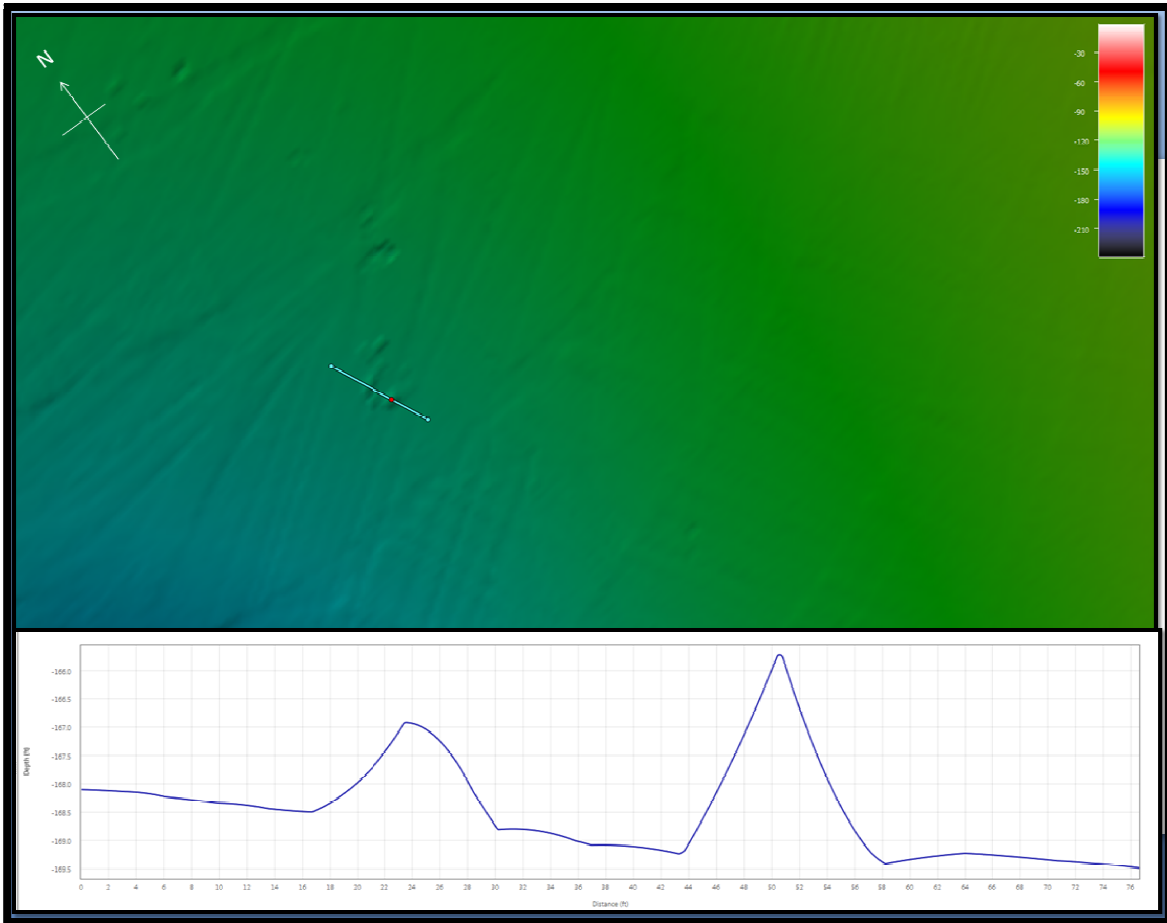
Data resolution and density was such that objects 6ft wide were detected past 100ft. The smallest note worthy object detected was 4x3x1ft. Rocks with diameters of 3ft were detected down to 170ft (see Figure 15).

Figure 15 Rock objects at 168ft depth

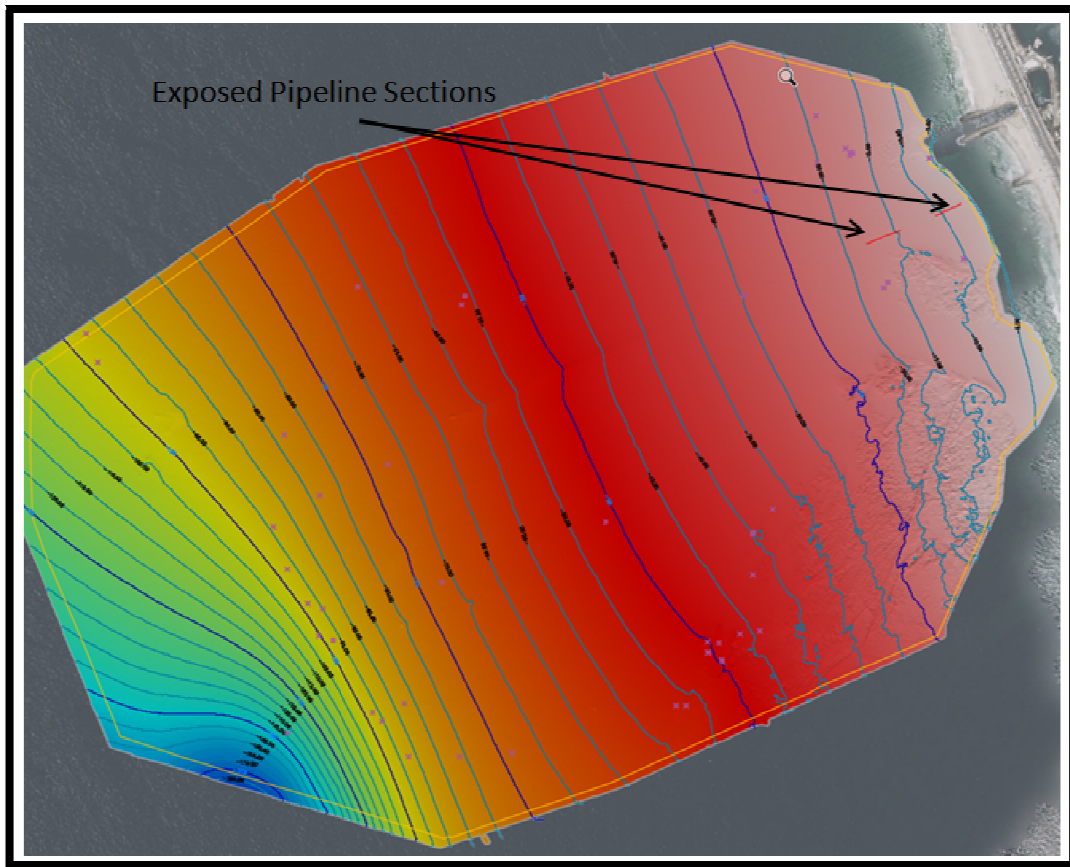
The pipeline was observed as being exposed for a total of 336ft. There are 3 exposure sections ranging from 51ft to 172ft. As the pipeline transitions from sea to land the pipe was mapped to the point at which it becomes buried nearshore at 5ft MLLW. The pipeline was not identified further inshore where coverage was achieved up to 3ft MLLW. It is therefore assumed that the pipe is buried during the transition from water to land. These sections are shown below in Figure 18.

Figure 18 Pipeline exposure sections

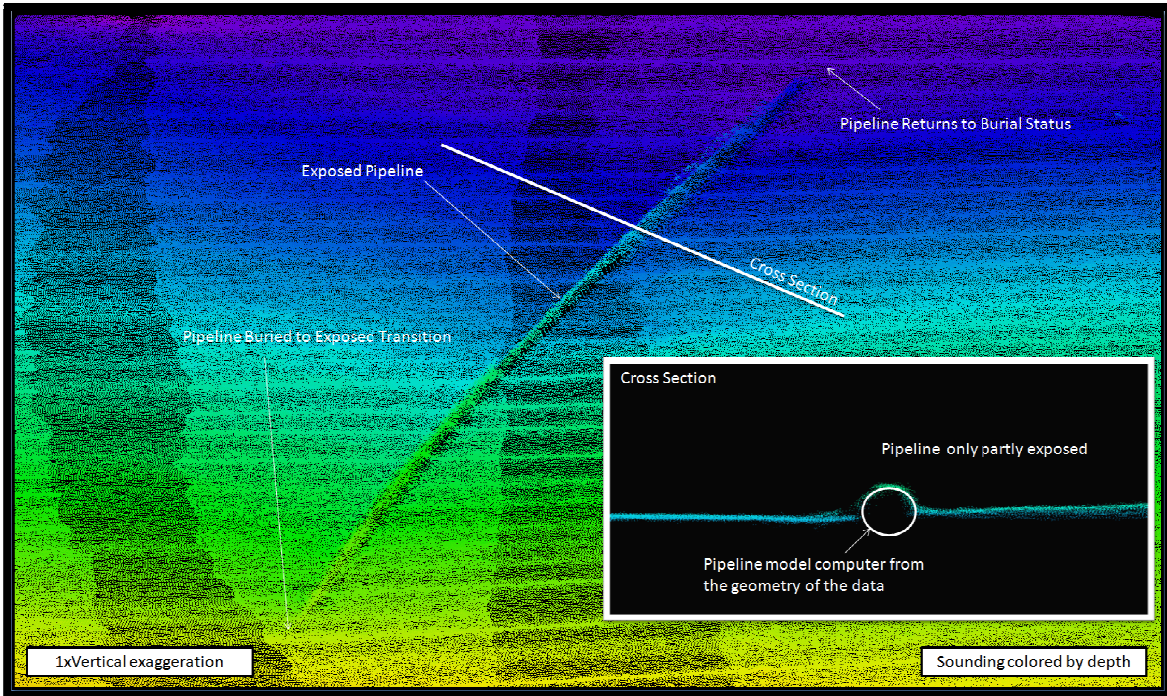
The pipeline as seen in the multibeam 3D point cloud data in Figure 19 (exposure section) below. The curved geometry of the pipeline is evident which allows the determination that the pipeline is not fully exposed.

Figure 19 The pipeline in 3D point cloud data

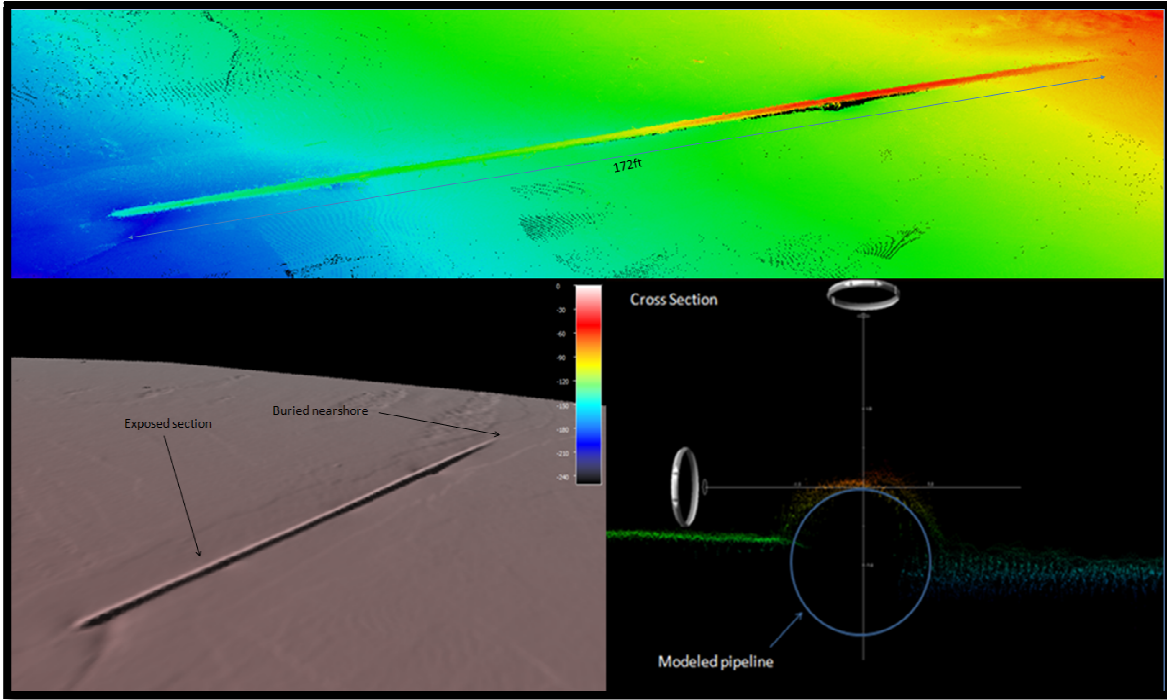
The pipeline in the transition zone is shown below in Figure 20.

Figure 20 Pipeline in transition zone from water to land

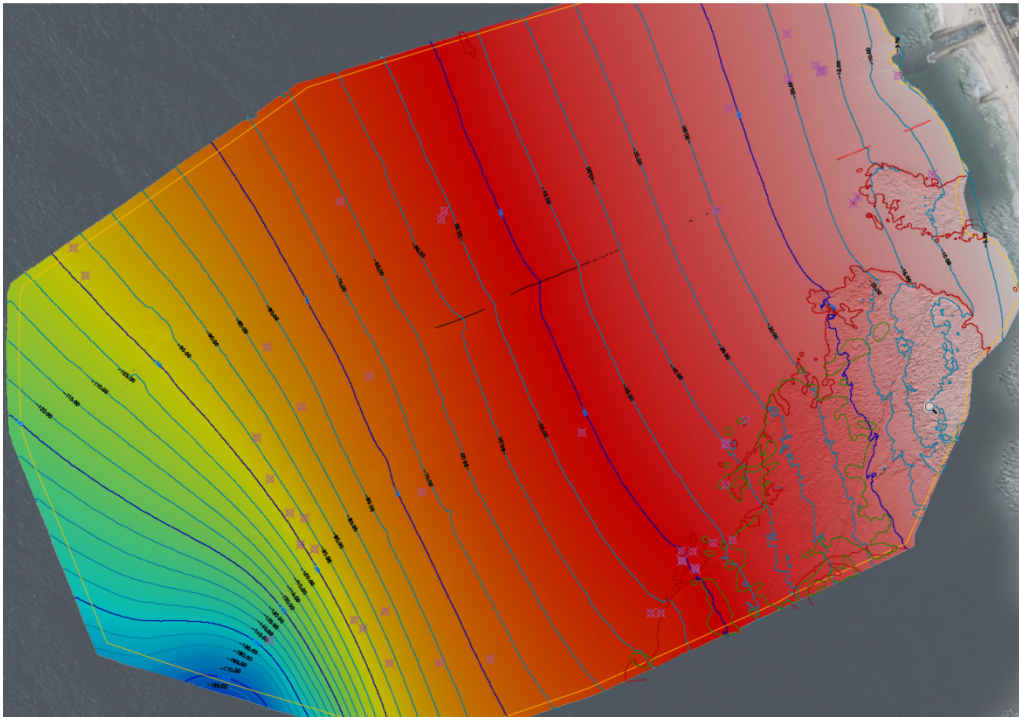
Figure 36 Location of the 32 rocks in the survey area

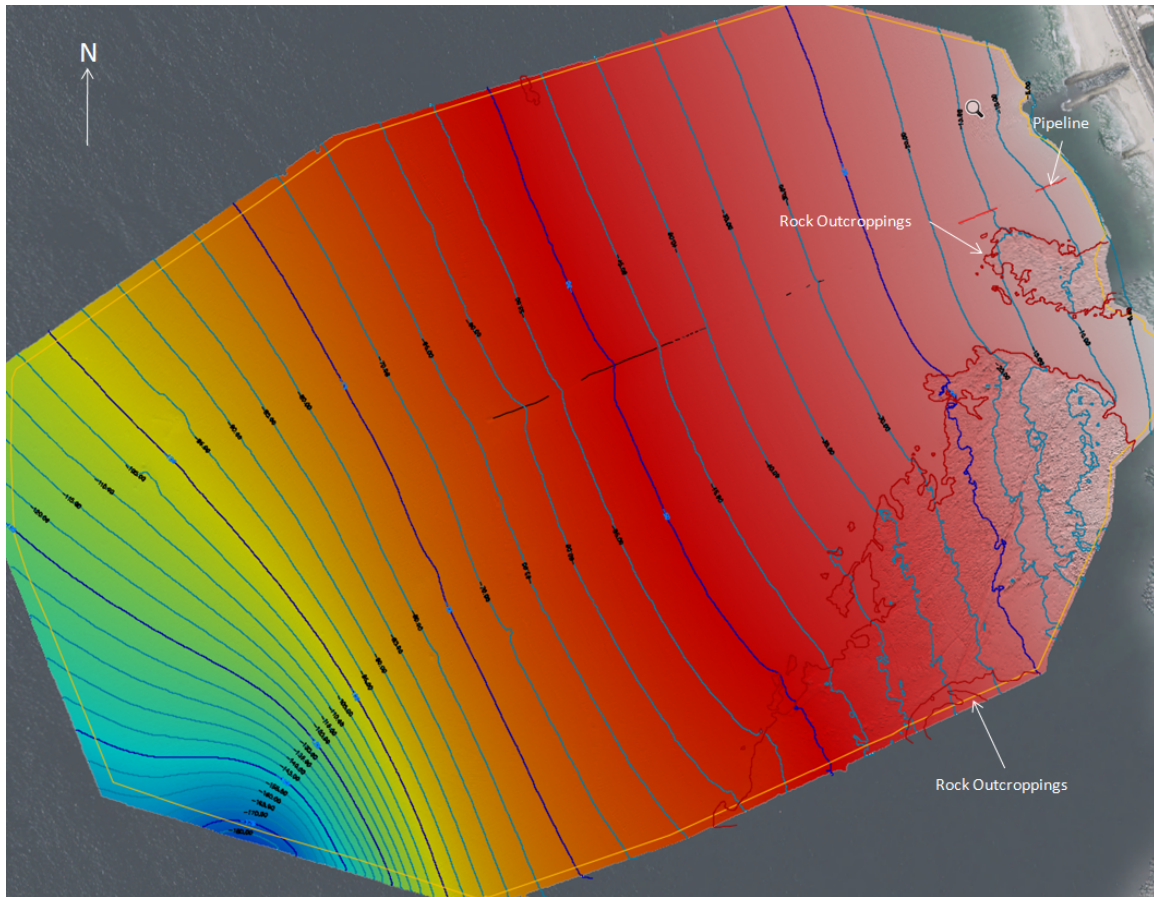
Rock outcroppings are located in two main areas. There is one large contiguous area of rock outcropping to the south and south west. This area covers 44 acres up to survey boundary (The area could extend further outside the survey boundary and to shore). Then there is a smaller area to the west. This is 3.3 acres in the survey area (The area could extend further outside the survey boundary and to shore). Smaller rock outcropping areas were identified adjacent to and less than 250ft from the larger areas. These were between 0.01 acres and 0.05 acres. The map below in Figure 38 shows these rock outcropping areas.

Figure 38 Rock outcroppings in the survey area
