STAFF REPORT INFORMATIONAL **109**

04/19/18 W 40102 G. Pelka R. Lee

STATUS REPORT ON THE REMEDIATION OF ABANDONED MINE FEATURES LOCATED ON STATE SCHOOL LANDS UNDER THE COMMISSION'S JURISDICTION

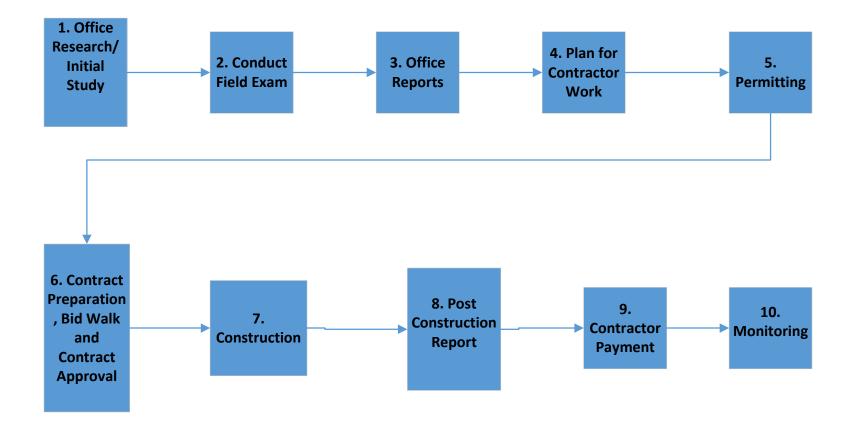
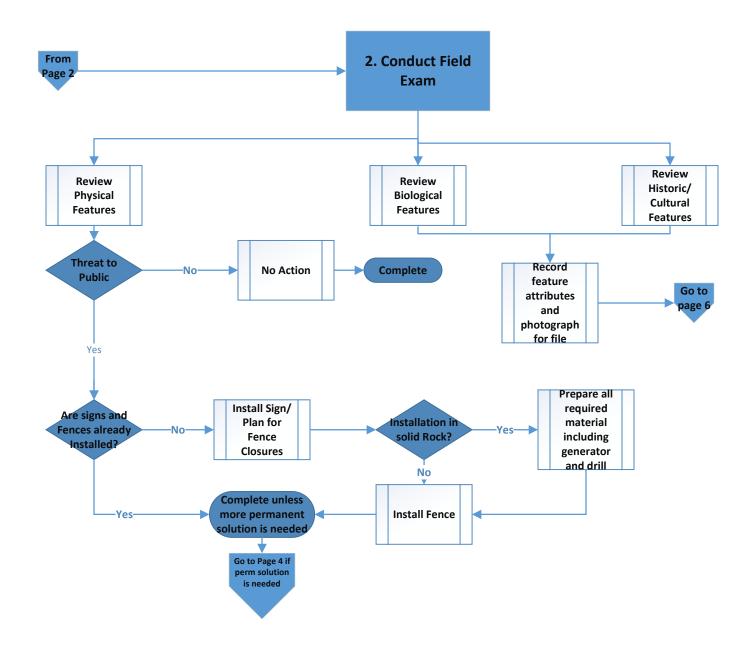
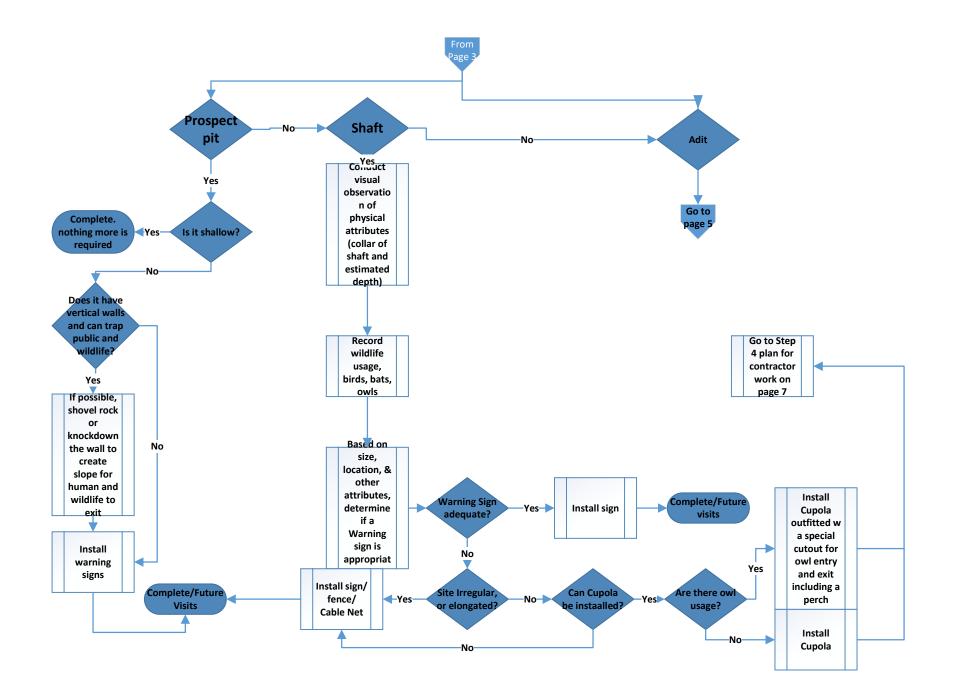
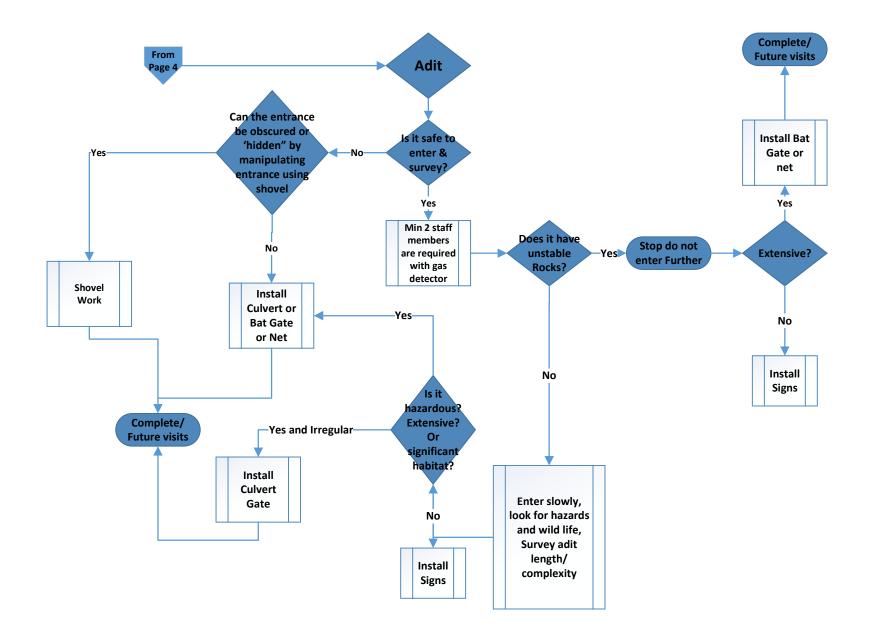
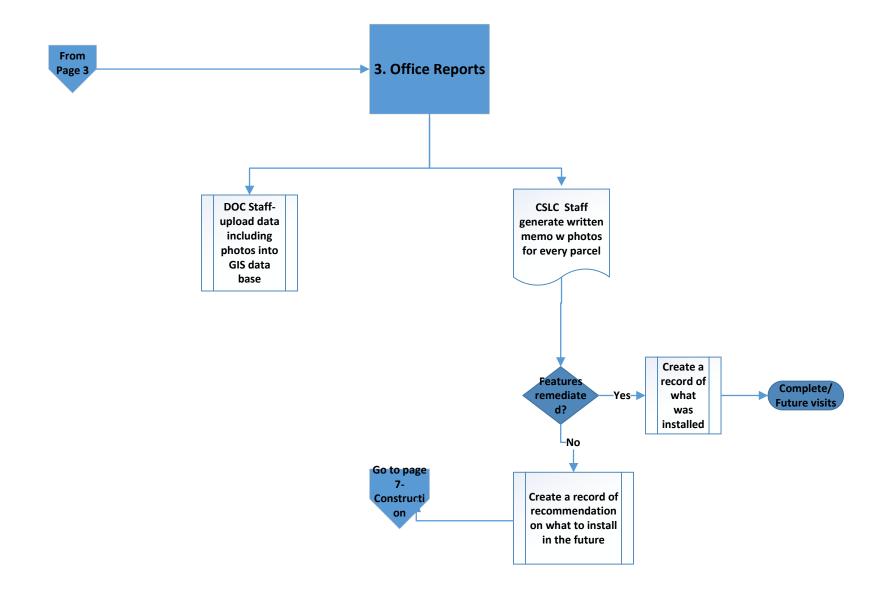
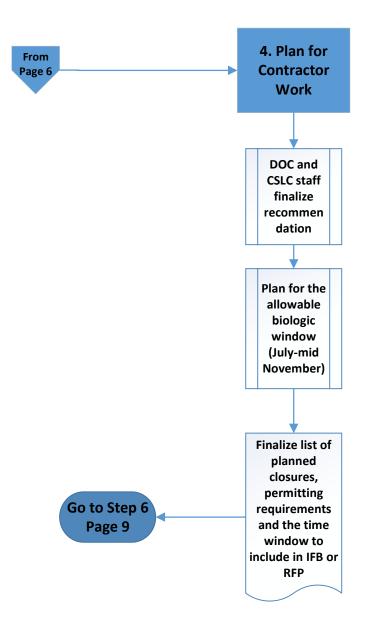
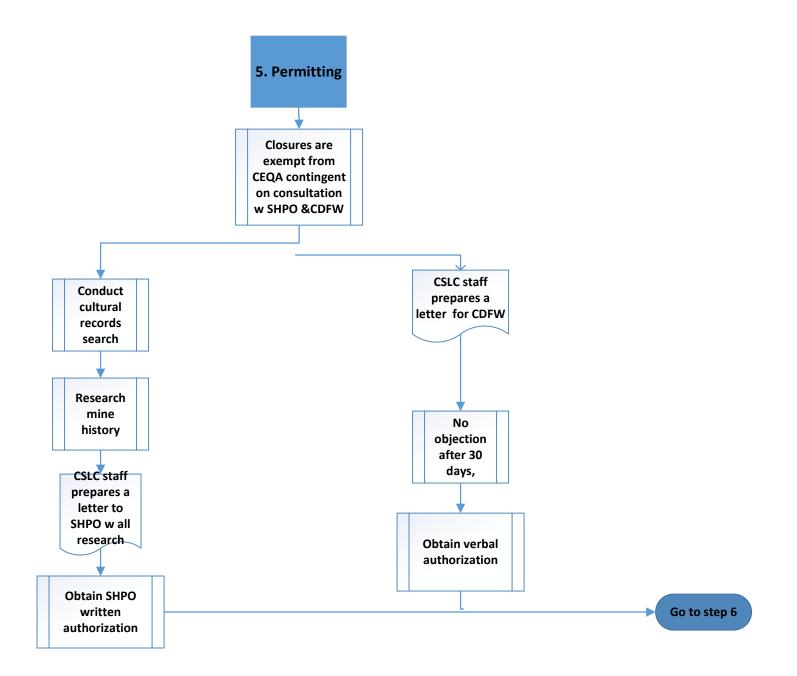
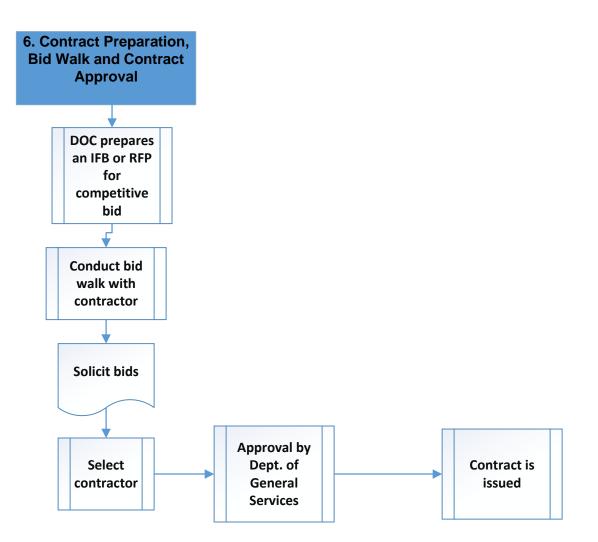
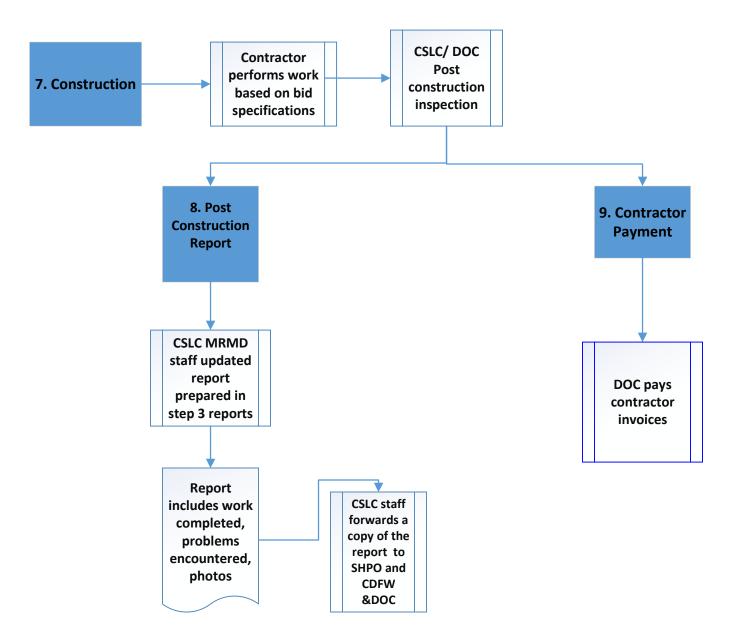
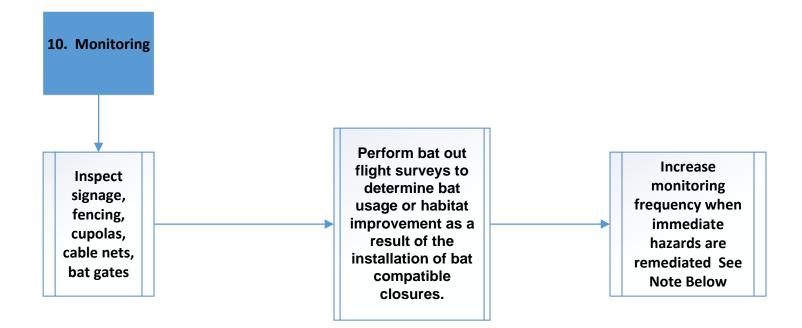
Major Steps in Identification and Remediation Process of CA Abandoned Mines on State School Lands

Note:

- Every 5 Years for remotely located AML parcels.
- Every 2 years for easily reachable parcels

As a result of this successful collaboration, DMR and Commission staff have worked together and have developed a comprehensive process for determining the most appropriate remediation approach. This process is included in Exhibit A, attached.
