Memorandum

Subject: Broad Beach Foredune Impact Analysis

This memorandum provides an assessment of the impacts to foredune habitat that may have occurred or that could occur as a result of previous and proposed shoreline stabilization efforts at Broad Beach. This material is intended to support the application for a California Coastal Commission (“CCC”) Coastal Development Permit (“CDP”) for the proposed Broad Beach Restoration Project located in Malibu, Los Angeles County, California (“Study Area”; Figure 1). The information included here is based on inferred historical conditions, observed current conditions, and predicted future conditions at Broad Beach. As noted in the previous CDP submittals for the project, detailed records of historical habitat conditions and shoreline stabilization efforts at Broad Beach are lacking, and much information had to be inferred from historic aerial imagery, a sporadic record of photographs from the site, and comparisons with similar habitats in the region. As such, the analysis presented here is subject to a number of caveats which are presented in the following sections. The analysis follows in six parts, each of which contains (1) an assess

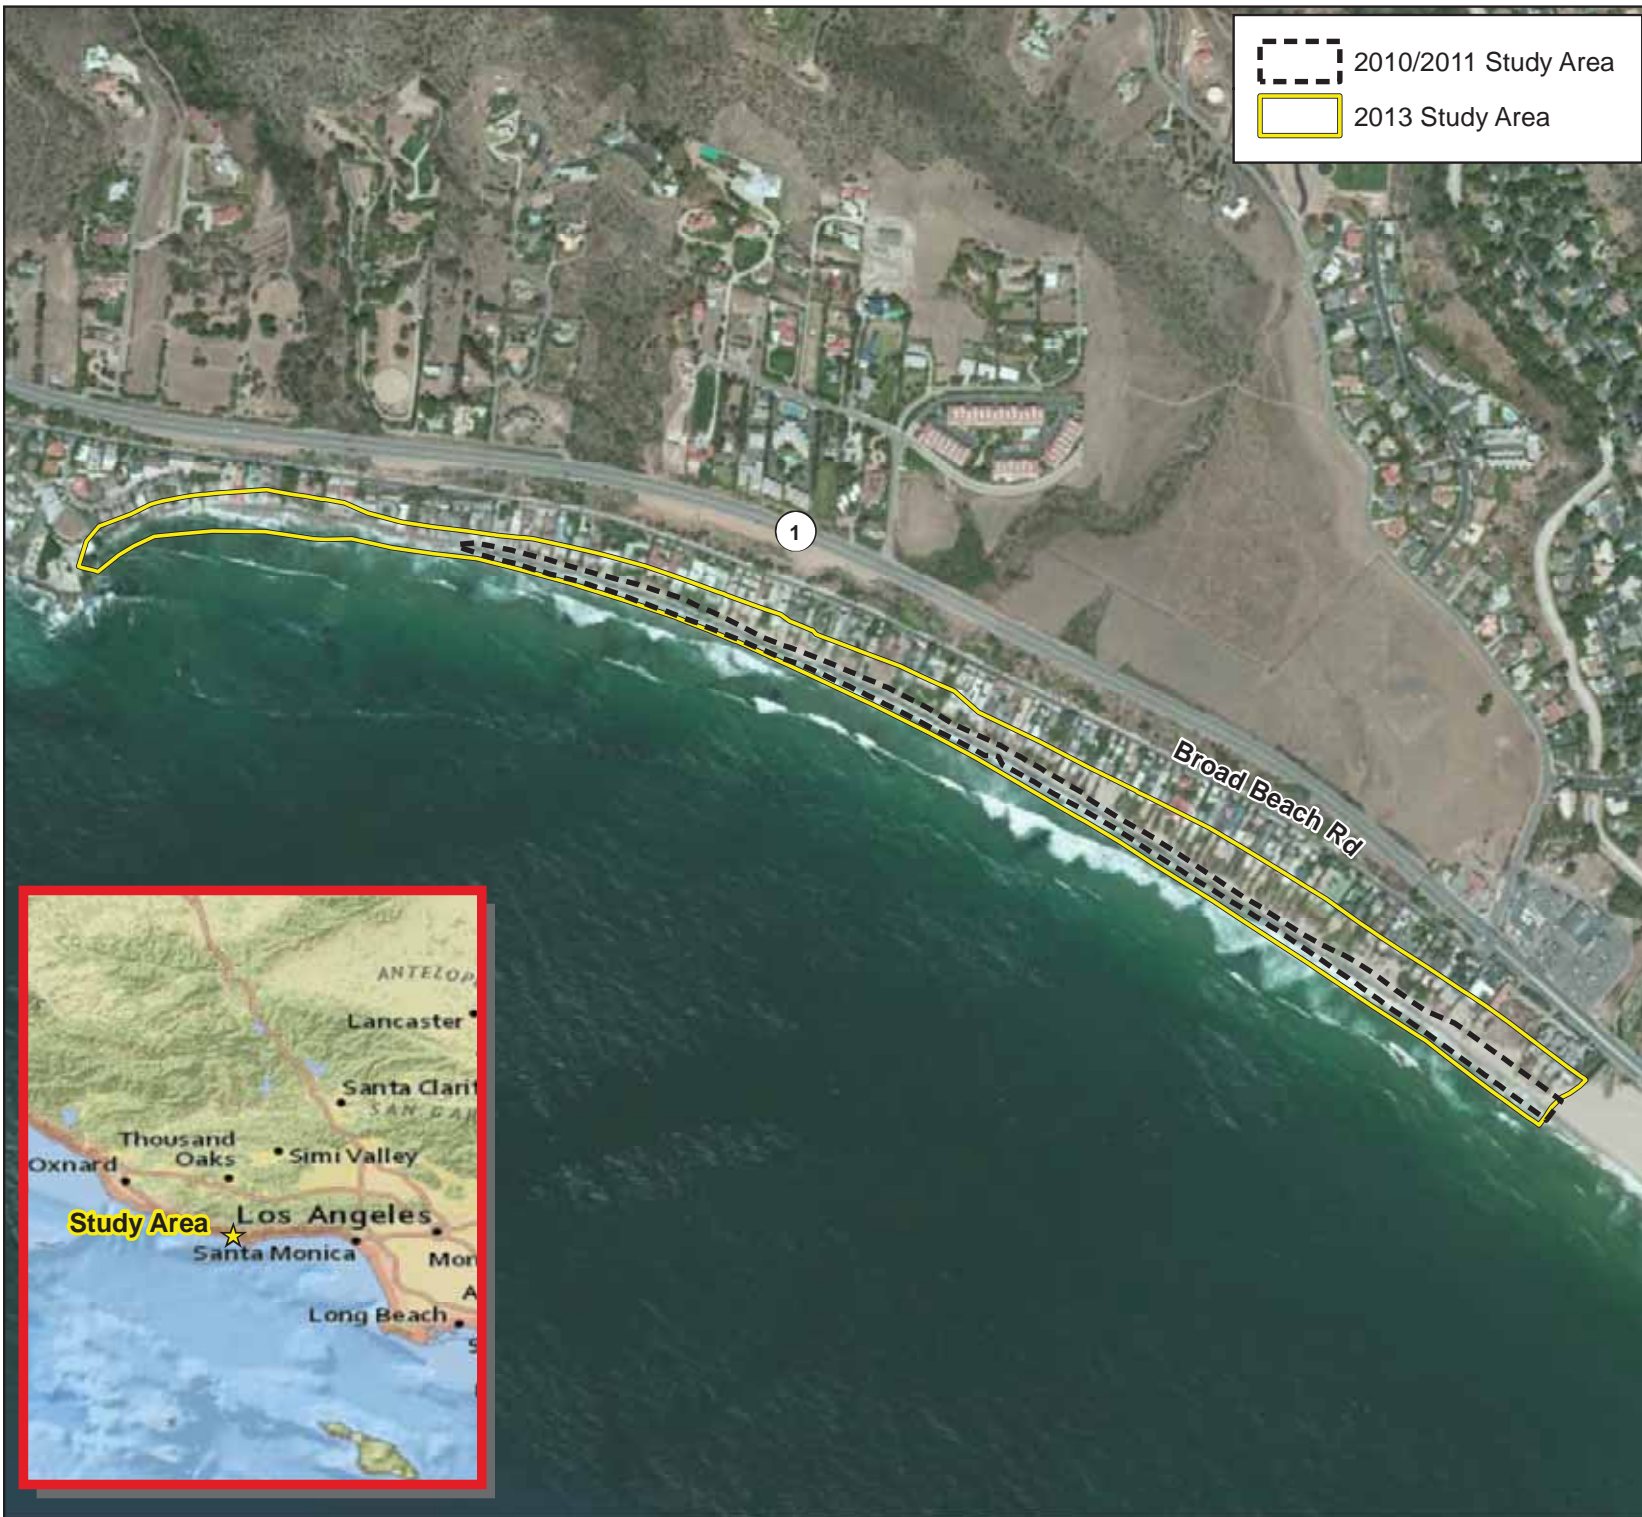
Figure 1.
Study Area
Location Map

² It should be noted that this acreage is dependent on the size of the 2013 Study Area as shown in Figure 1. Whereas the seaward extent of foredune habitat is determined by the beach-dune escarpment line which is relatively fixed, the inland extent of foredune habitat is defined by the edge of the Study Area which is somewhat arbitrary. Moving the inland edge of the Study Area will affect the acreage of foredune habitat considered present at Broad Beach.

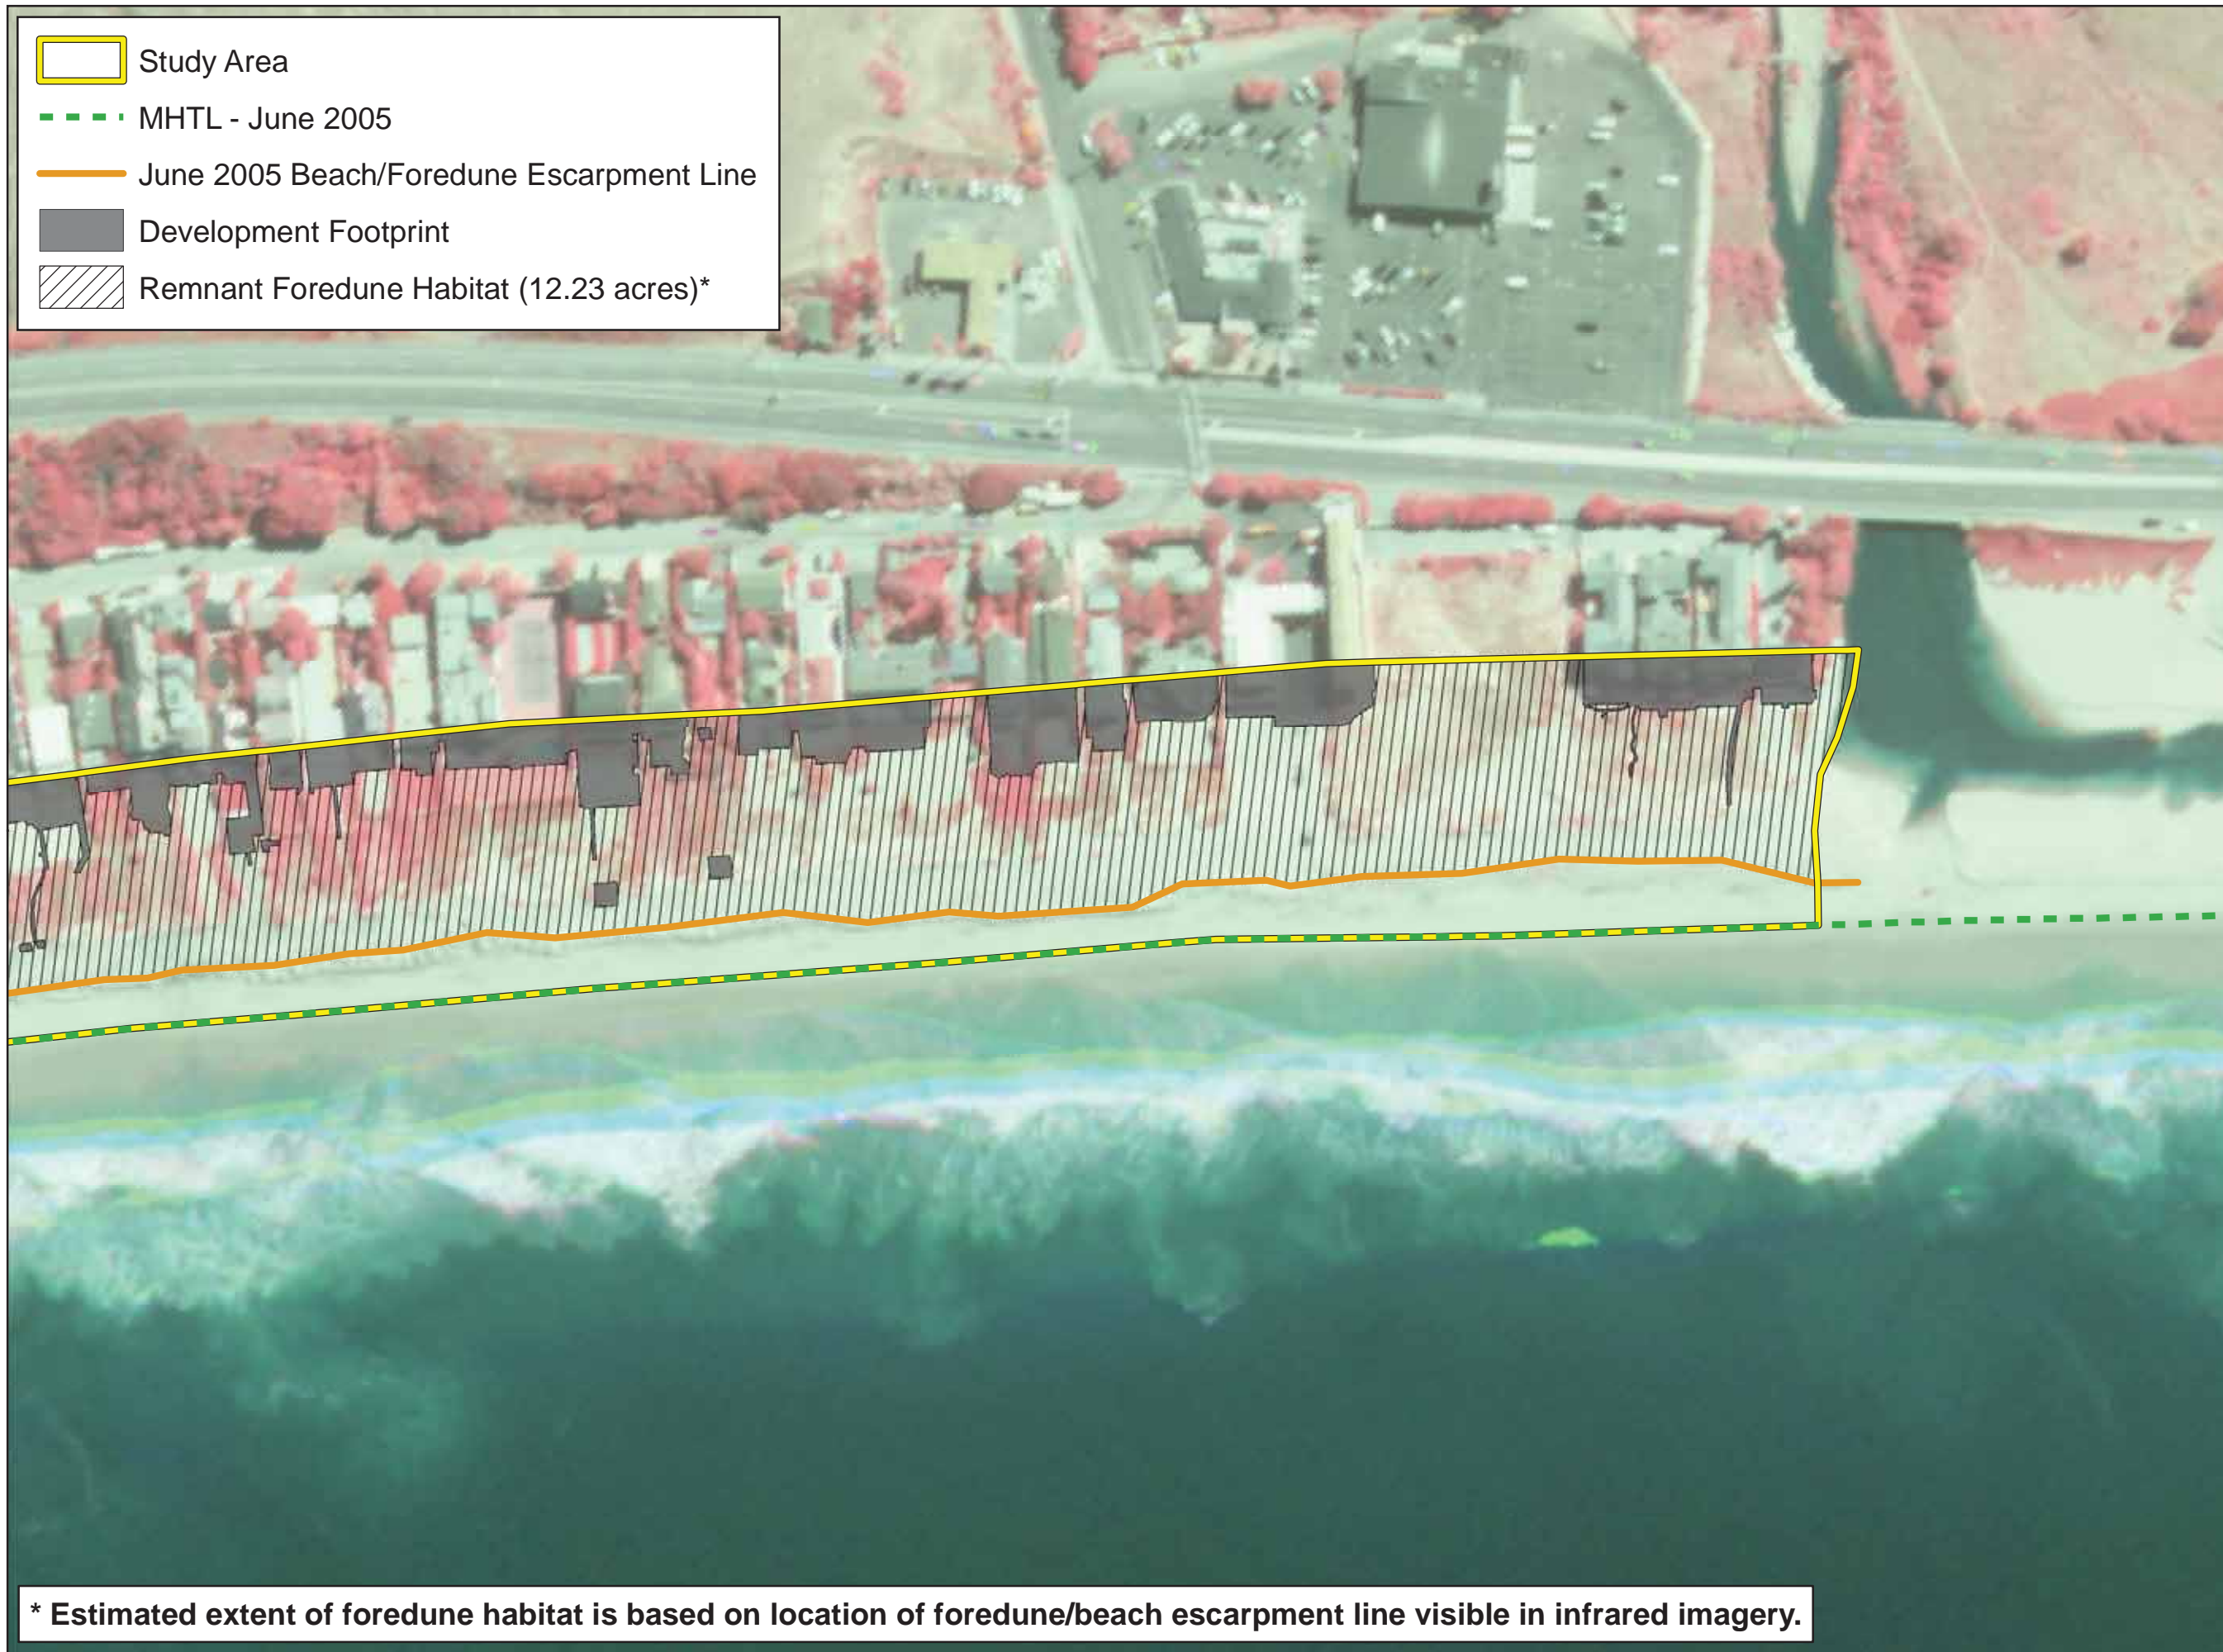
Figure 2a.

Broad Beach
Baseline Extent
of Foredune Habitat
(2005)

For the assessment of impacts relative to the 2005 baseline condition, it was assumed that the 2010 emergency rock revetment was installed on top of foredune habitat. Based on this analysis, any portion of the 2010 revetment that was installed landward of the 2005 beach/dune escarpment line shown in Figure 2 impacted foredune habitat. This theoretical maximum extent of impacts to foredune habitat is shown in Figure 6-2 and includes approximately 1.57 acres of permanent impacts associated with the retention of the 2010 revetment and 3.23 acres of temporary impacts associated with the proposed foredune enhancement.

For the assessment of impacts relative to the 2005 baseline condition, WRA assumed that the area landward of the 2005 beach/dune escarpment line shown in Figure 2 represents existing foredune habitat at the site. Using the 2005 baseline extent of foredune habitat, WRA assumed that all potential foredune habitat seaward of the inland edge of the 2010 revetment could be lost to wave action under conditions of beach nourishment failure. This theoretical maximum extent of impacts to foredune habitat is shown in Figure 7-2 and includes approximately 4.82 acres of permanent impacts to foredune habitat. Similar to the chronological assessment, it was assumed that an increase in sea level of between 8.5 and 18 inches by the year 2040 would not result in significant impacts to foredune habitat landward of the 2010 revetment.

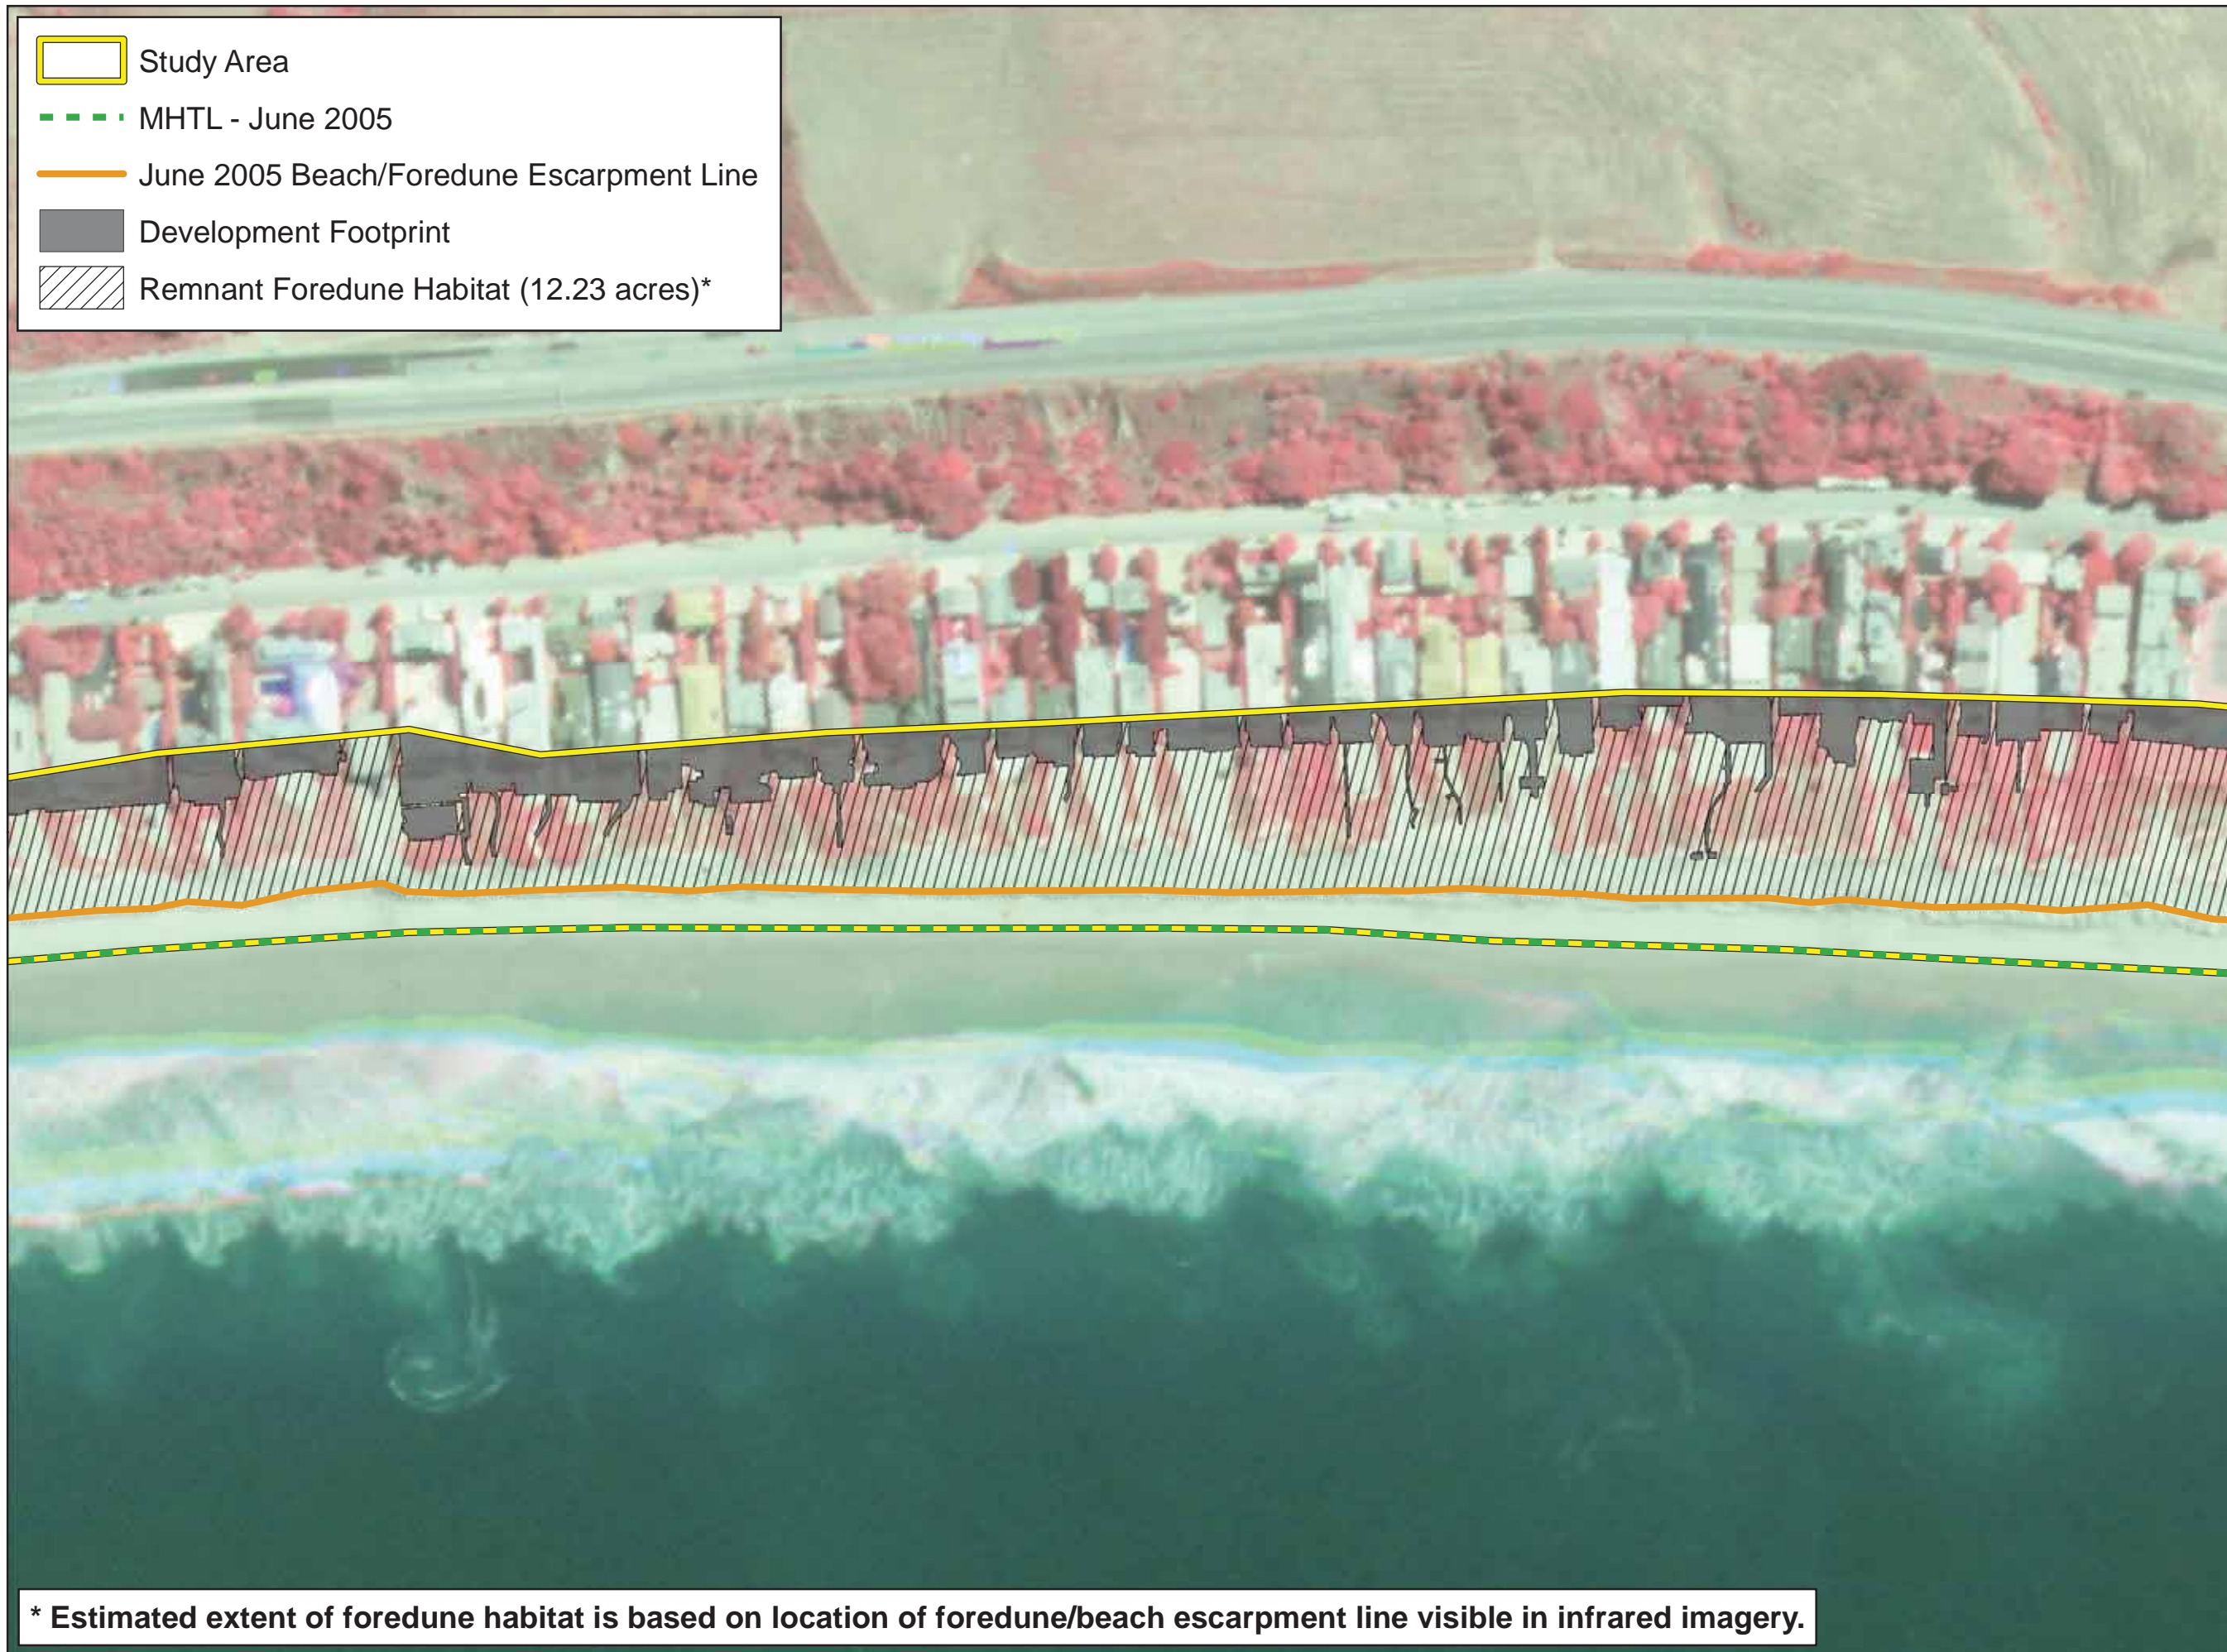
Figure 2b.

Broad Beach
Baseline Extent
of Foredune Habitat
(2005)

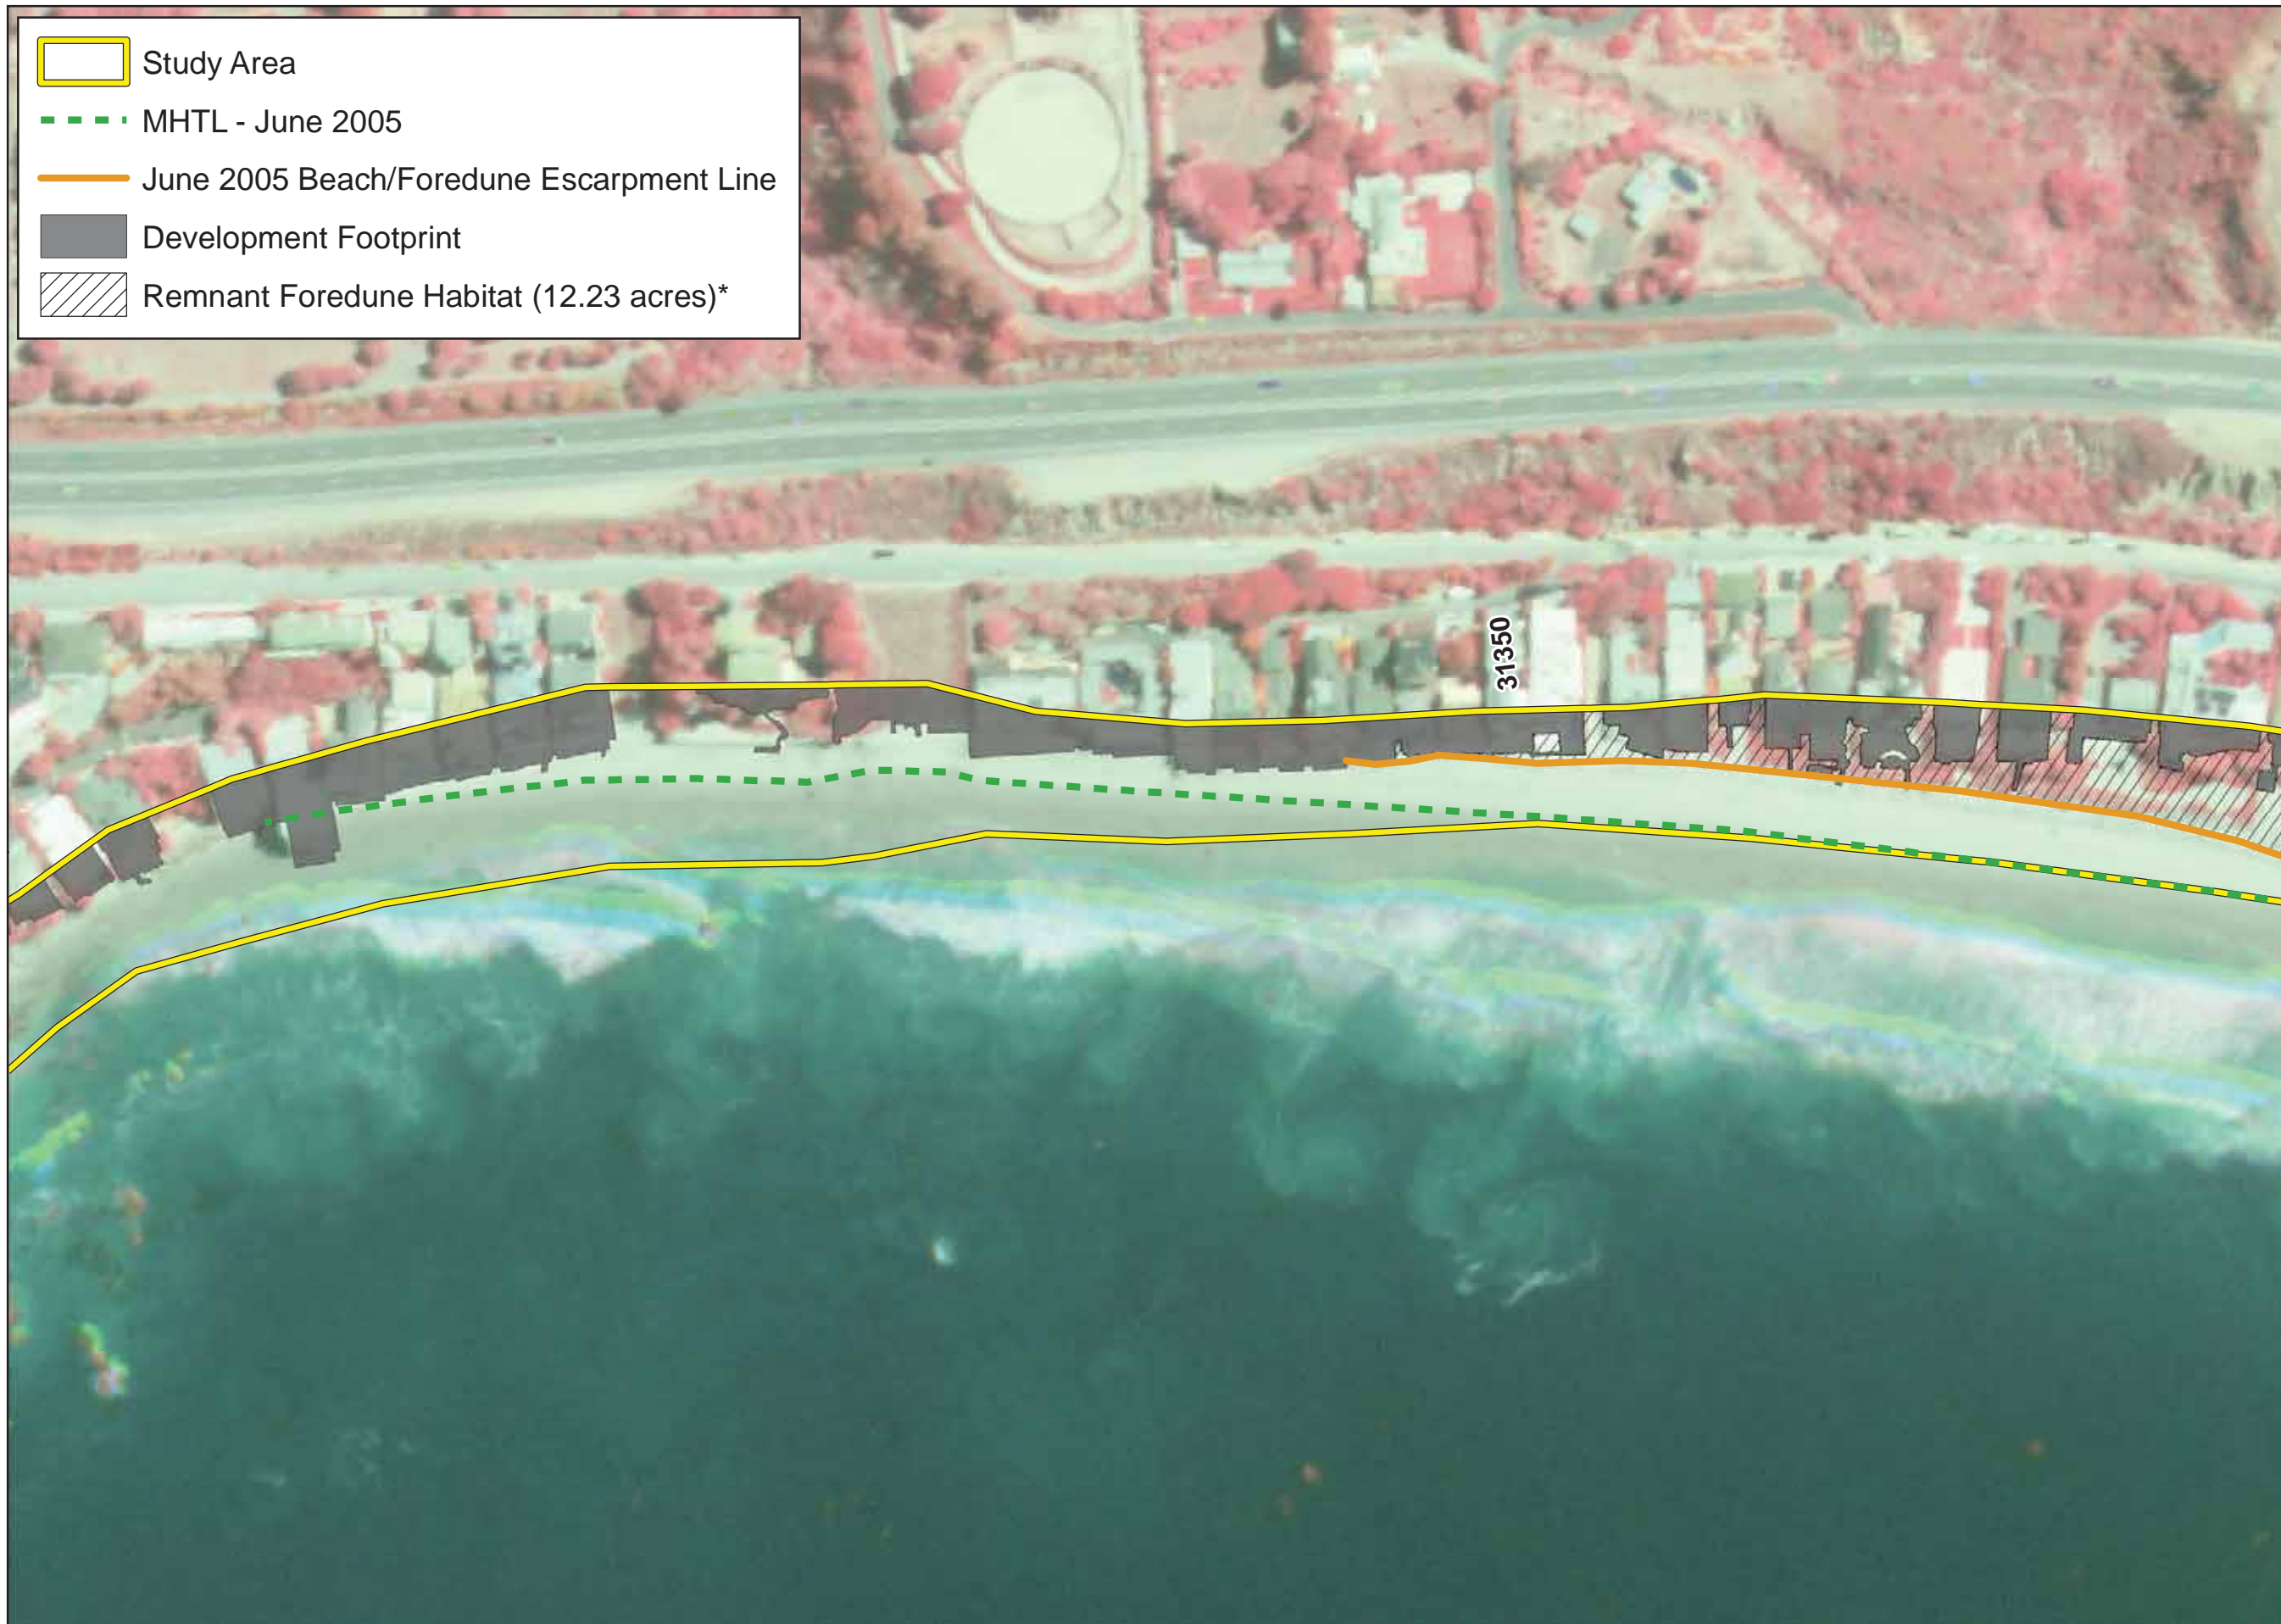
Remnant Foredune Habitat (12.23 acres)*

* Estimated extent of foredune habitat is based on location of foredune/beach escarpment line visible in infrared imagery.

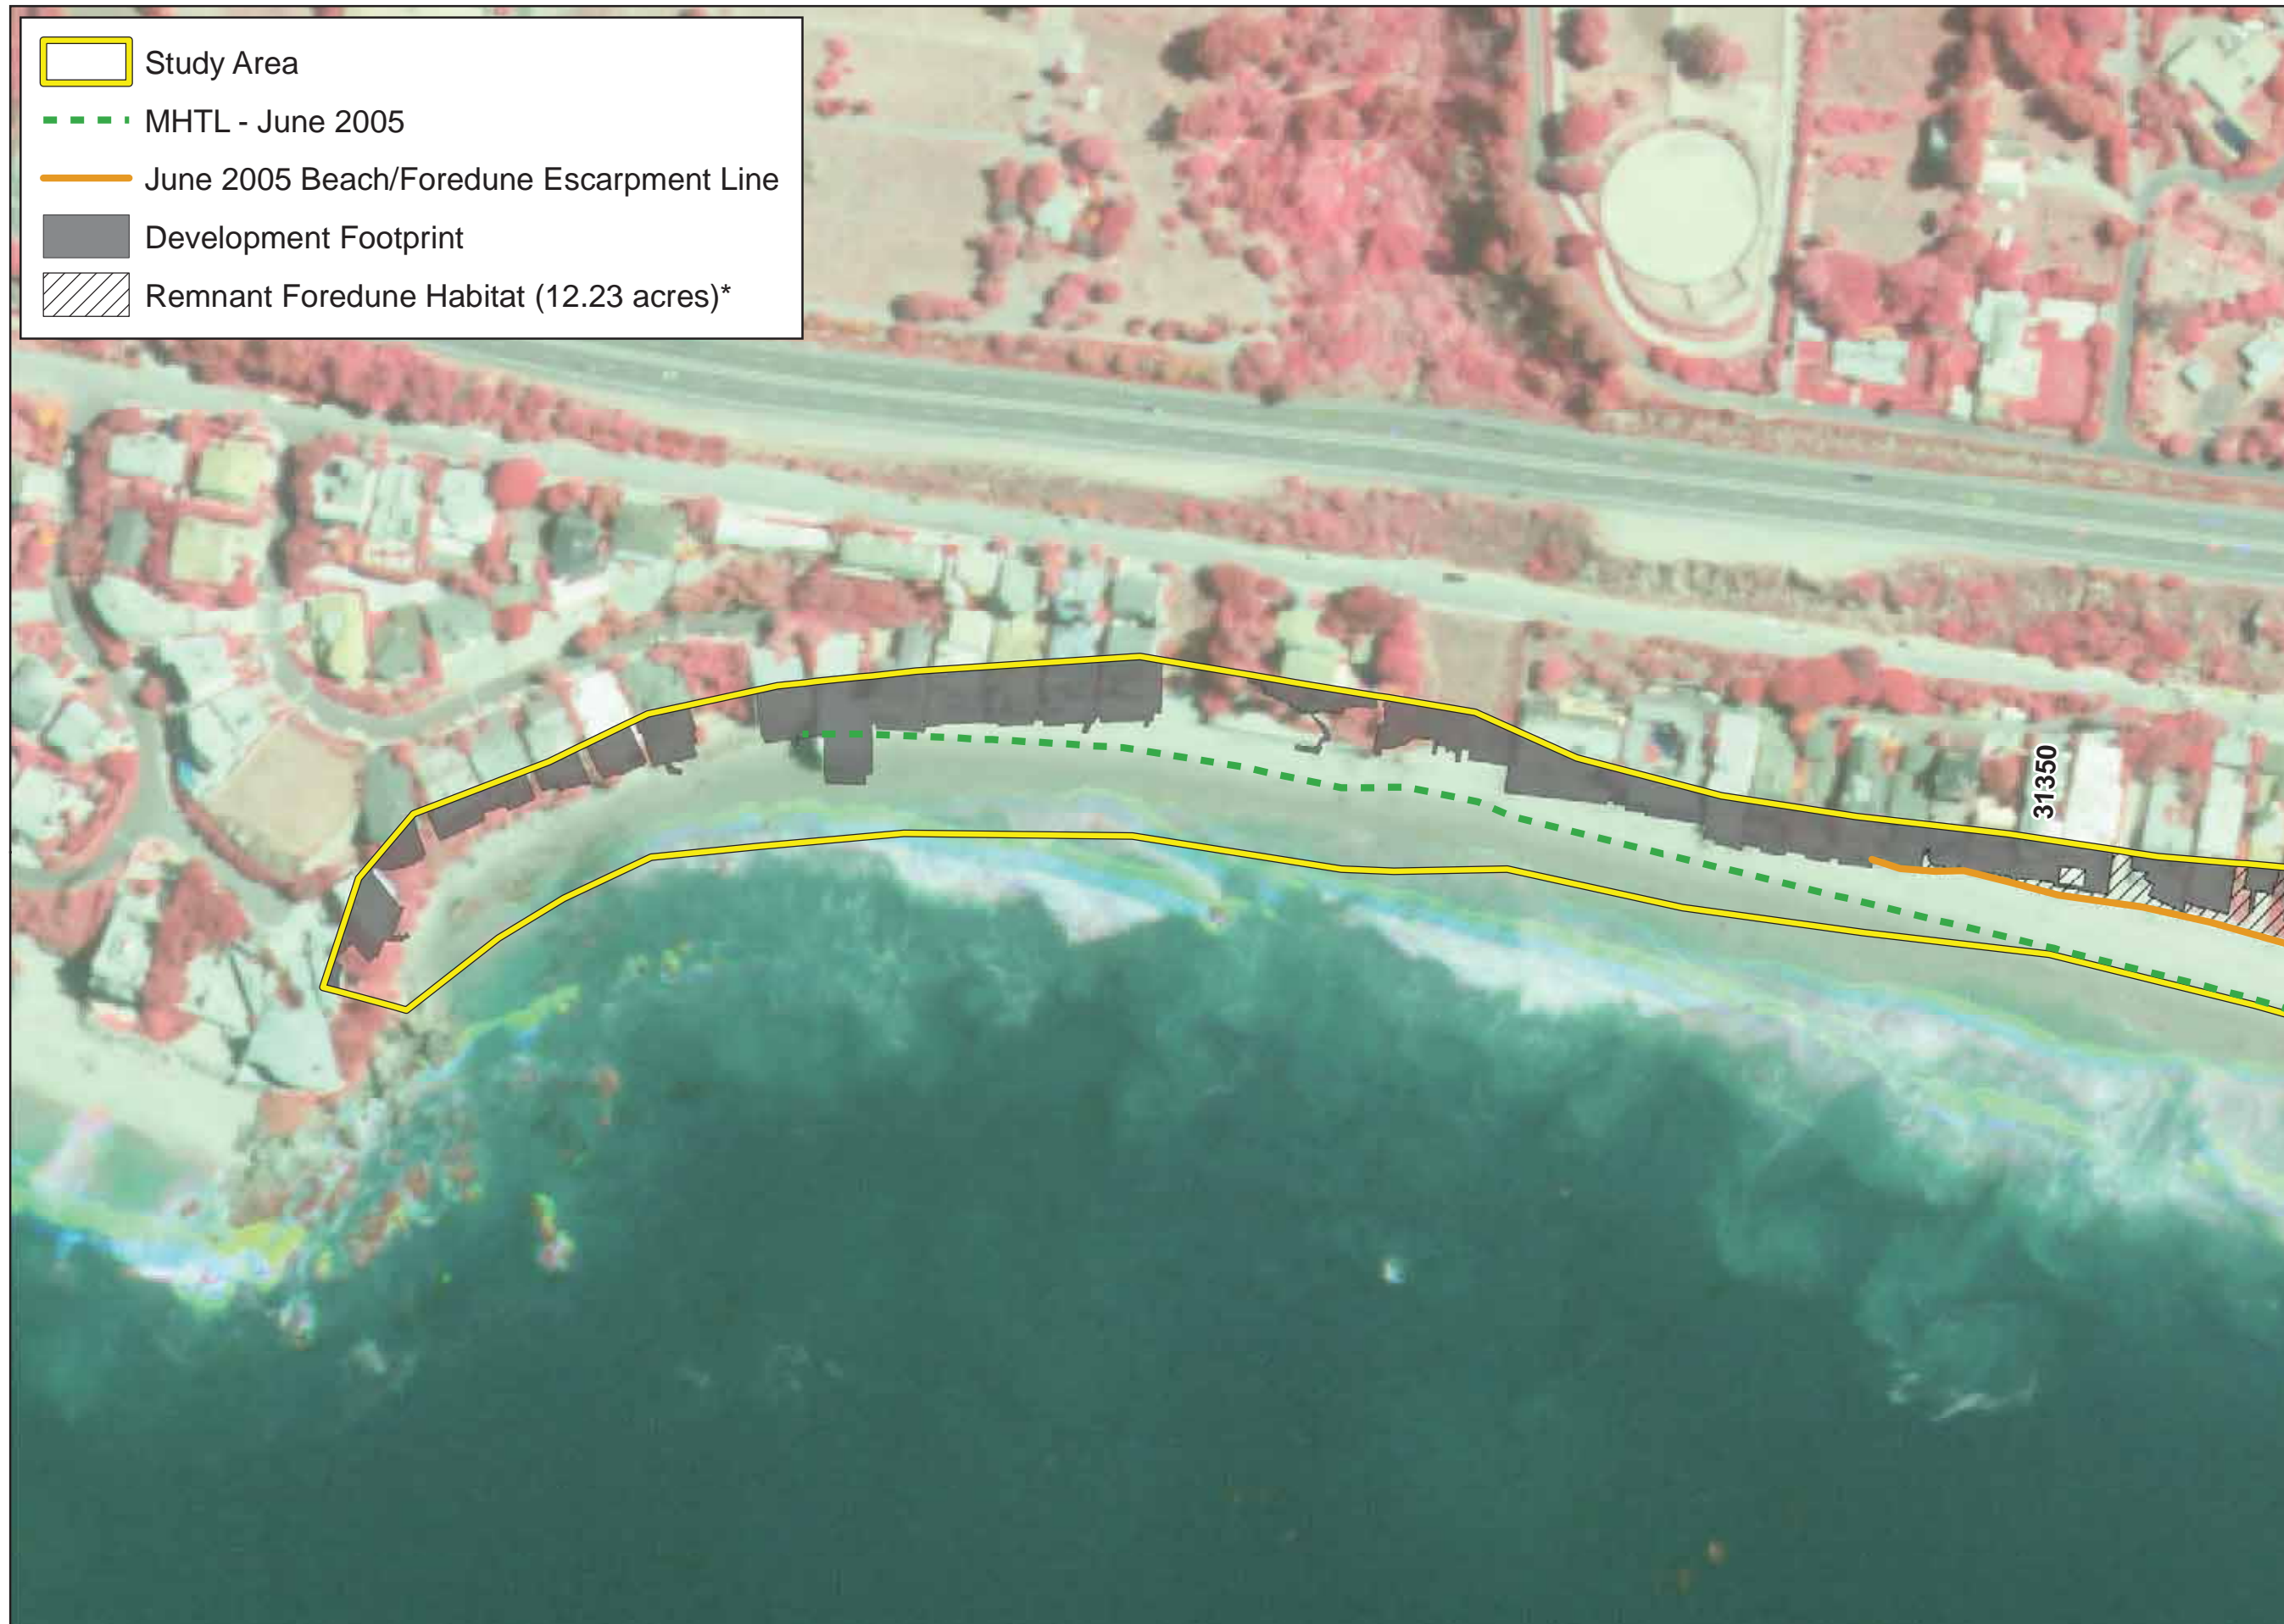
Figure 2e.

Broad Beach
Baseline Extent
of Foredune Habitat
(2005)

* Estimated extent of foredune habitat is based on location of foredune/beach escarpment line visible in infrared imagery.

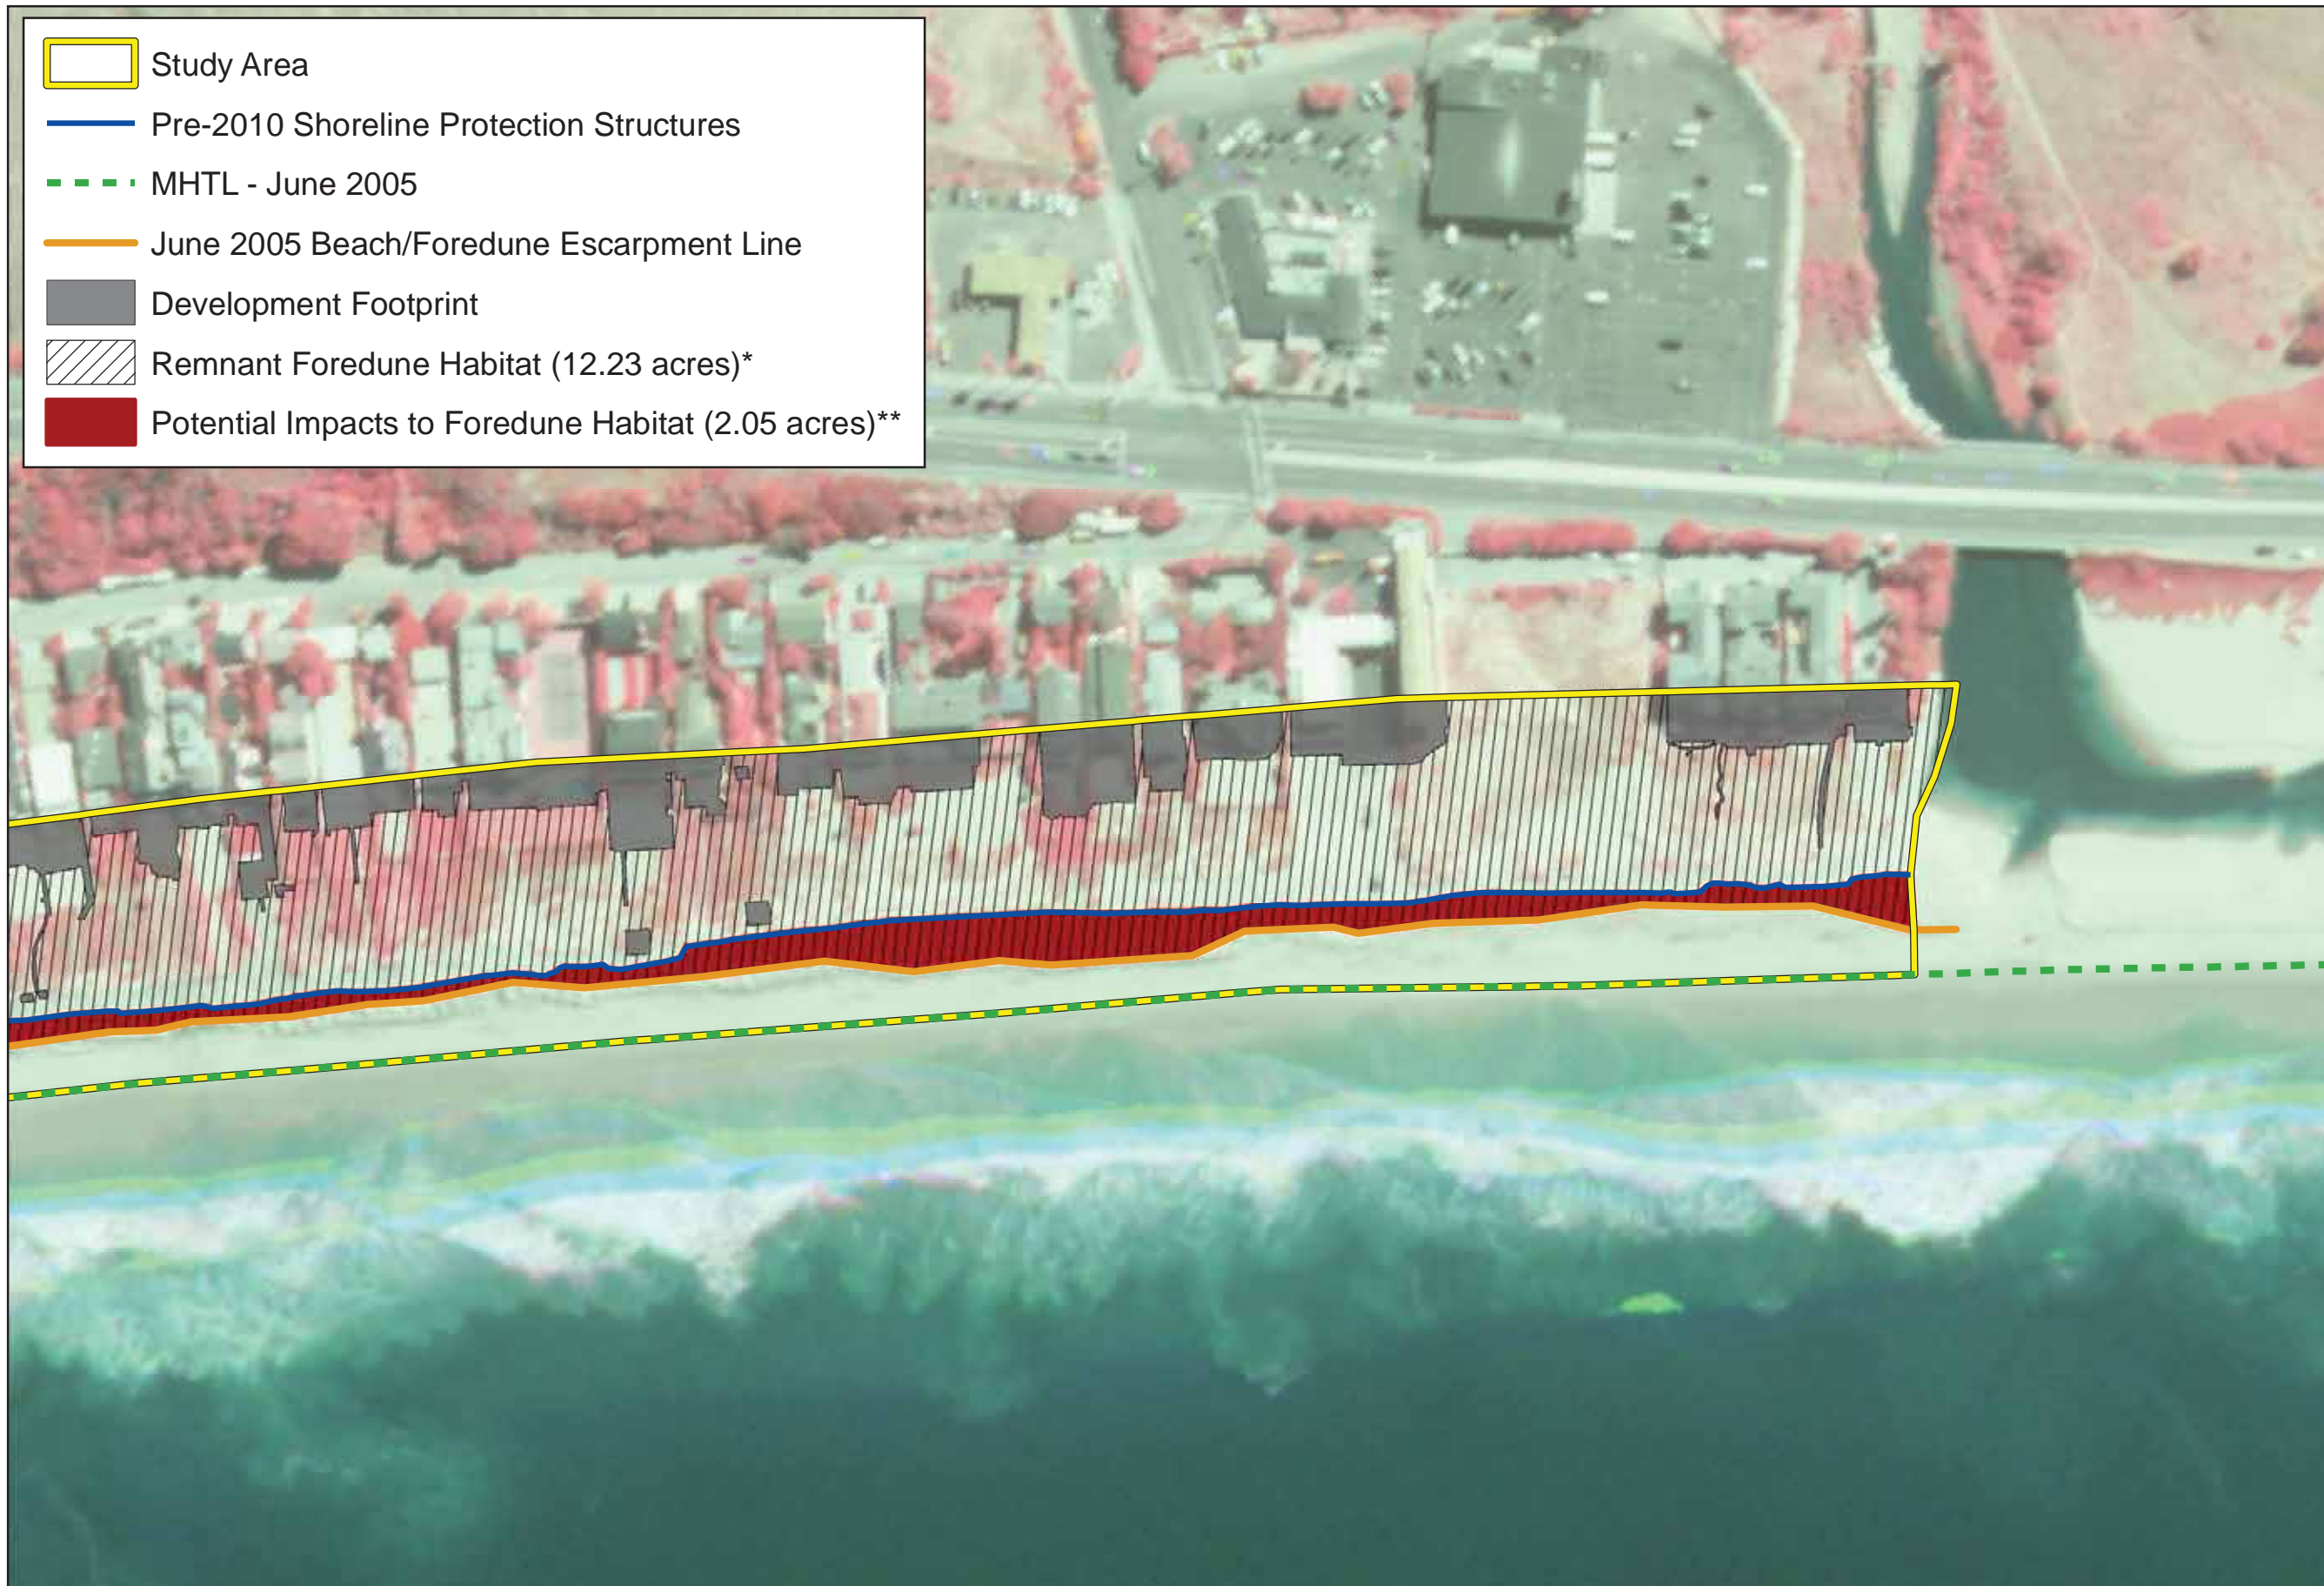
Potential Impacts to
Foredune Habitat
from Pre-2010
Revetment Materials
Relative to 2005
Baseline Conditions

This assessment focuses on the potential impacts to foredune habitat associated with the installation of shoreline stabilization materials between 2005 and 2010. For this assessment, WRA used the baseline extent of foredune habitat at the site as established above (Baseline Conditions) and the location of the pre-2010 shoreline stabilization materials as provided by Moffatt and Nichol. Using the approximated extent of foredune habitat at the site in 2005 (12.23 acres; Figure 2) as a baseline, WRA overlaid the location of the pre-2010 shoreline stabilization materials and considered all foredune habitat seaward of the pre-2010 shoreline stabilization materials and landward of the beach/dune escarpment line to be foredune habitat potentially impacted by the installation of said revetment materials. This portion of the analysis is the same for both the chronological assessment of impacts and the assessment of impacts relative to the 2005 baseline condition.
