Memorandum

Subject: Broad Beach Foredune Impact Analysis

This memorandum provides an assessment of the impacts to foredune habitat that may have occurred or that could occur as a result of previous and proposed shoreline stabilization efforts at Broad Beach. This material is intended to support the application for a California Coastal Commission (“CCC”) Coastal Development Permit (“CDP”) for the proposed Broad Beach Restoration Project located in Malibu, Los Angeles County, California (“Study Area”; Figure 1). The information included here is based on inferred historical conditions, observed current conditions, and predicted future conditions at Broad Beach. As noted in the previous CDP submittals for the project, detailed records of historical habitat conditions and shoreline stabilization efforts at Broad Beach are lacking, and much information had to be inferred from historic aerial imagery, a sporadic record of photographs from the site, and comparisons with similar habitats in the region. As such, the analysis presented here is subject to a number of caveats which are presented in the following sections. The analysis follows in six parts, each of which contains (1) an assess

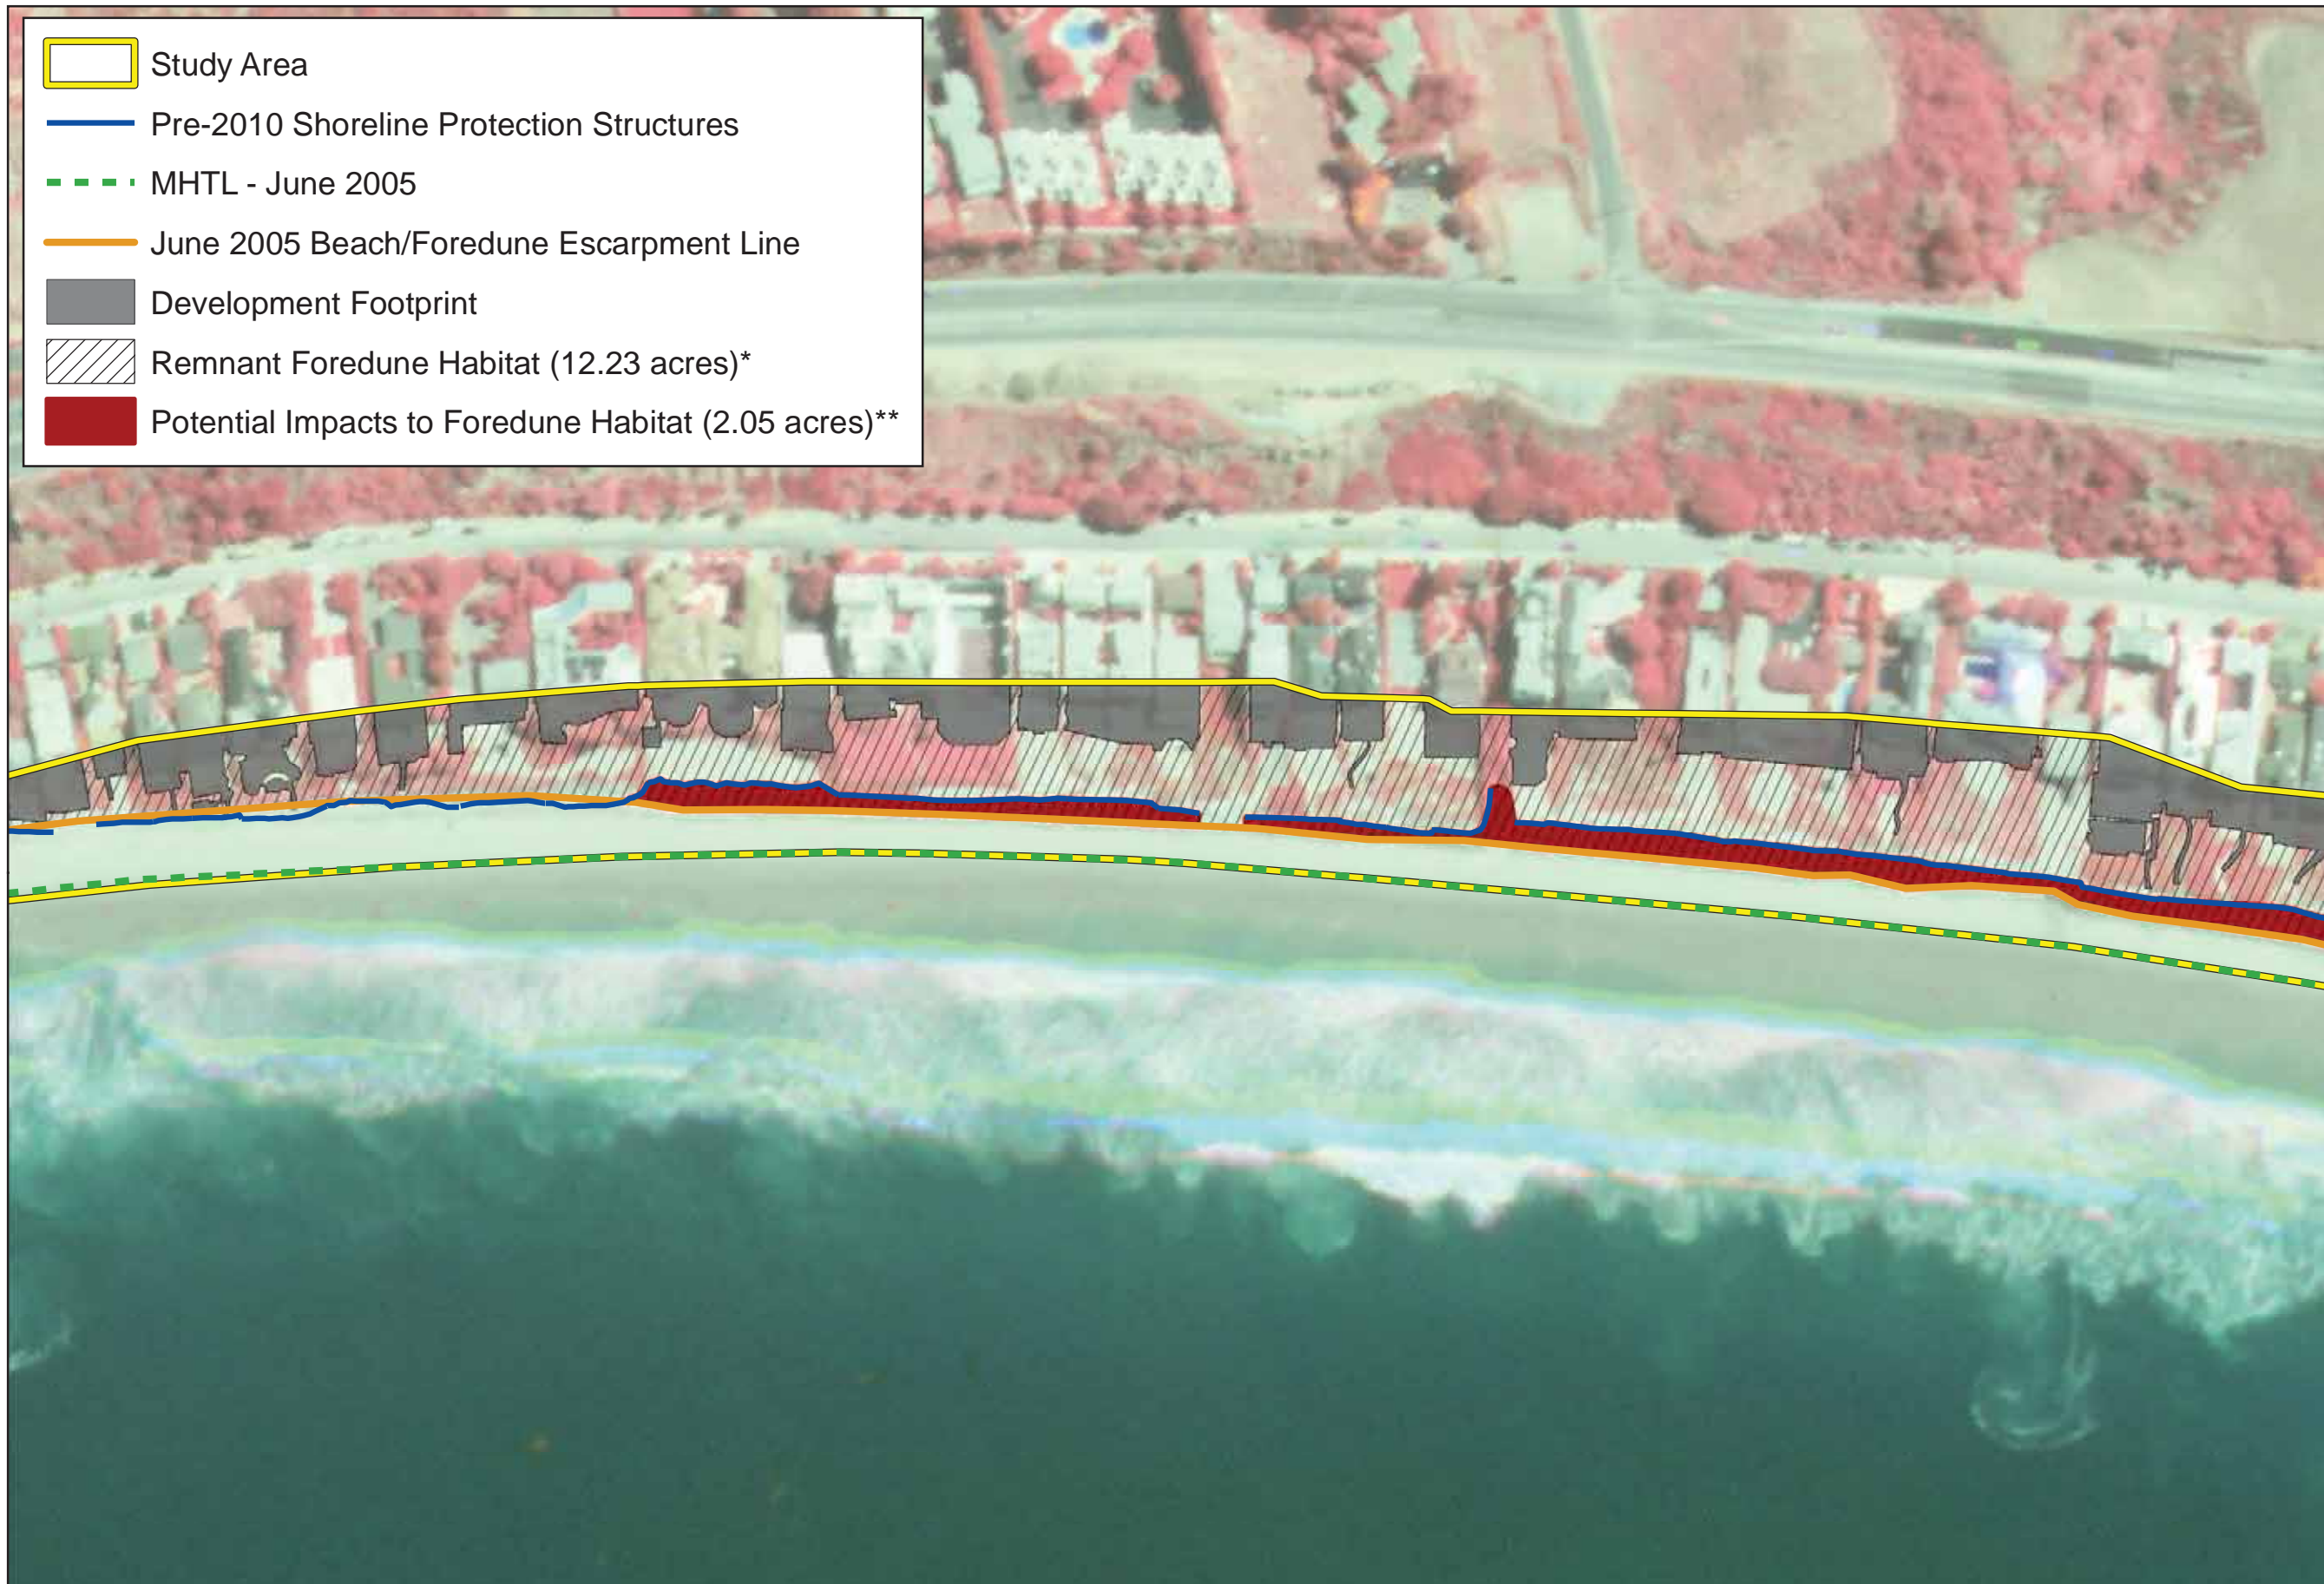
Potential Impacts to Foredune Habitat (2.05 acres)**

* Remnant foredune habitat based on 2005 extent shown in Figure 2.
 ** Potential impacts assume that the entire area seaward of the pre-2010 shoreline protection structures and landward of the 2005 beach/ foredune escarpment line was remnant foredune habitat.

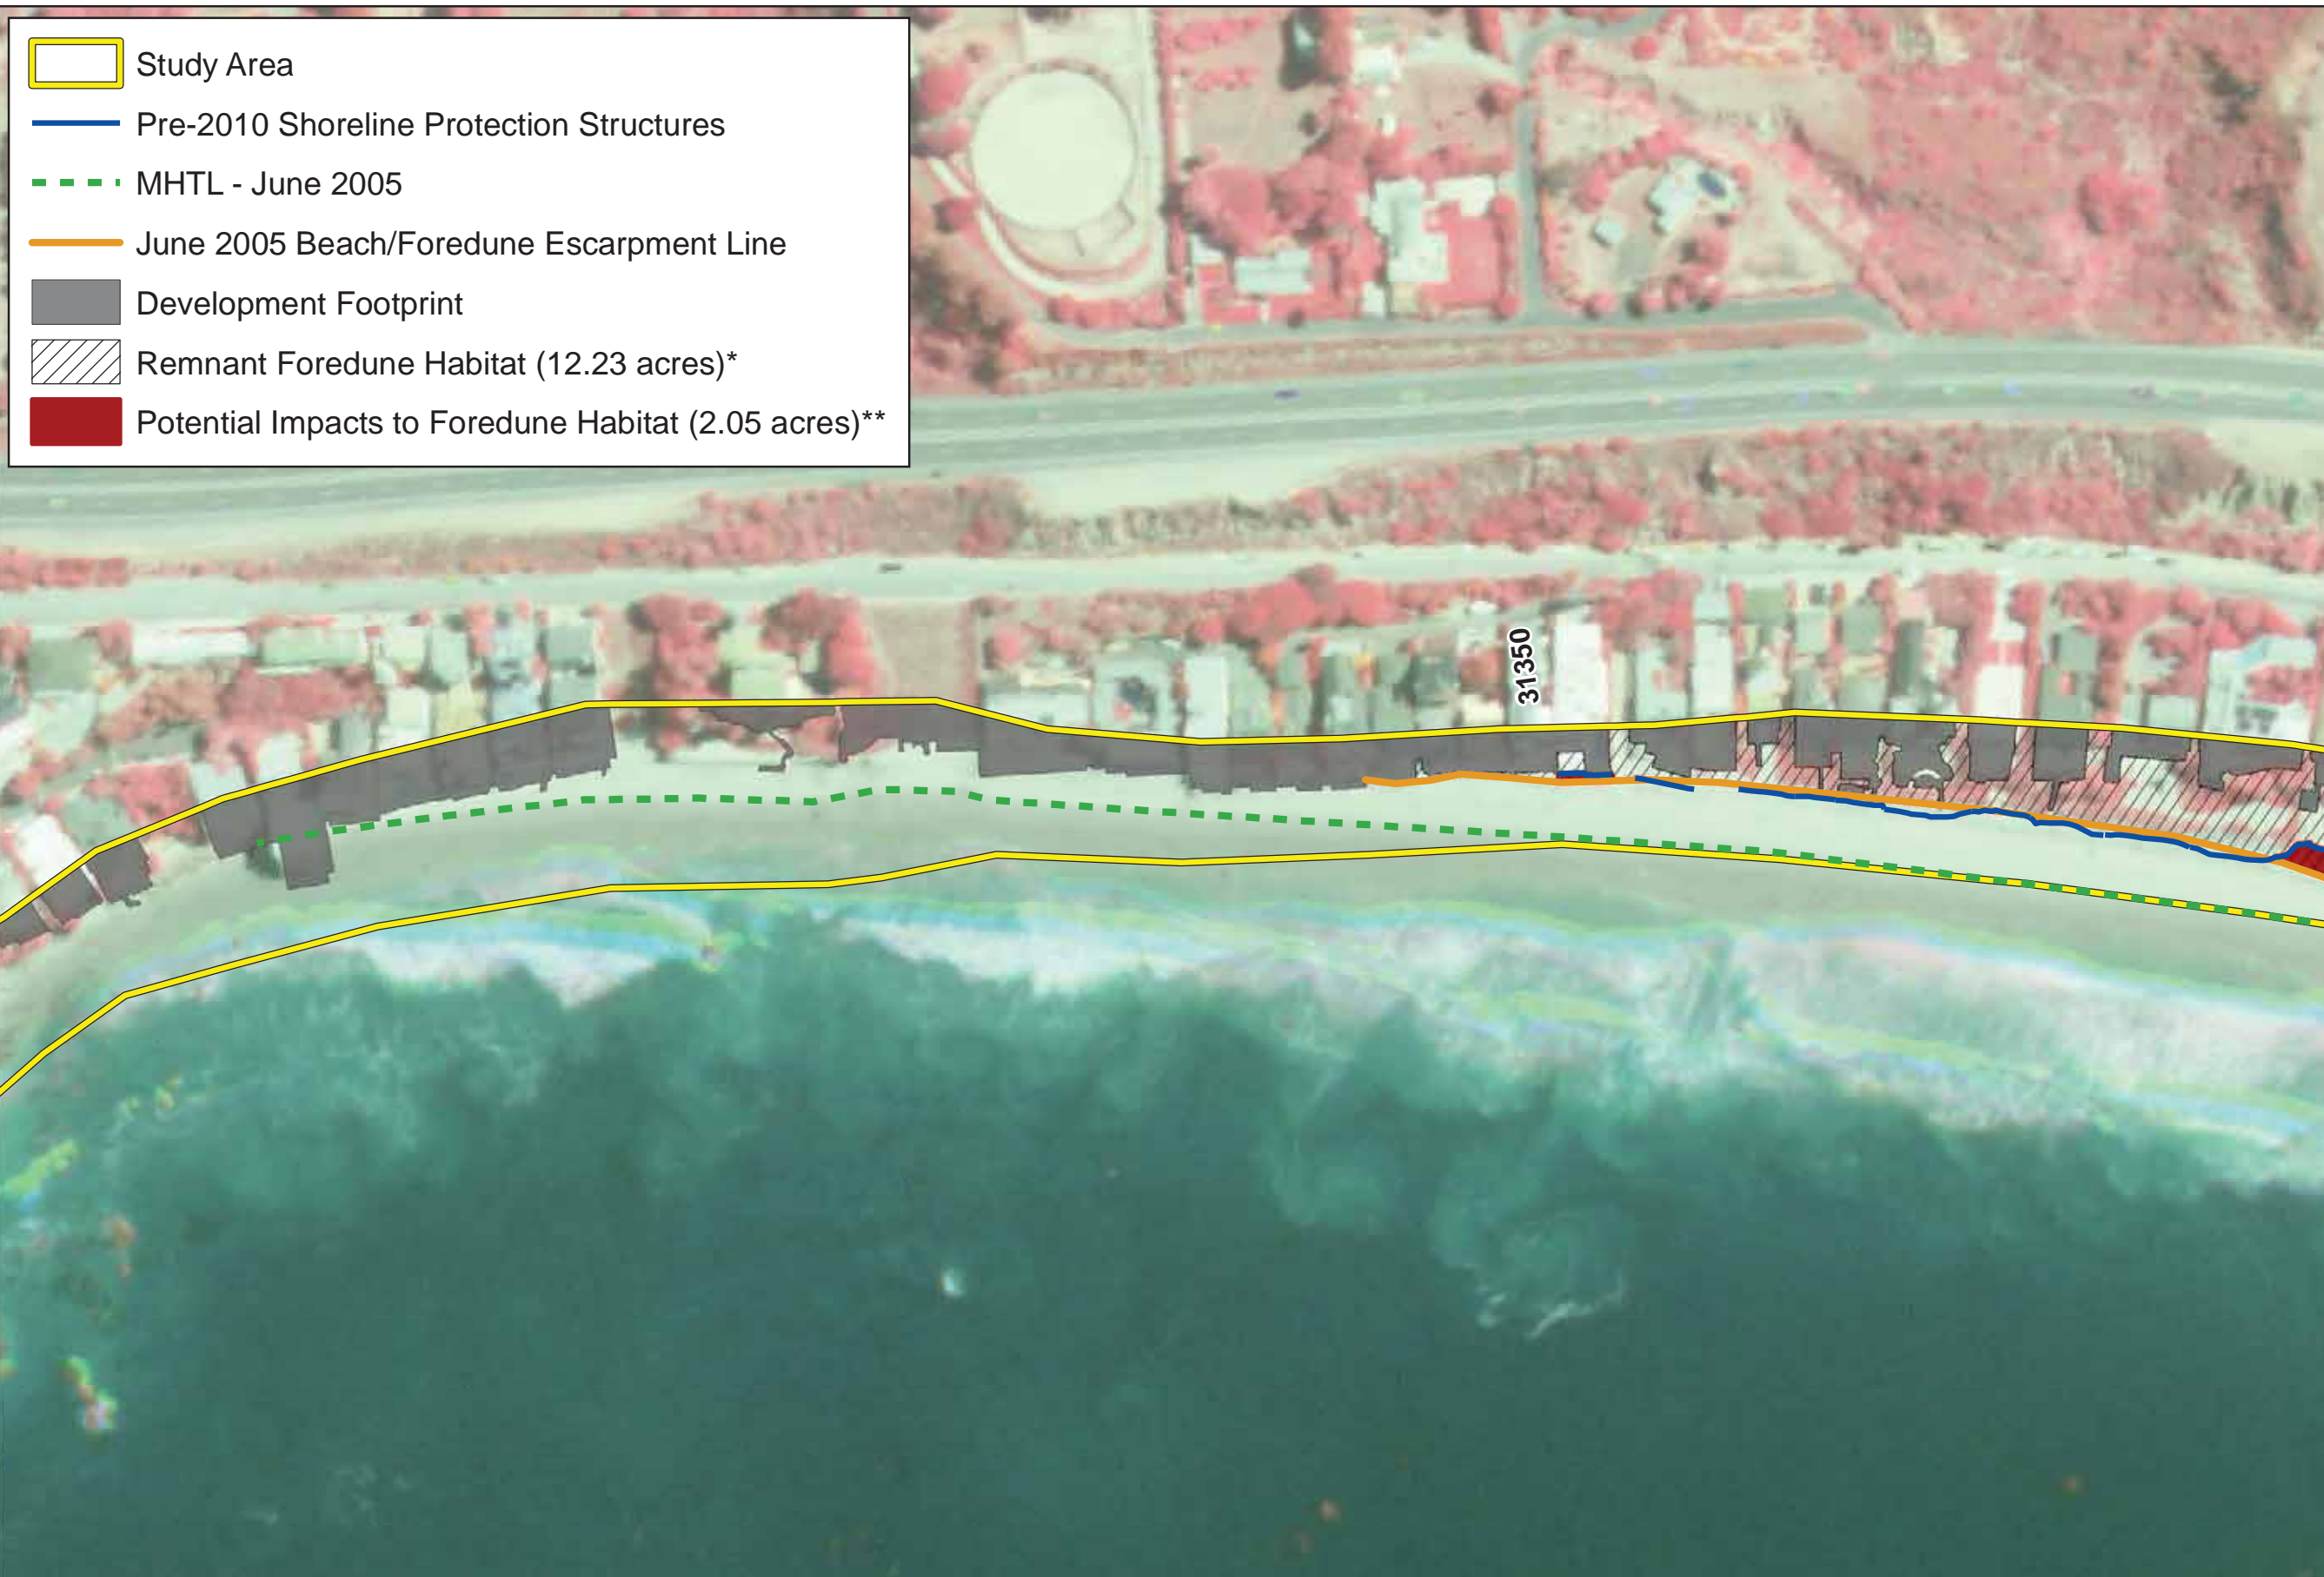
Potential Impacts to
Foredune Habitat
from Pre-2010
Revetment Materials
Relative to 2005
Baseline Conditions

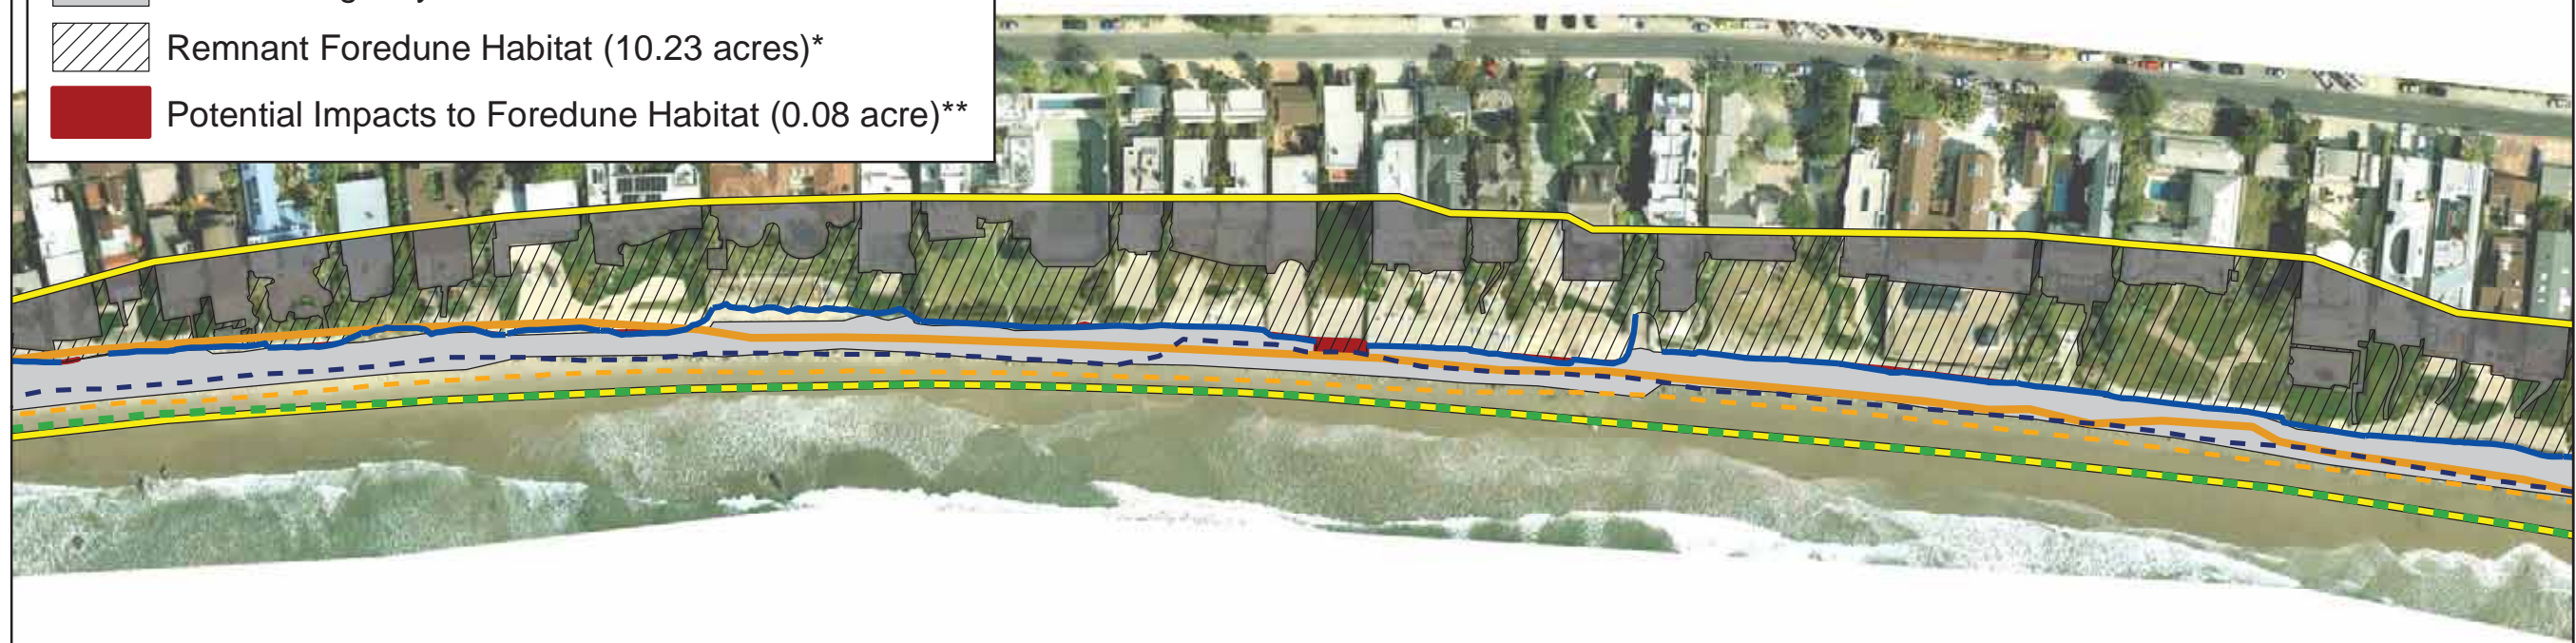
Potential Impacts to
Foredune Habitat from
2010 Emergency
Rock Revetment
Relative to 2009
Conditions

- Study Area
- MHTL - June 2005
- MHTL - JAN 19-20, 2010
- MHTL - OCT 15, 2009
- June 2005 Beach/Foredune Escarpment Line
- Pre-2010 Shoreline Protection Structures
- Development Footprint
- 2010 Emergency Rock Revetment
- Remnant Foredune Habitat (10.23 acres)*
- Potential Impacts to Foredune Habitat (0.08 acre)**

* Remnant foredune habitat based on 2010 foredune extent (i.e., foredune habitat remaining after installation of Pre-2010 Shoeline Protection Structures).
 ** Potential impacts assume that all foredune habitat seaward of the pre-2010 shoreline protection structures was lost to wave action. Impacts are those areas where the 2010 emergency rock revetment occurs landward of pre-2010 shoreline protection structures or where such structures were not installed.

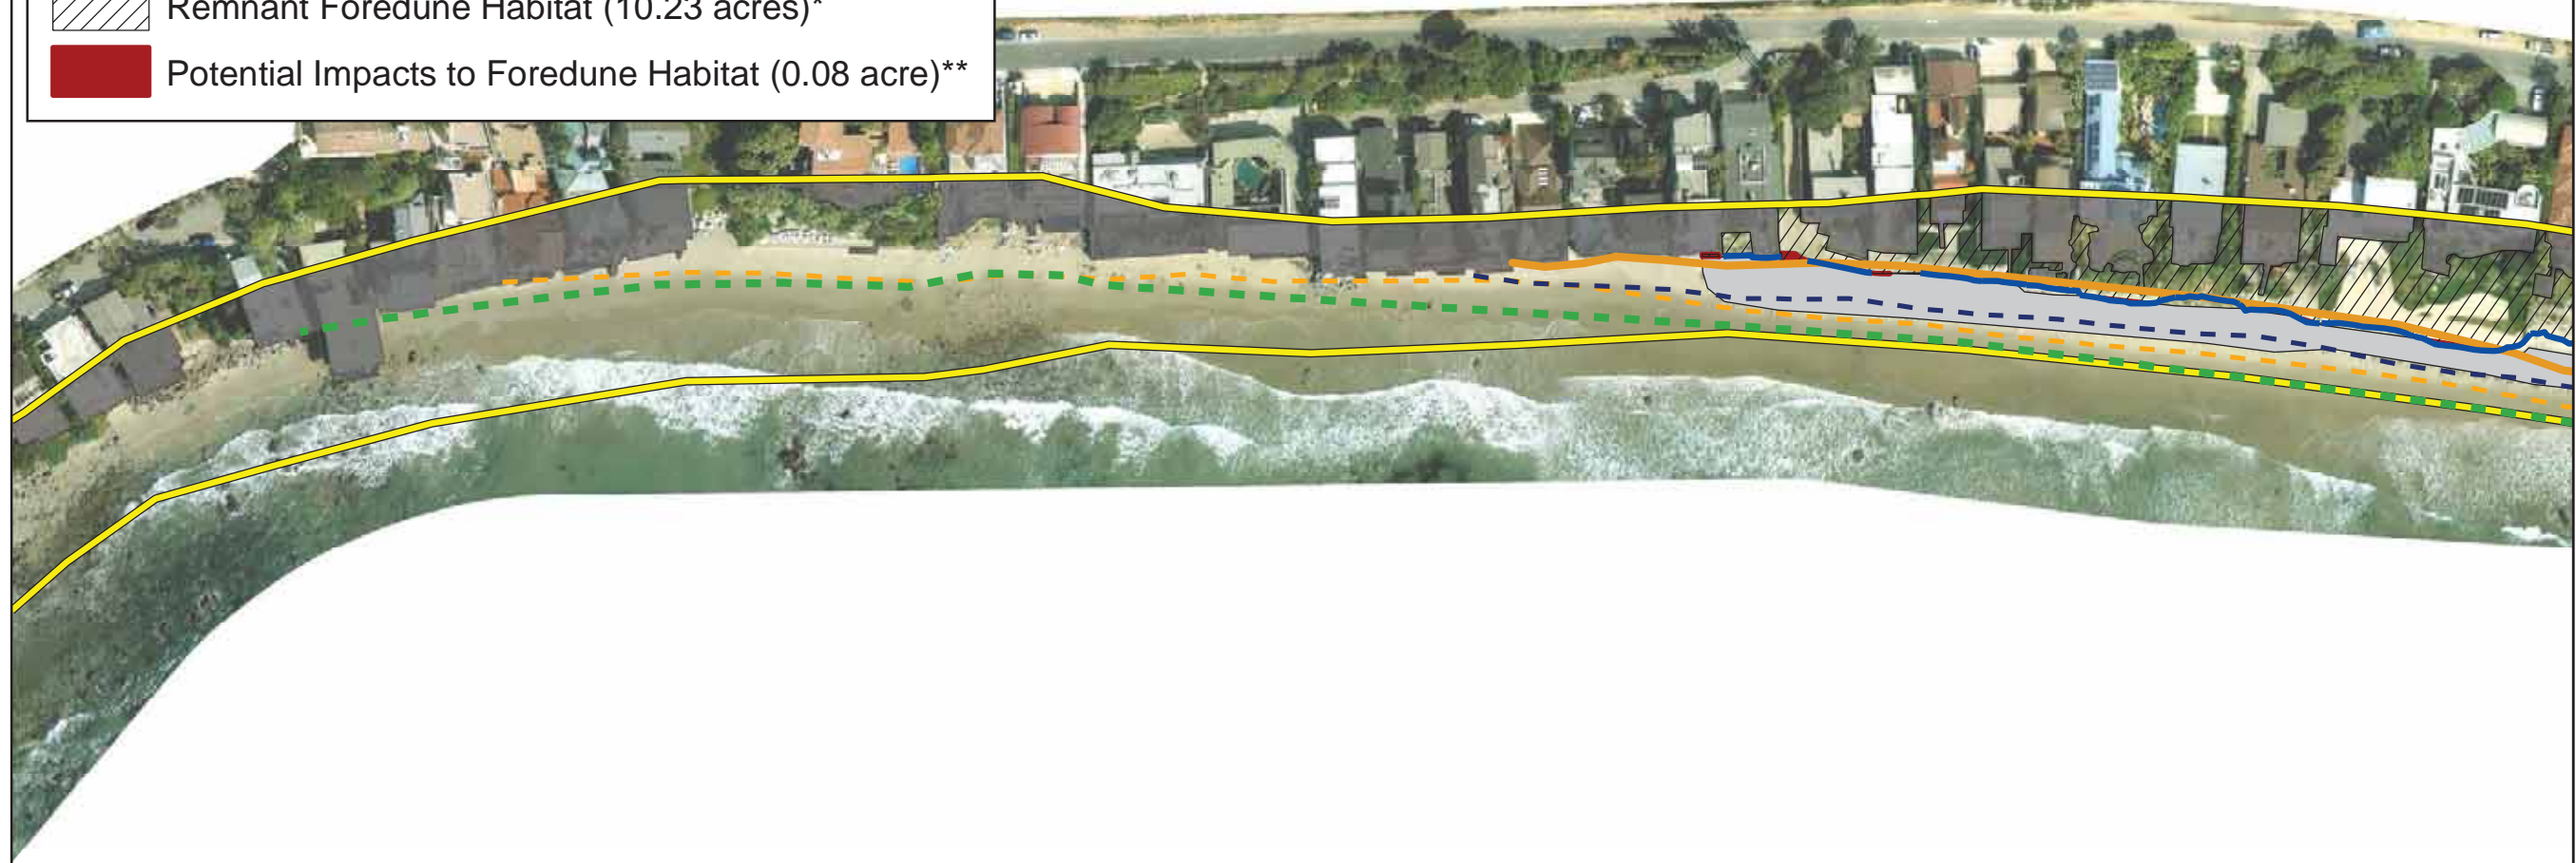
Potential Impacts to
Foredune Habitat from
2010 Emergency Rock
Revetment
Relative to 2009
Conditions

* Remnant foredune habitat based on 2010 foredune extent (i.e., foredune habitat remaining after installation of Pre-2010 Shoeline Protection Structures).
 ** Potential impacts assume that all foredune habitat seaward of the pre-2010 shoreline protection structures was lost to wave action. Impacts are those areas where the 2010 emergency rock revetment occurs landward of pre-2010 shoreline protection structures or where such structures were not installed.

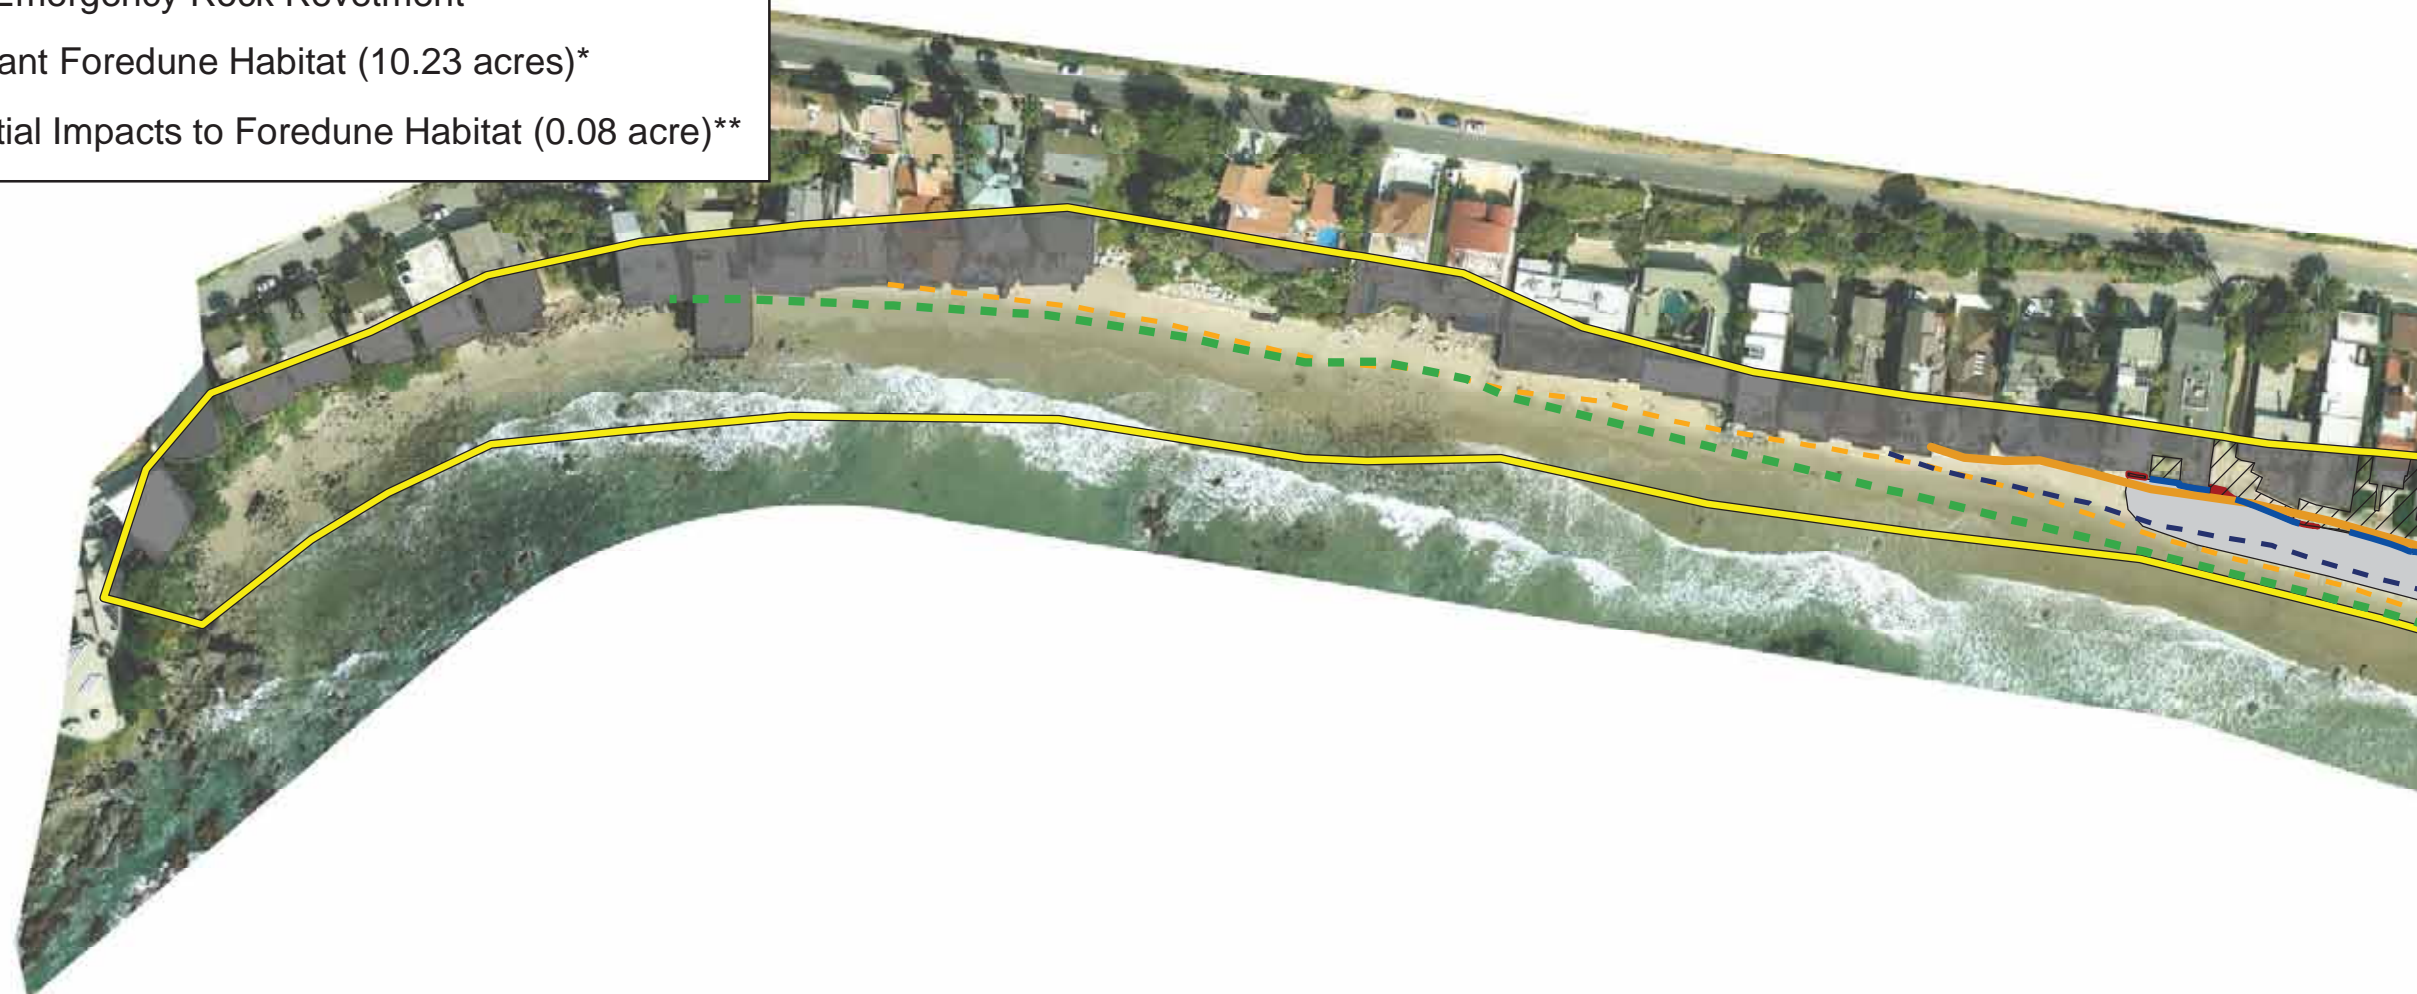
* Remnant foredune habitat based on 2010 foredune extent (i.e., foredune habitat remaining after installation of Pre-2010 Shoeline Protection Structures).
 ** Potential impacts assume that all foredune habitat seaward of the pre-2010 shoreline protection structures was lost to wave action. Impacts are those areas where the 2010 emergency rock revetment occurs landward of pre-2010 shoreline protection structures or where such structures were not installed.

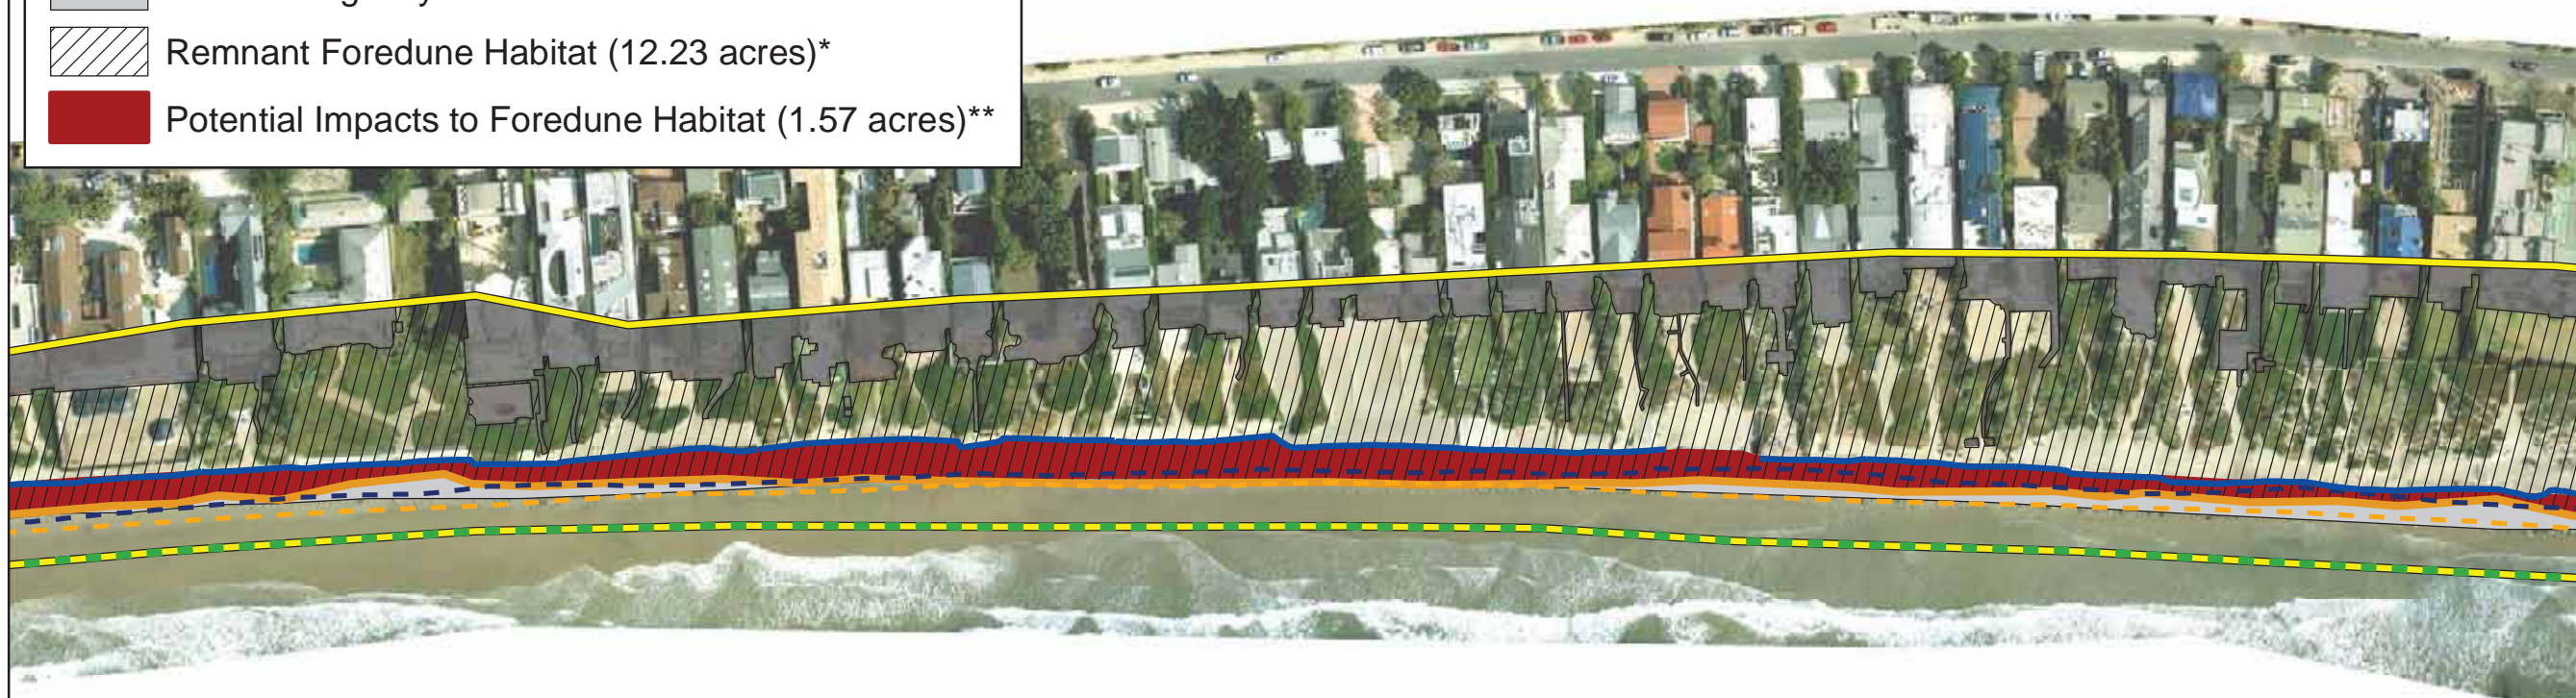
Potential Impacts to Foredune Habitat (1.57 acres)**

* Remnant Foredune habitat based on 2005 foredune extent shown in Figure 2.

** Potential impacts assume that any area seaward of the pre-2010 shoreline protection structures and landward of the 2005 beach/foredune escarpment line was remnant foredune habitat.

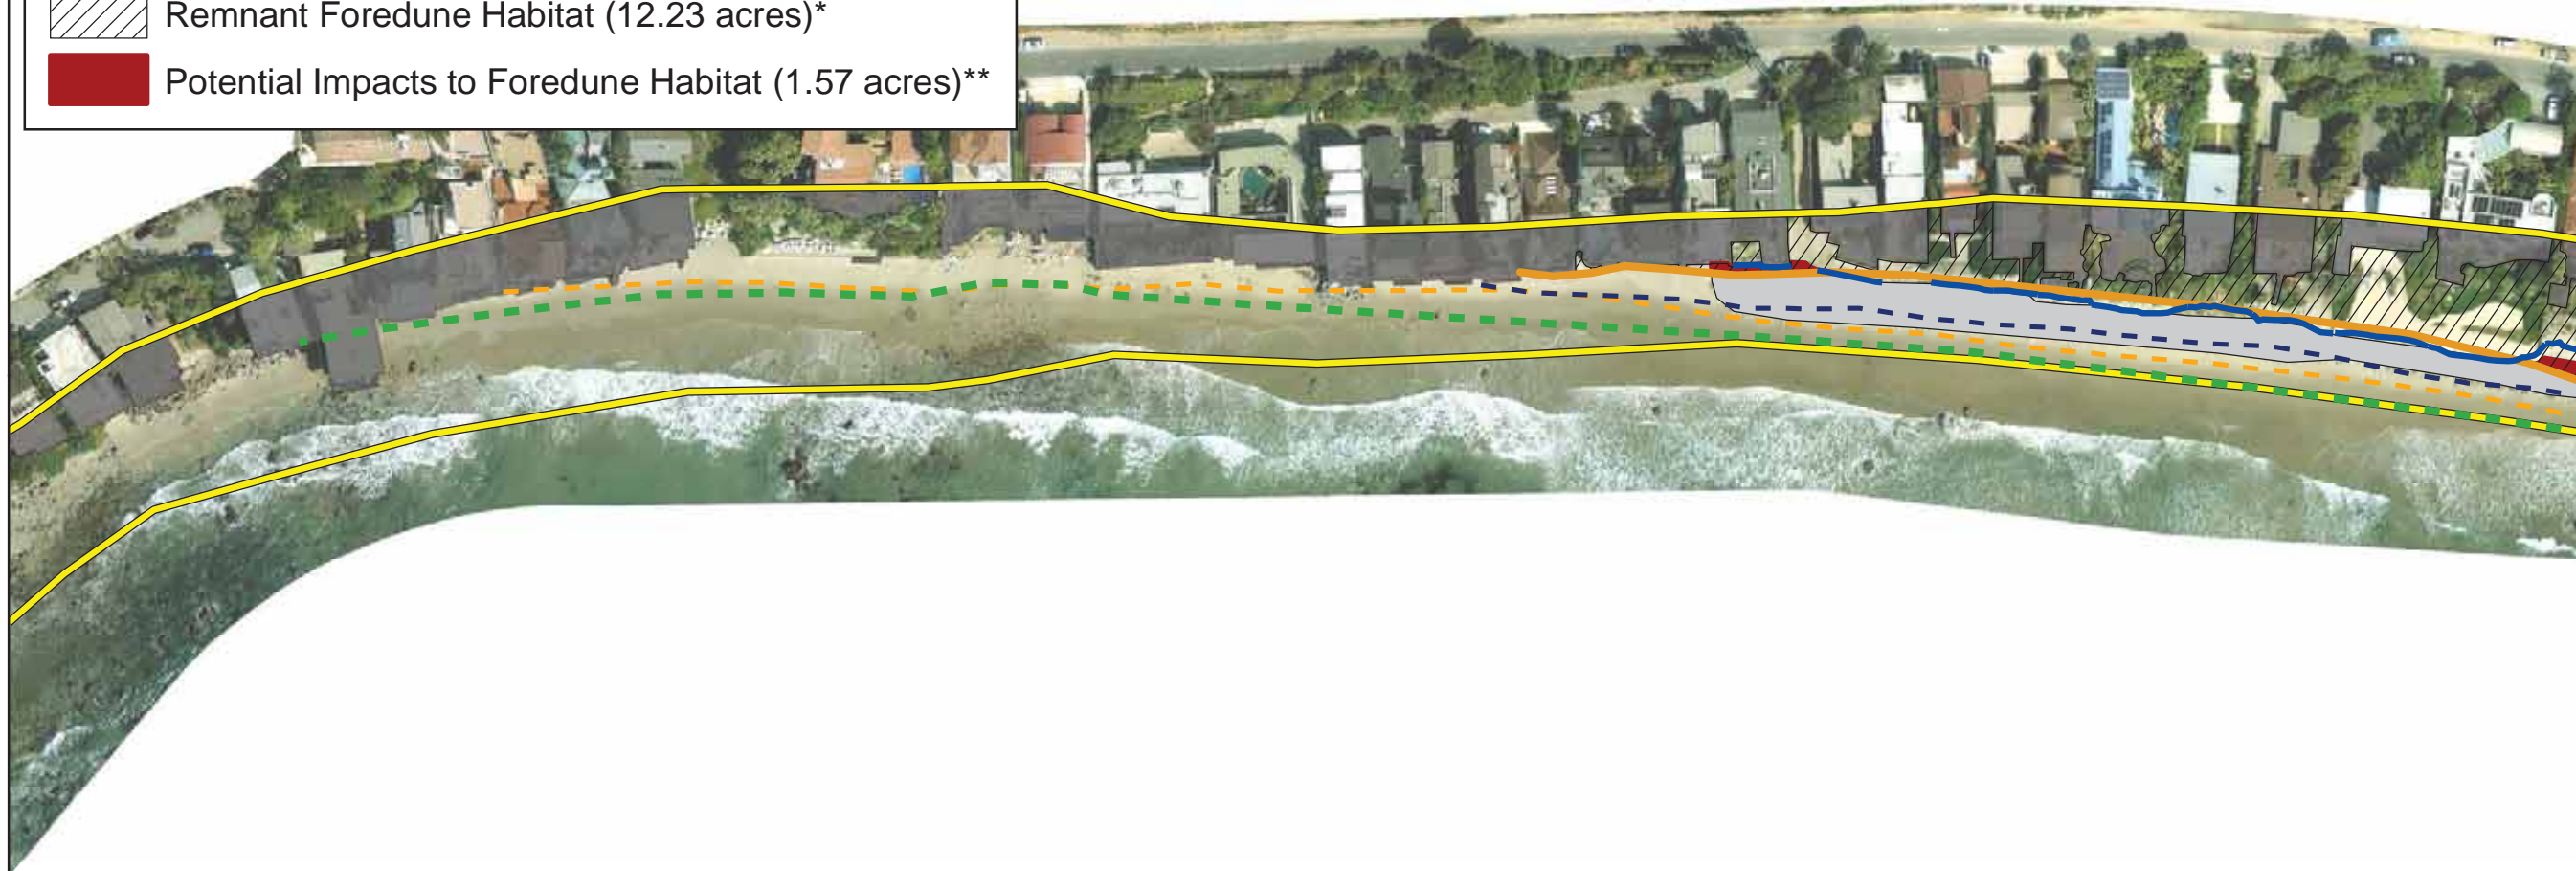
Potential Impacts to Foredune Habitat (1.57 acres)**

* Remnant Foredune habitat based on 2005 foredune extent shown in Figure 2.

** Potential impacts assume that any area seaward of the pre-2010 shoreline protection structures and landward of the 2005 beach/foredune escarpment line was remnant foredune habitat.

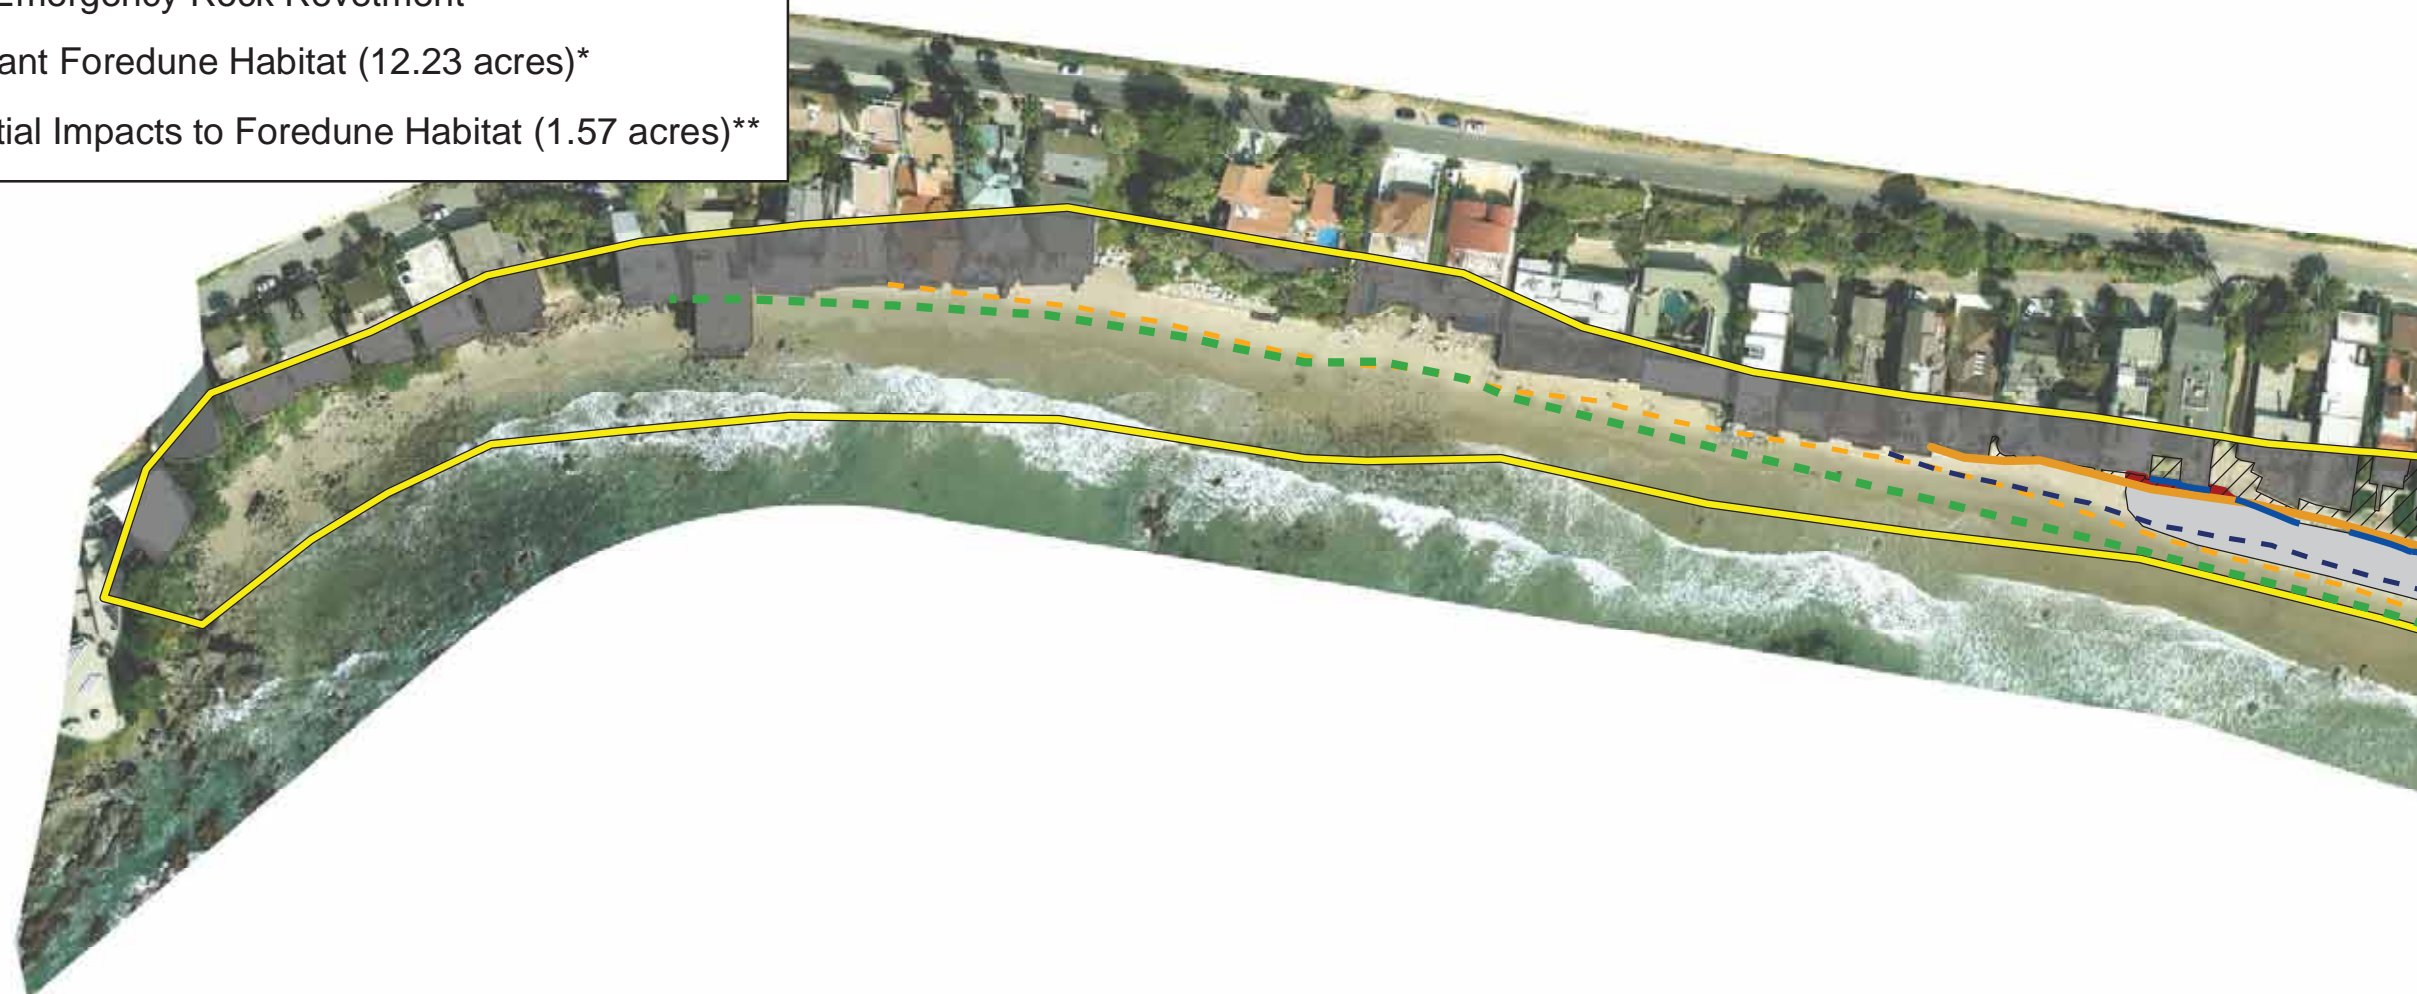
Potential Impacts to Foredune Habitat (1.57 acres)**

* Remnant Foredune habitat based on 2005 foredune extent shown in Figure 2.

** Potential impacts assume that any area seaward of the pre-2010 shoreline protection structures and landward of the 2005 beach/foredune escarpment line was remnant foredune habitat.
