Memorandum

Subject: Broad Beach Foredune Impact Analysis

This memorandum provides an assessment of the impacts to foredune habitat that may have occurred or that could occur as a result of previous and proposed shoreline stabilization efforts at Broad Beach. This material is intended to support the application for a California Coastal Commission (“CCC”) Coastal Development Permit (“CDP”) for the proposed Broad Beach Restoration Project located in Malibu, Los Angeles County, California (“Study Area”; Figure 1). The information included here is based on inferred historical conditions, observed current conditions, and predicted future conditions at Broad Beach. As noted in the previous CDP submittals for the project, detailed records of historical habitat conditions and shoreline stabilization efforts at Broad Beach are lacking, and much information had to be inferred from historic aerial imagery, a sporadic record of photographs from the site, and comparisons with similar habitats in the region. As such, the analysis presented here is subject to a number of caveats which are presented in the following sections. The analysis follows in six parts, each of which contains (1) an assess

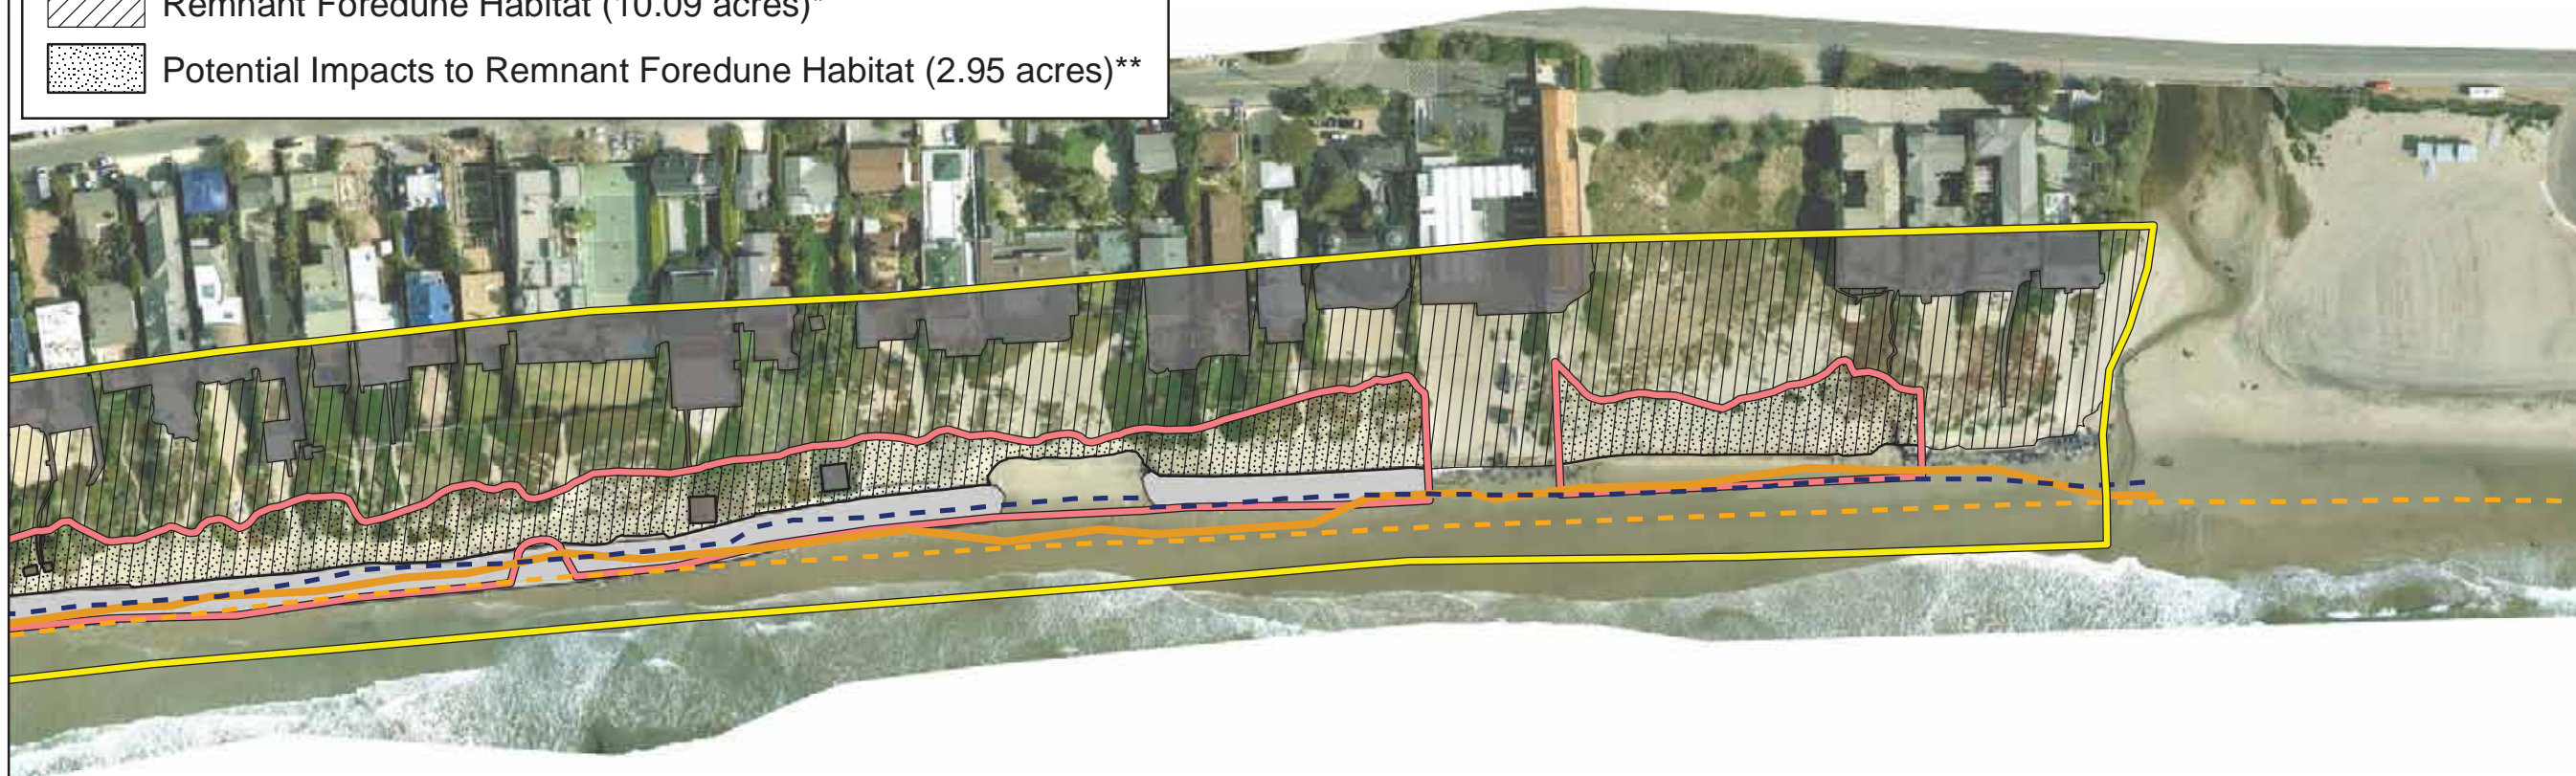
Potential Impacts to
Foredune Habitat from
the Proposed Project
Relative to 2013
Existing Conditions

Potential Impacts to Remnant Foredune Habitat (2.95 acres)**

* Remnant foredune habitat remaining after installation of Pre-2010 Shoreline Protection Structures and 2010 Emergency Rock Revetment, including areas of pocket cove formation where revetment materials were not installed or were installed but failed.

** Potential impacts are due to enhancement of existing degraded foredune habitat and are temporary in nature.

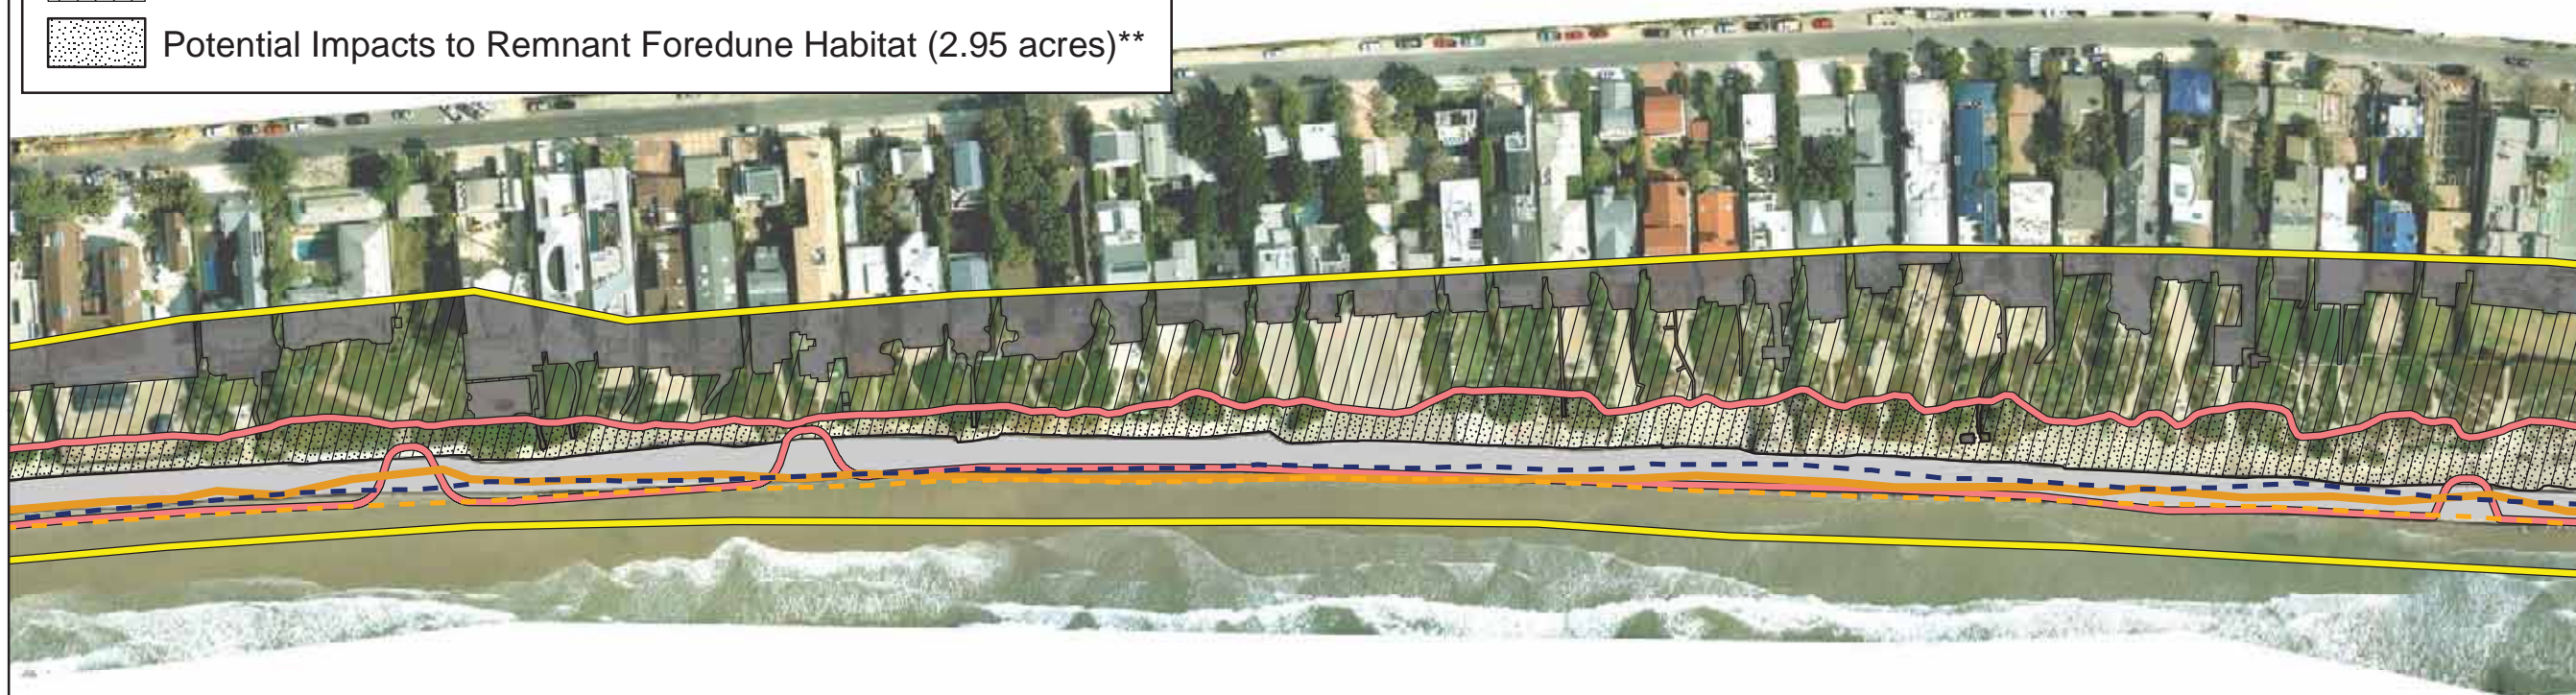
Potential Impacts to
Foredune Habitat from
the Proposed Project
Relative to 2013
Existing Conditions

Potential Impacts to Remnant Foredune Habitat (2.95 acres)**

* Remnant foredune habitat remaining after installation of Pre-2010 Shoreline Protection Structures and 2010 Emergency Rock Revetment, including areas of pocket cove formation where revetment materials were not installed or were installed but failed.

** Potential impacts are due to enhancement of existing degraded foredune habitat and are temporary in nature.

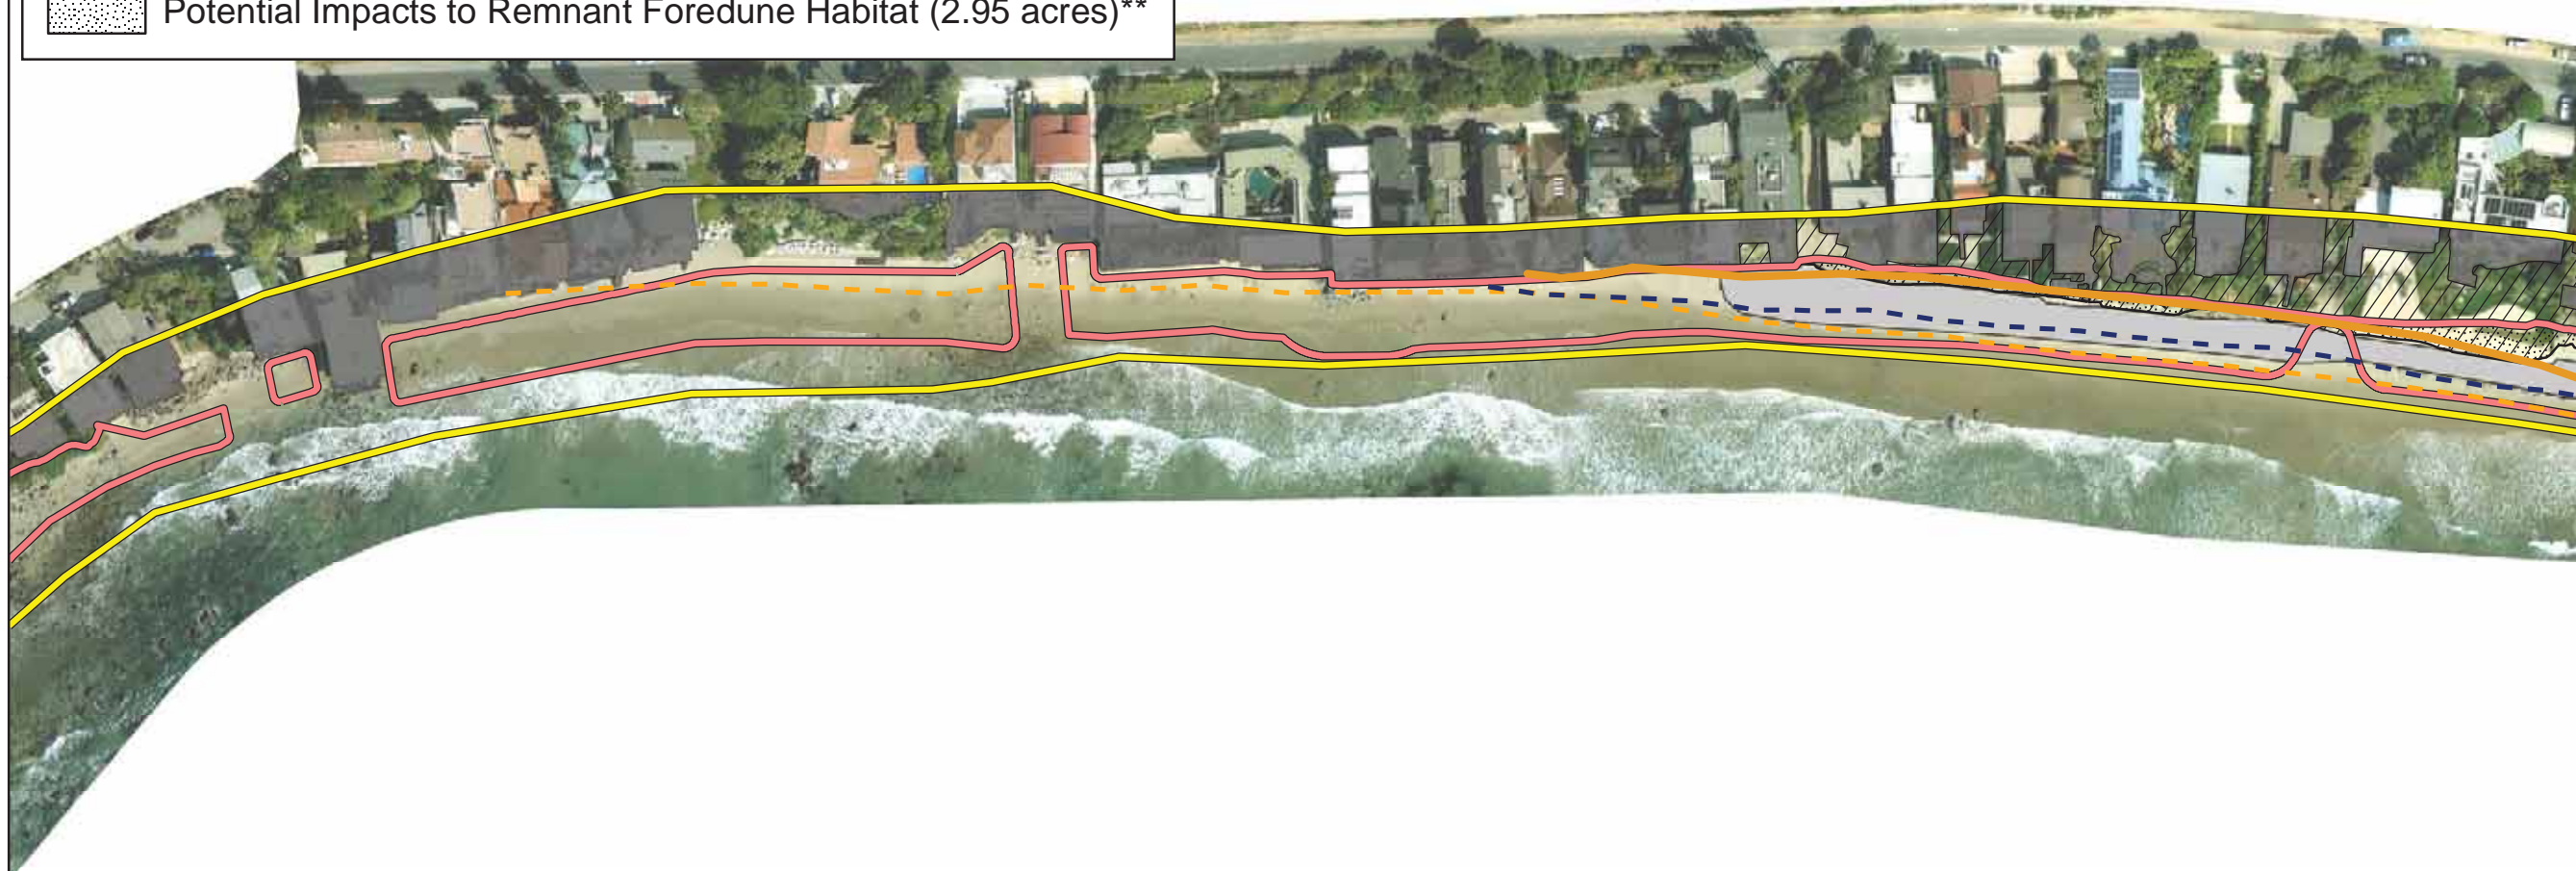
Potential Impacts to
Foredune Habitat from
the Proposed Project
Relative to 2013
Existing Conditions

Potential Impacts to Remnant Foredune Habitat (2.95 acres)**

* Remnant foredune habitat remaining after installation of Pre-2010 Shoreline Protection Structures and 2010 Emergency Rock Revetment, including areas of pocket cove formation where revetment materials were not installed or were installed but failed.

** Potential impacts are due to enhancement of existing degraded foredune habitat and are temporary in nature.

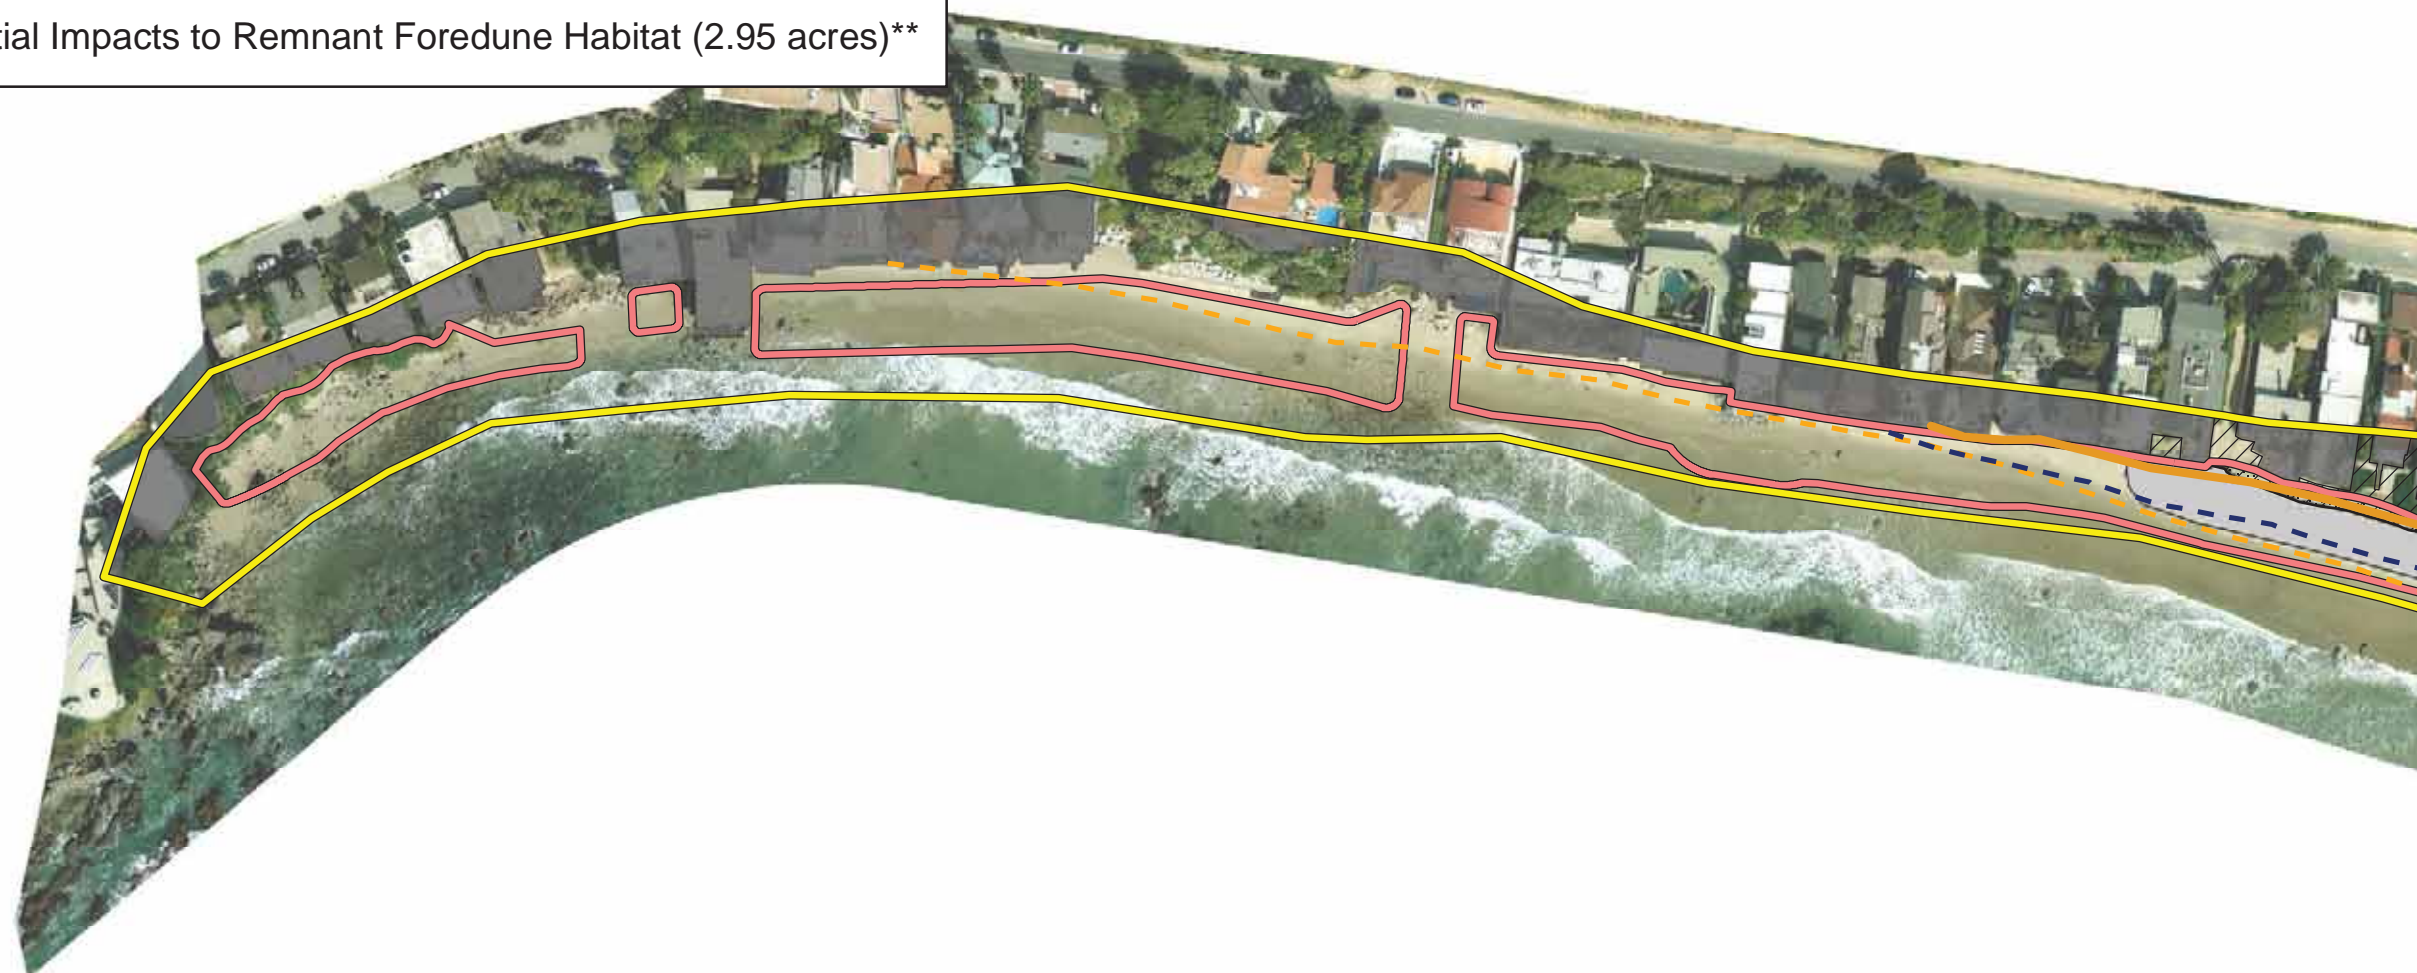
Potential Impacts to
Foredune Habitat from
the Proposed Project
Relative to 2013
Existing Conditions

Potential Impacts to Remnant Foredune Habitat (2.95 acres)**

* Remnant foredune habitat remaining after installation of Pre-2010 Shoreline Protection Structures and 2010 Emergency Rock Revetment, including areas of pocket cove formation where revetment materials were not installed or were installed but failed.

** Potential impacts are due to enhancement of existing degraded foredune habitat and are temporary in nature.

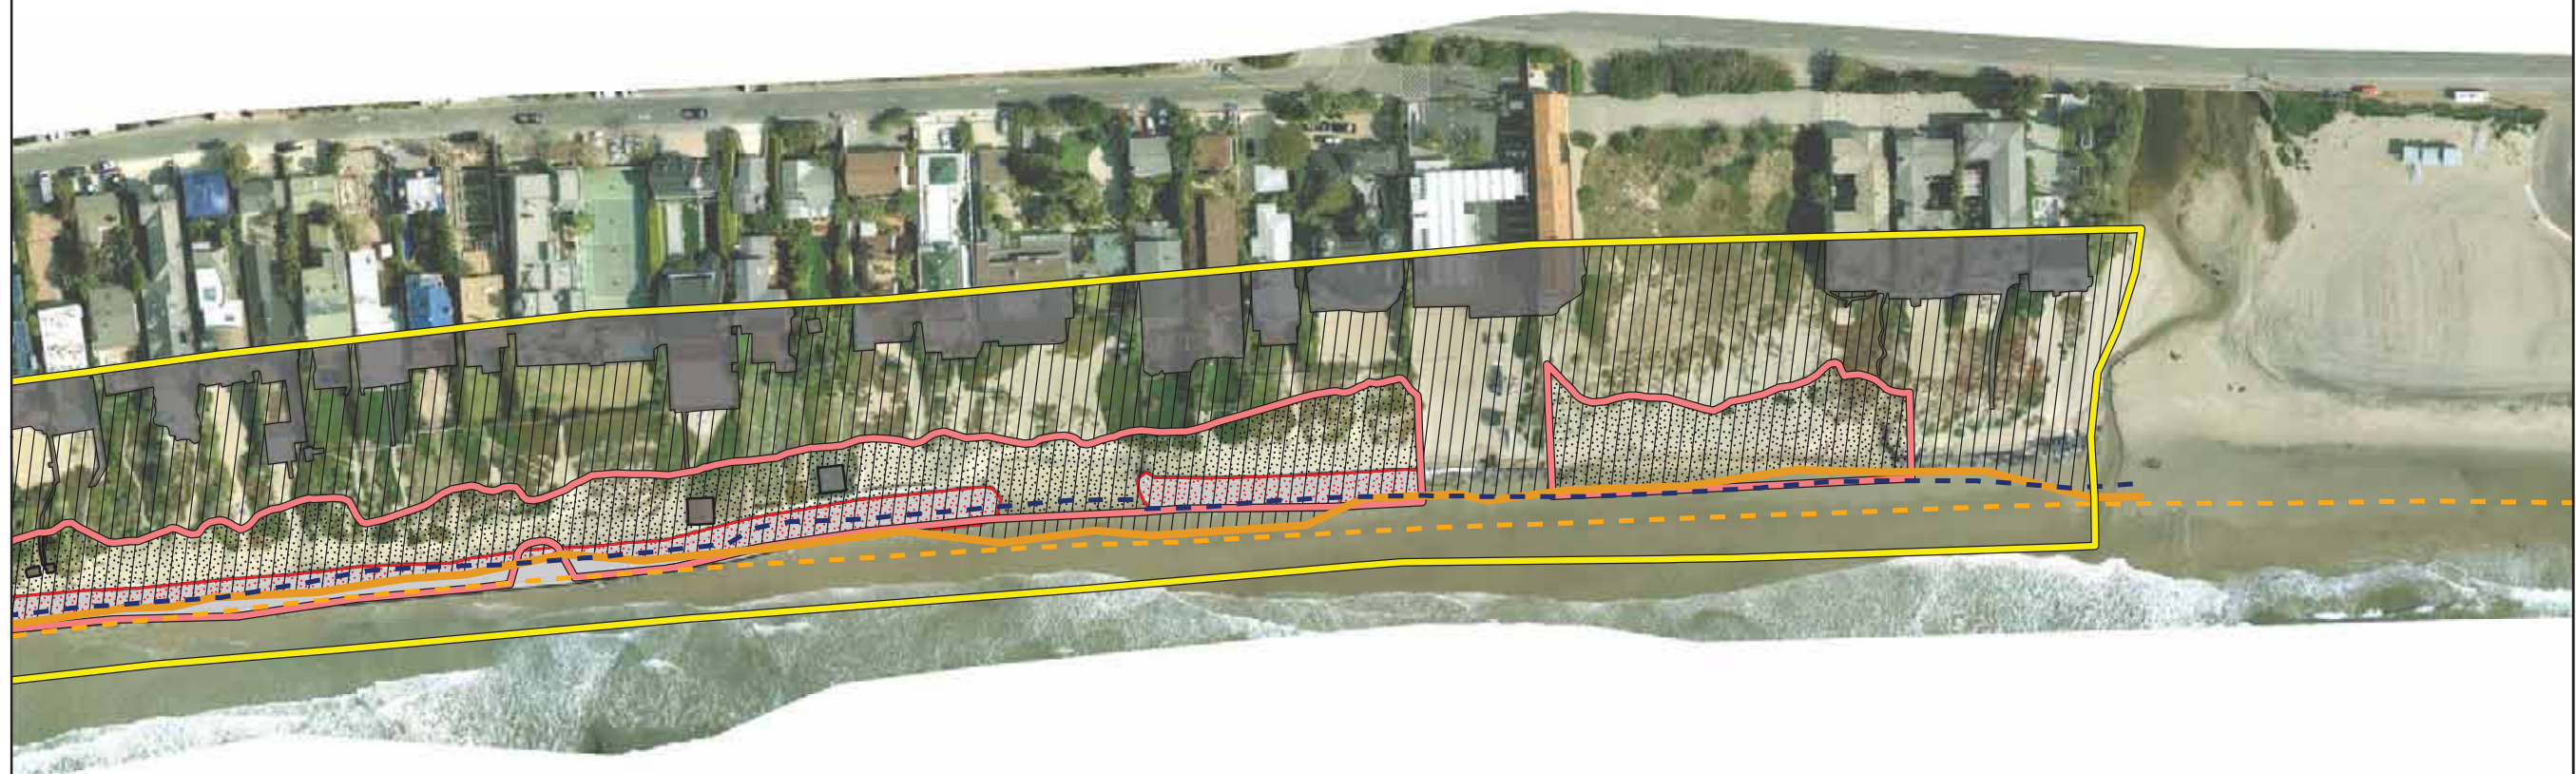
Figure 6-2a.

Potential Impacts to
Foredune Habitat from
the Proposed Project
Relative to 2005
Baseline Conditions

Study Area	Proposed Dune Restoration Footprint (7.71 acres)
MHTL - JAN 19-20, 2010	Remnant Foredune Habitat (12.23 acres)*
MHTL - OCT 15, 2009	Potential Impacts to Remnant Foredune Habitat**
June 2005 Beach/Foredune Escarpment Line	Temporary Impacts (3.23 acres)
Development Footprint	Permanent Impacts (1.57 acres)
2010 Emergency Rock Revetment

** Temporary impacts are due to enhancement of existing degraded foredune habitat. Permanent impacts are due to retention of the rock revetment in the project design.

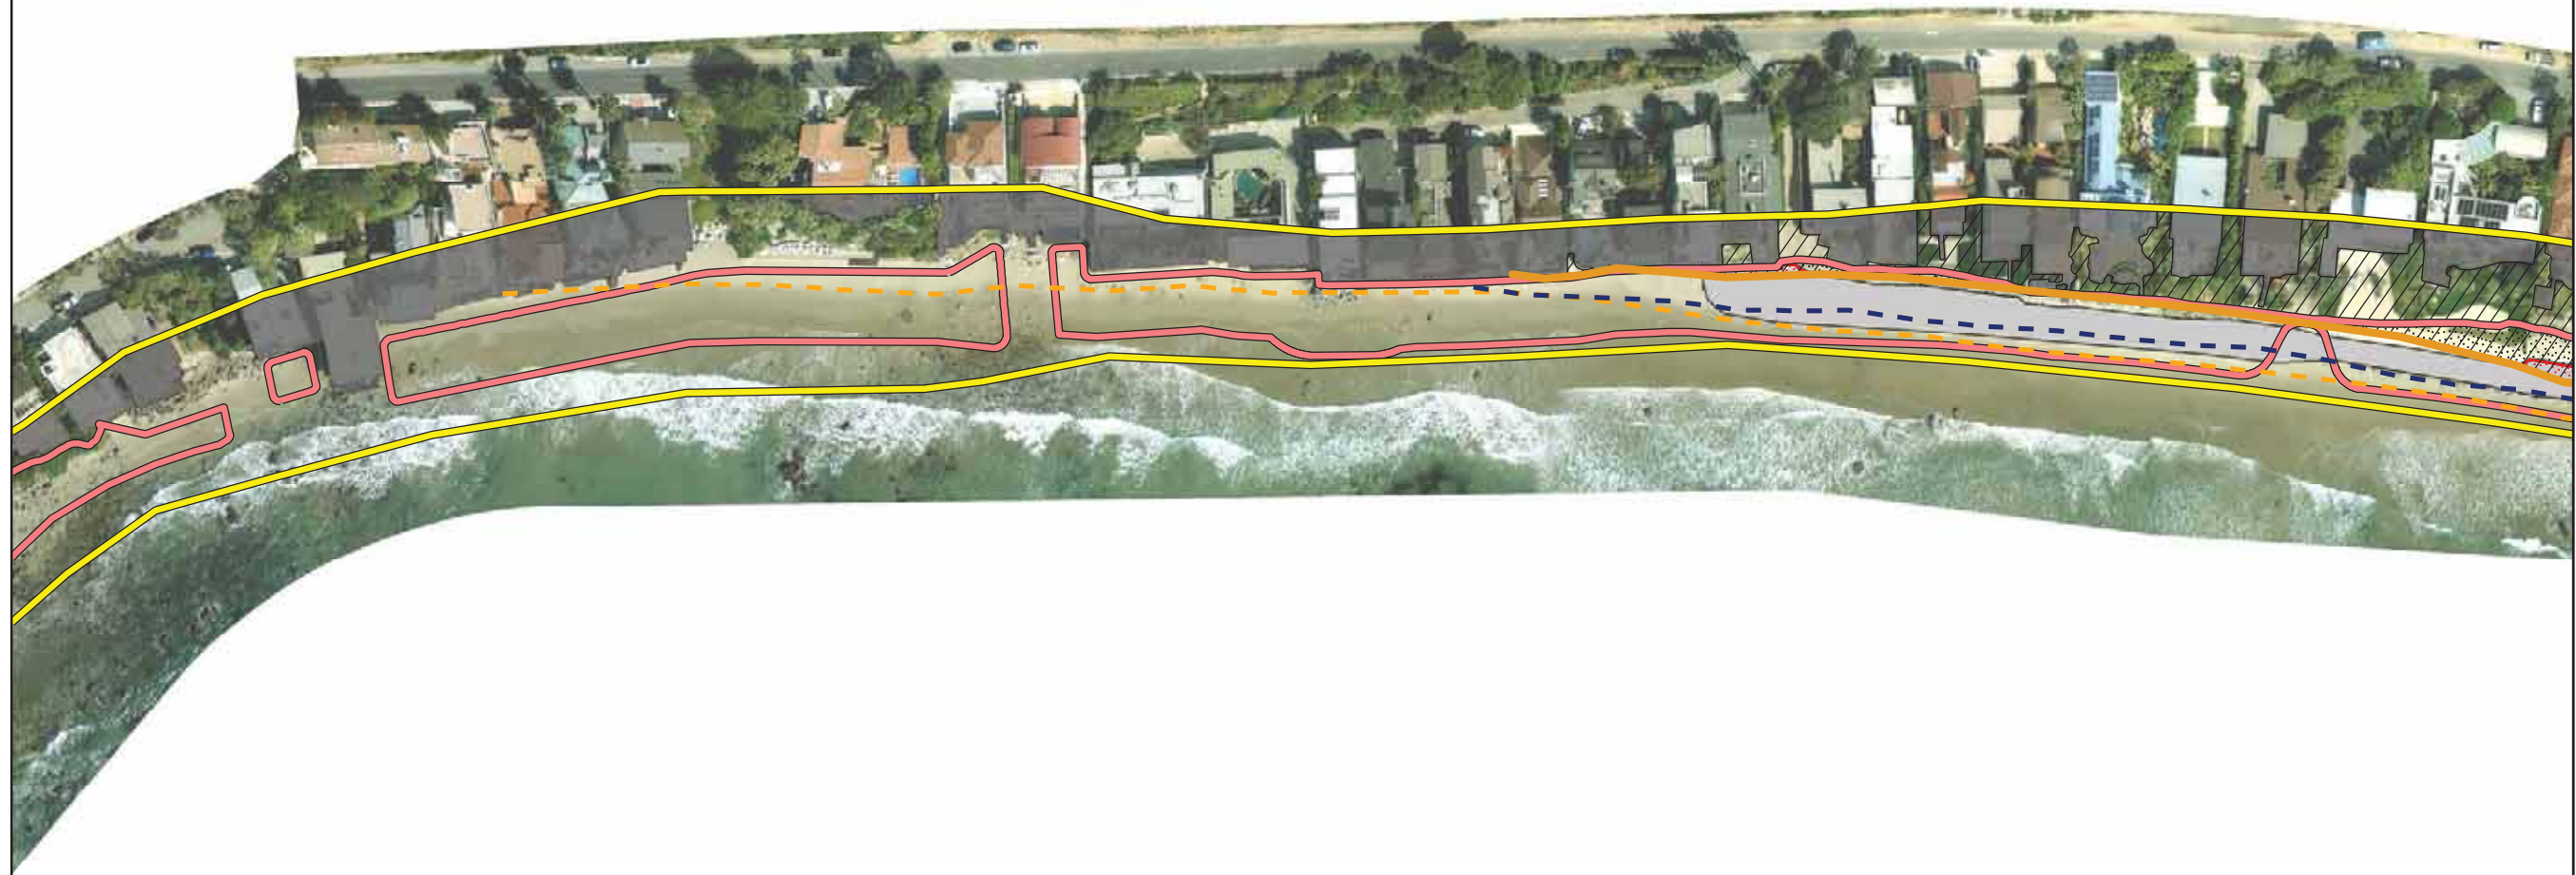
Figure 6-2d.

Potential Impacts to
Foredune Habitat from
the Proposed Project
Relative to 2005
Baseline Conditions

Study Area	Proposed Dune Restoration Footprint (7.71 acres)
MHTL - JAN 19-20, 2010	Remnant Foredune Habitat (12.23 acres)*
MHTL - OCT 15, 2009	Potential Impacts to Remnant Foredune Habitat**
June 2005 Beach/Foredune Escarpment Line	Temporary Impacts (3.23 acres)
Development Footprint	Permanent Impacts (1.57 acres)
2010 Emergency Rock Revetment

** Temporary impacts are due to enhancement of existing degraded foredune habitat. Permanent impacts are due to retention of the rock revetment in the project design.

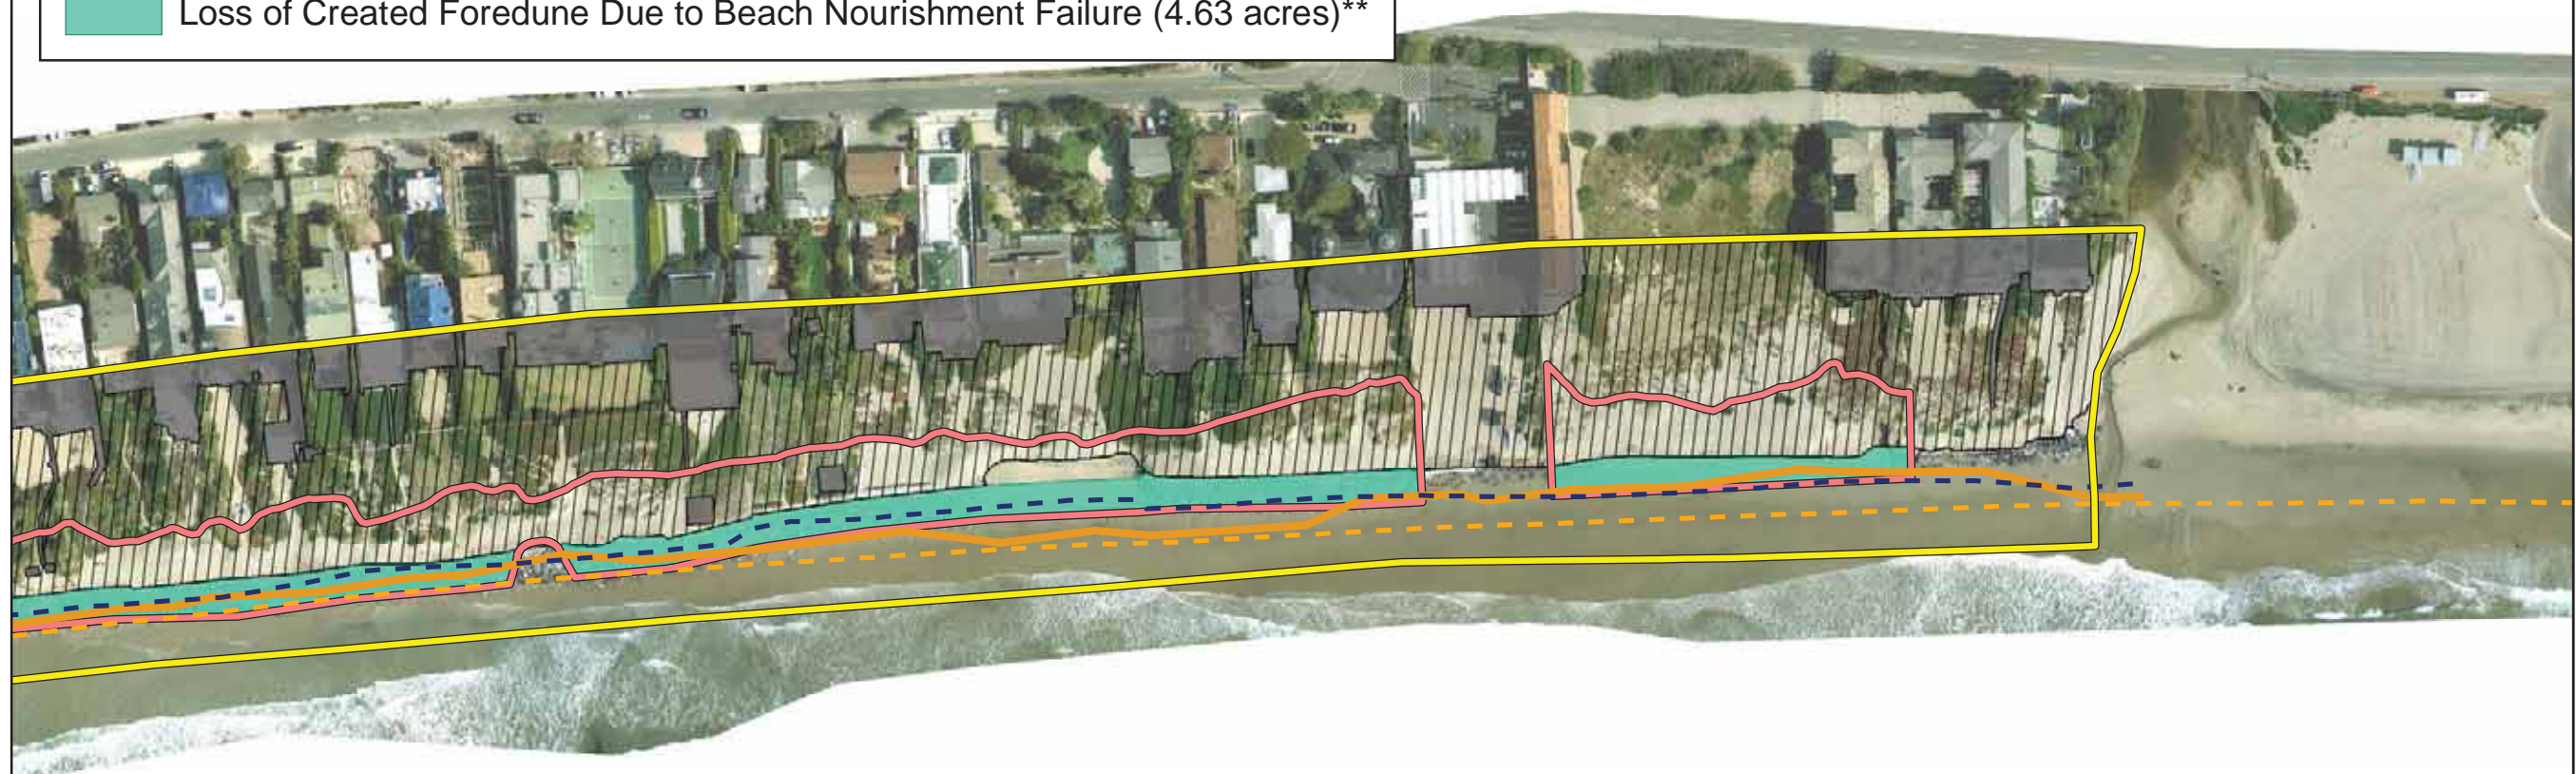
Figure 7-1a.

Potential Impacts to
Foredune Habitat from
the Proposed Project
Under Conditions of
Beach Nourishment
Failure Relative to
2013 Existing Conditions

Loss of Created Foredune Due to Beach Nourishment Failure (4.63 acres)**

* Remnant foredune habitat remaining after installation of Pre-2010 Shoreline Protection Structures and 2010 Emergency Rock Revetment, including areas of pocket cove formation where revetment materials were not installed or were installed but failed.
 ** All foredune habitat to the landward edge of the 2010 emergency rock revetment may be lost; this represents foredune habitat to be created on top or in front of the 2010 emergency rock revetment.

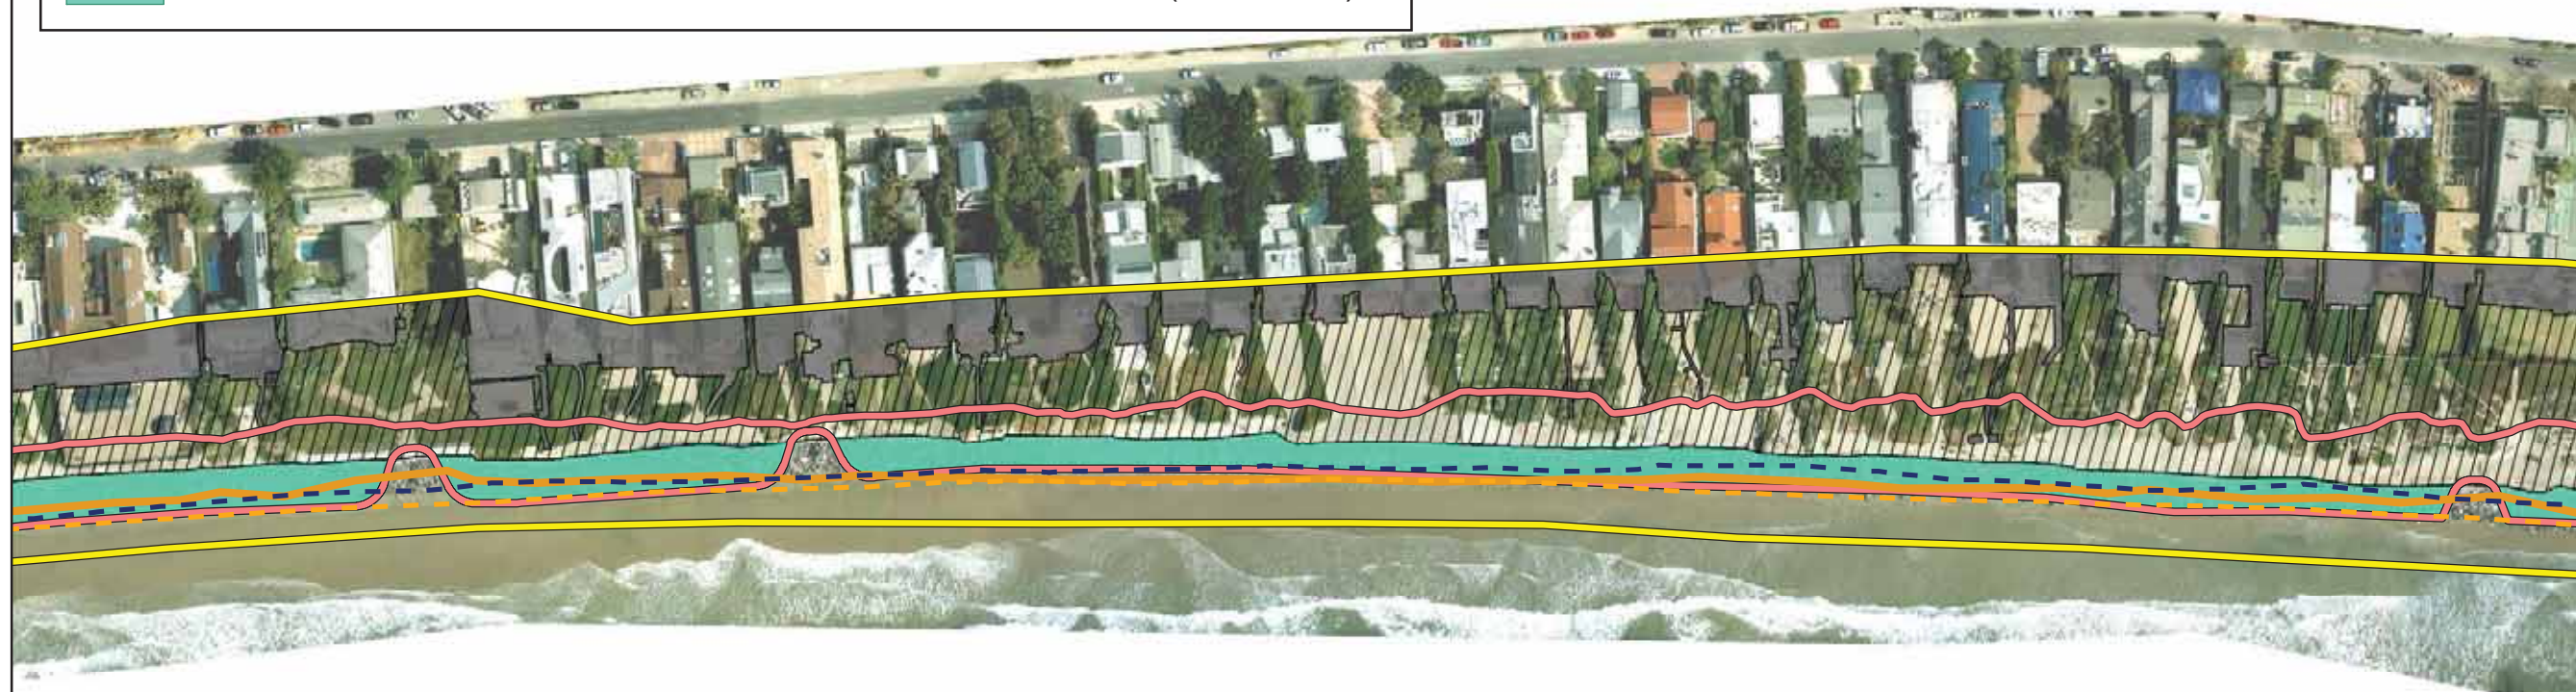
Figure 7-1b.

Potential Impacts to
Foredune Habitat from
the Proposed Project
Under Conditions of
Beach Nourishment
Failure Relative to
2013 Existing Conditions

- Study Area
- MHTL - JAN 19-20, 2010
- MHTL - OCT 15, 2009
- June 2005 Beach/Foredune Escarpment Line
- Development Footprint
- Proposed Dune Restoration Footprint (7.71 acres)
- Remnant Foredune Habitat (10.09 acres)*
- Loss of Created Foredune Due to Beach Nourishment Failure (4.63 acres)**

* Remnant foredune habitat remaining after installation of Pre-2010 Shoreline Protection Structures and 2010 Emergency Rock Revetment, including areas of pocket cove formation where revetment materials were not installed or were installed but failed.
 ** All foredune habitat to the landward edge of the 2010 emergency rock revetment may be lost; this represents foredune habitat to be created on top or in front of the 2010 emergency rock revetment.

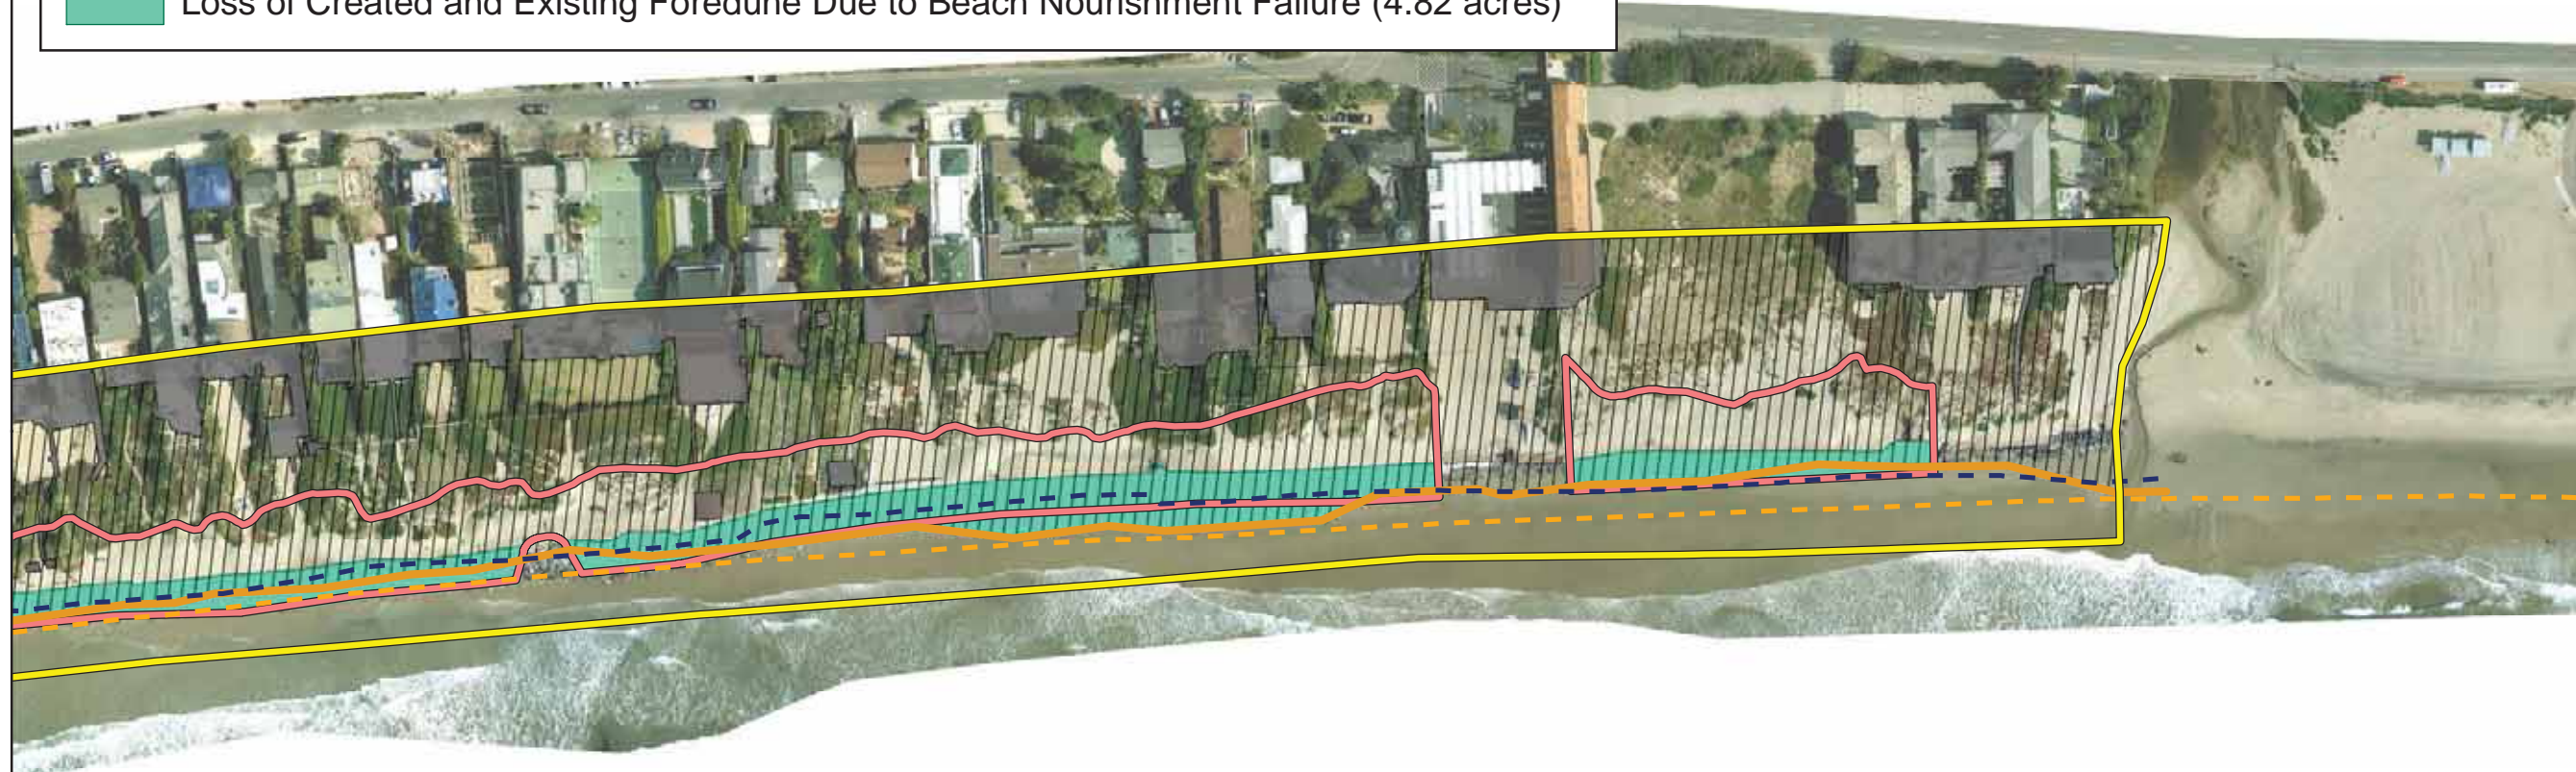
Figure 7-2a.

Potential Impacts to
Foredune Habitat from
the Proposed Project
Under Conditions of
Beach Nourishment
Failure Relative to
2005 Baseline Conditions

Loss of Created and Existing Foredune Due to Beach Nourishment Failure (4.82 acres)**

** All foredune habitat to the landward edge of the 2010 emergency rock revetment may be lost; this represents foredune habitat to be created on top of the revetment and the extent of potential existing foredune habitat in front of the revetment based on 2005 conditions.

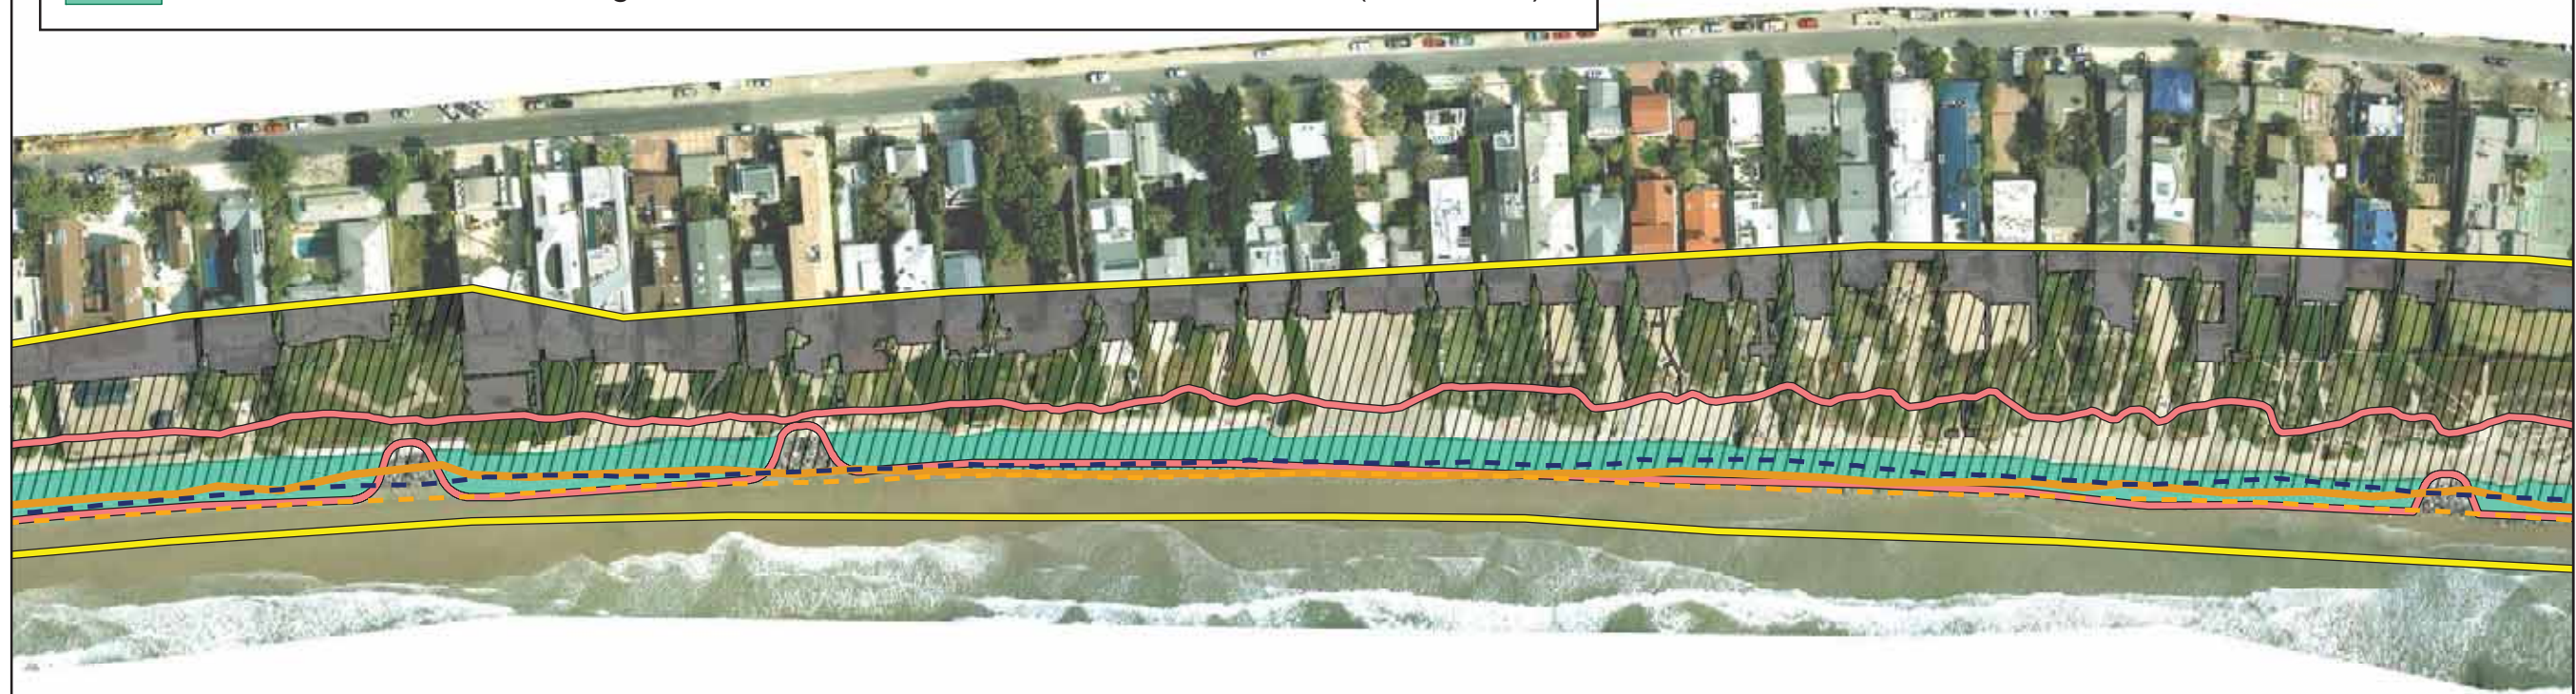
Figure 7-2b.

Potential Impacts to
Foredune Habitat from
the Proposed Project
Under Conditions of
Beach Nourishment
Failure Relative to
2005 Baseline Conditions

Loss of Created and Existing Foredune Due to Beach Nourishment Failure (4.82 acres)**

* Remnant foredune habitat based on 2005 foredune extent shown in Figure 2.
 ** All foredune habitat to the landward edge of the 2010 emergency rock revetment may be lost; this represents foredune habitat to be created on top of the revetment and the extent of potential existing foredune habitat in front of the revetment based on 2005 conditions.
