Memorandum

Subject: Broad Beach Foredune Impact Analysis

This memorandum provides an assessment of the impacts to foredune habitat that may have occurred or that could occur as a result of previous and proposed shoreline stabilization efforts at Broad Beach. This material is intended to support the application for a California Coastal Commission (“CCC”) Coastal Development Permit (“CDP”) for the proposed Broad Beach Restoration Project located in Malibu, Los Angeles County, California (“Study Area”; Figure 1). The information included here is based on inferred historical conditions, observed current conditions, and predicted future conditions at Broad Beach. As noted in the previous CDP submittals for the project, detailed records of historical habitat conditions and shoreline stabilization efforts at Broad Beach are lacking, and much information had to be inferred from historic aerial imagery, a sporadic record of photographs from the site, and comparisons with similar habitats in the region. As such, the analysis presented here is subject to a number of caveats which are presented in the following sections. The analysis follows in six parts, each of which contains (1) an assess

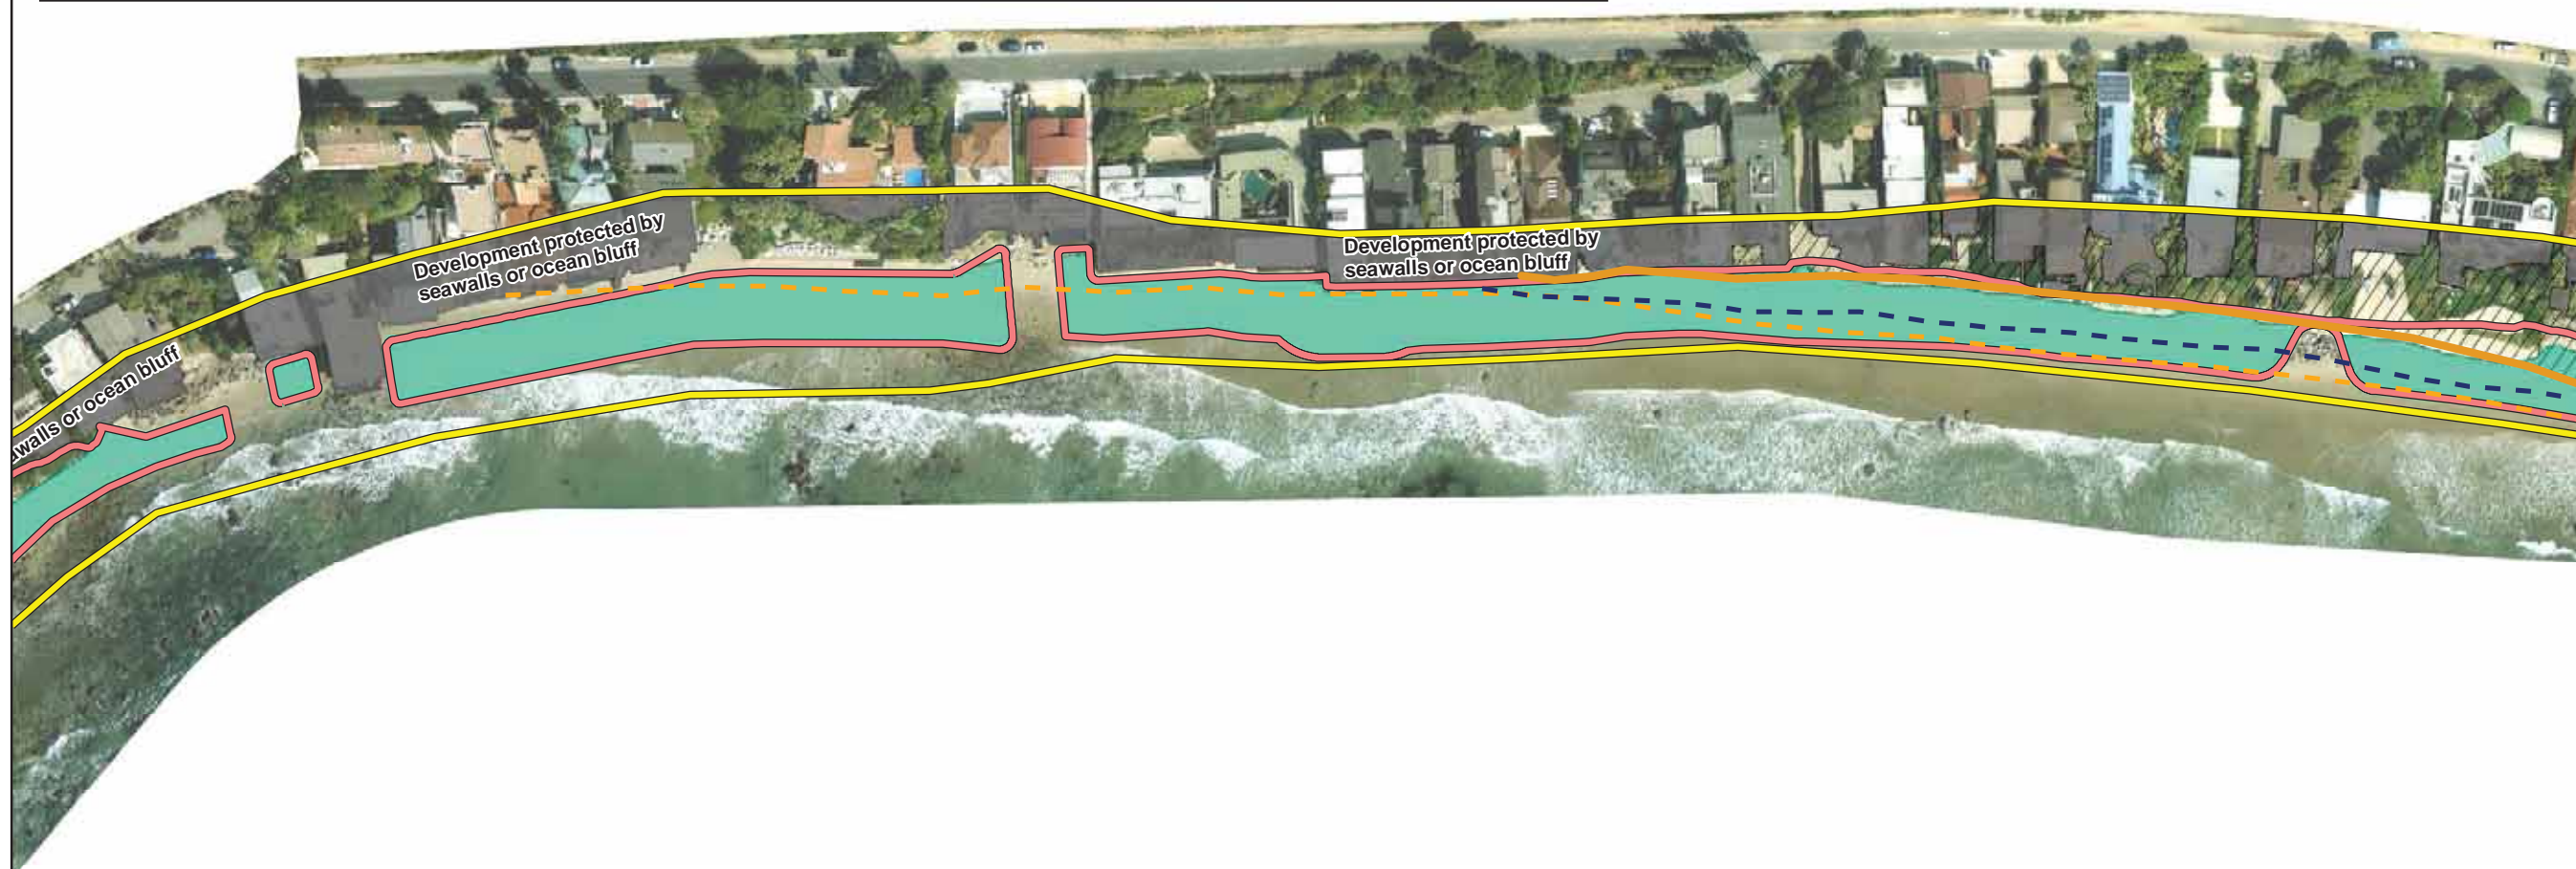
* Remnant foredune habitat based on 2005 foredune extent shown in Figure 2.
 ** All foredune habitat to the landward edge of the 2010 emergency rock revetment may be lost; this represents foredune habitat to be created on top of the revetment and the extent of potential existing foredune habitat in front of the revetment based on 2005 conditions.

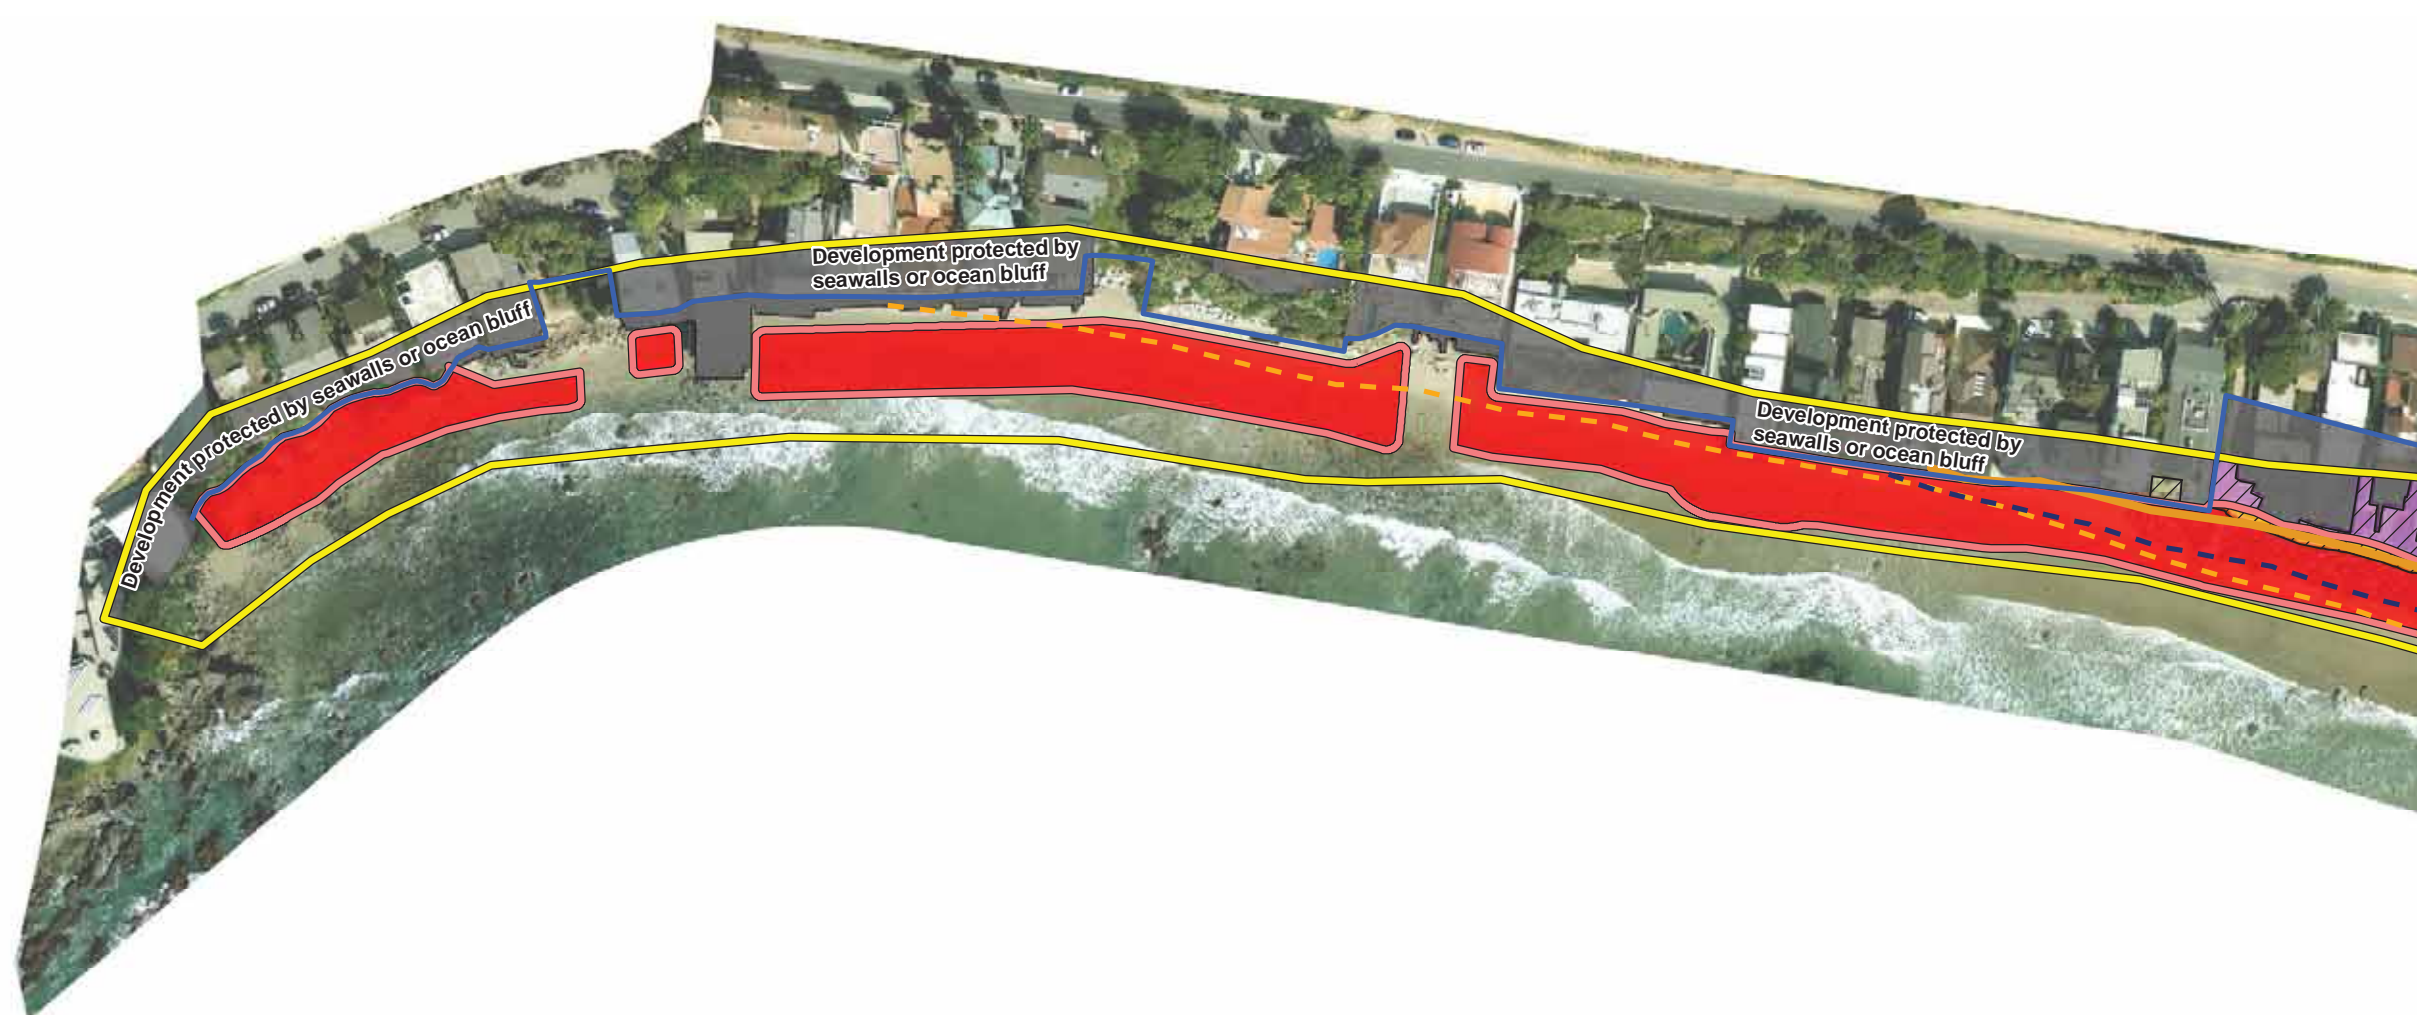
Figure 8-1e.

Potential Impacts to
Foredune Habitat from
the Proposed Project
Under Conditions of
Revetment Failure
Failure Relative to
2013 Existing Conditions

* Remnant foredune habitat remaining after installation of Pre-2010 Shoreline Protection Structures and 2010 Emergency Rock Revetment, including areas of pocket cove formation where revetment materials were not installed or were installed but failed.
 ** No Project Wave Uprush Limit provided by Moffatt and Nichol
 *** All habitat & development up to No Project Wave Uprush Limit may be lost. Additional losses may occur under conditions of sea level rise.

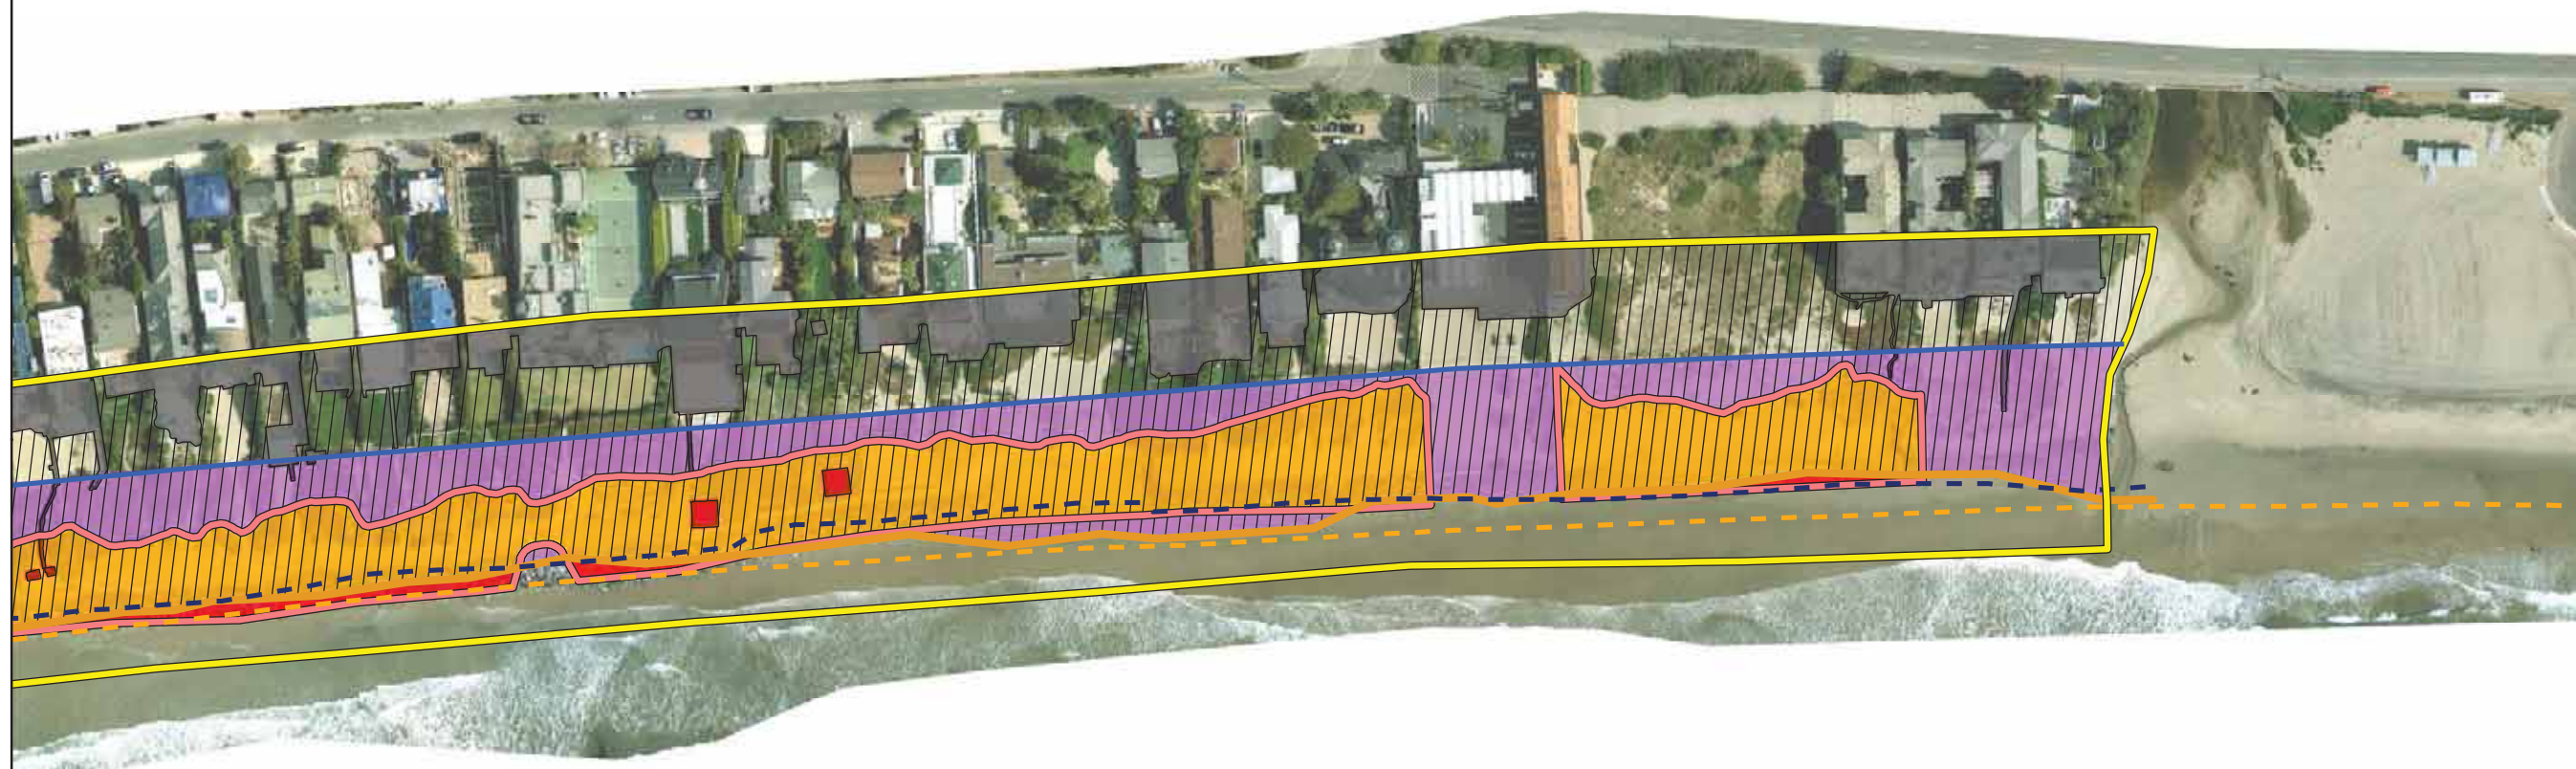
Figure 8-2a.

Potential Impacts to
Foredune Habitat from
the Proposed Project
Under Conditions of
Revetment Failure
Failure Relative to
2005 Baseline Conditions

* Remnant foredune habitat based on 2005 foredune extent shown in Figure 2.

*** All habitat & development up to No Project Wave Uprush Limit may be lost. Additional losses may occur under conditions of sea level rise.

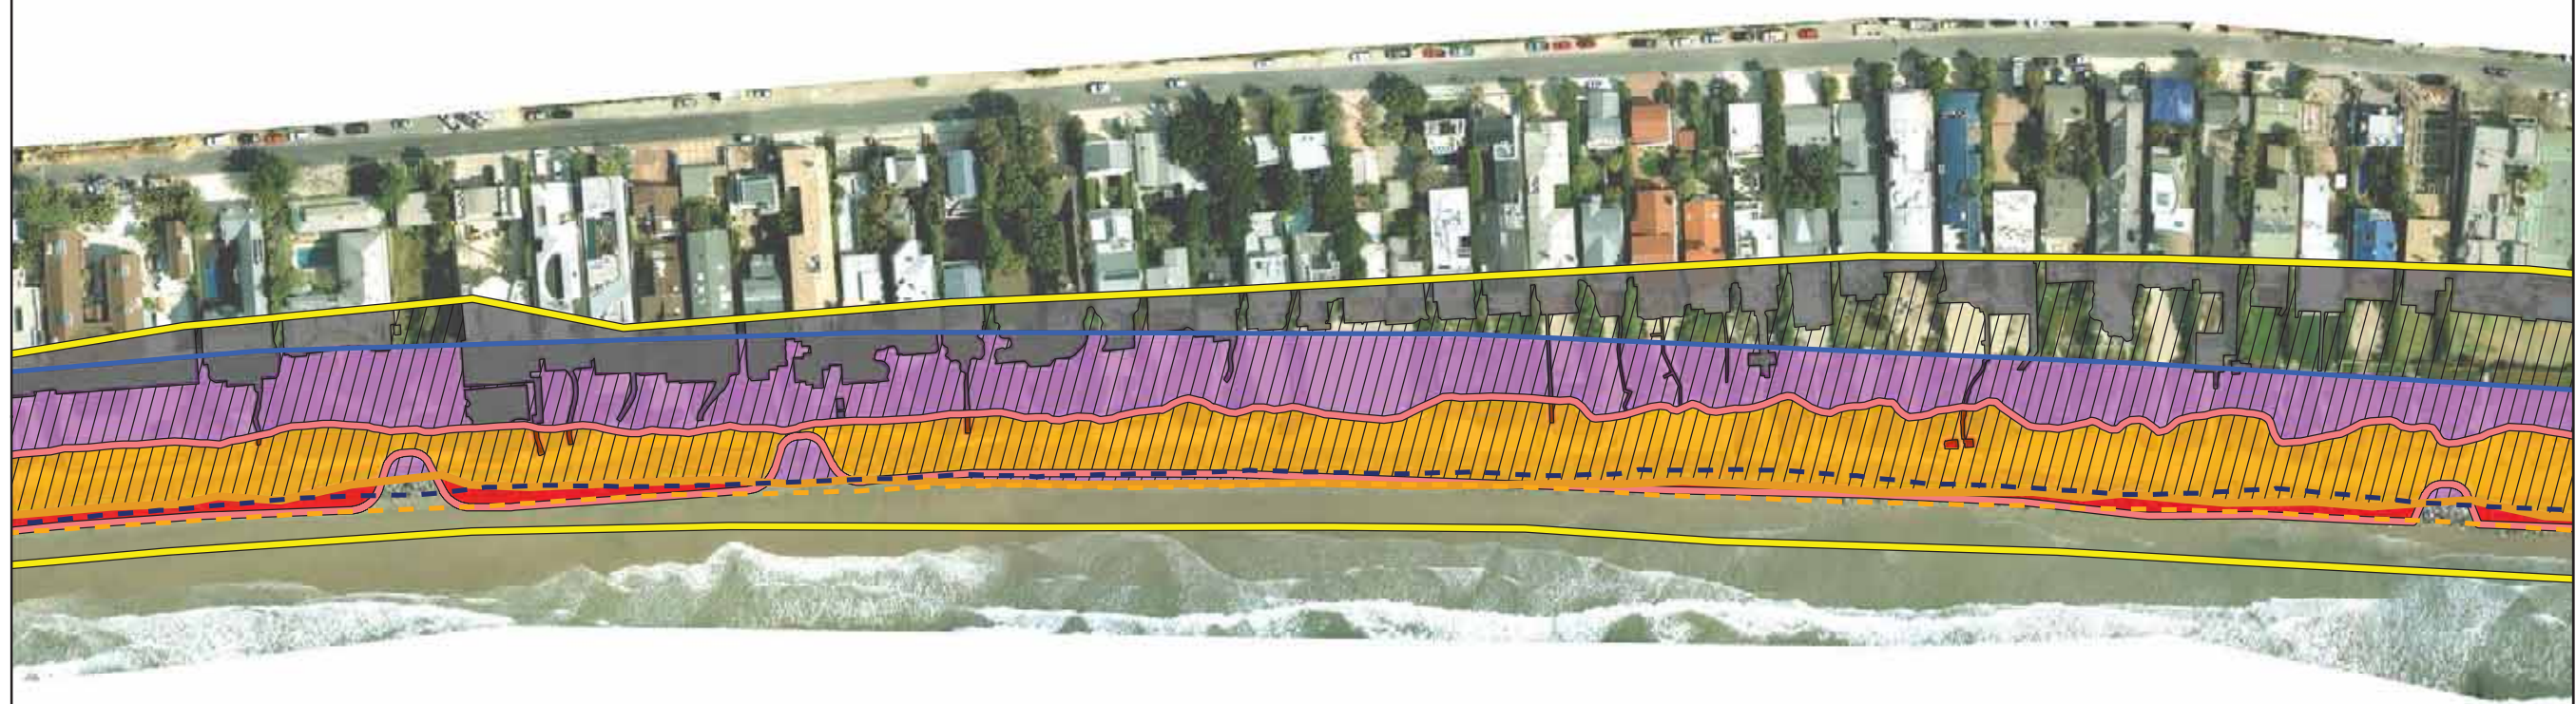
Figure 8-2b.

Potential Impacts to
Foredune Habitat from
the Proposed Project
Under Conditions of
Revetment Failure
Failure Relative to
2005 Baseline Conditions

* Remnant foredune habitat based on 2005 foredune extent shown in Figure 2.
 ** No Project Wave Uprush Limit provided by Moffatt and Nichol
 *** All habitat & development up to No Project Wave Uprush Limit may be lost. Additional losses may occur under conditions of sea level rise.

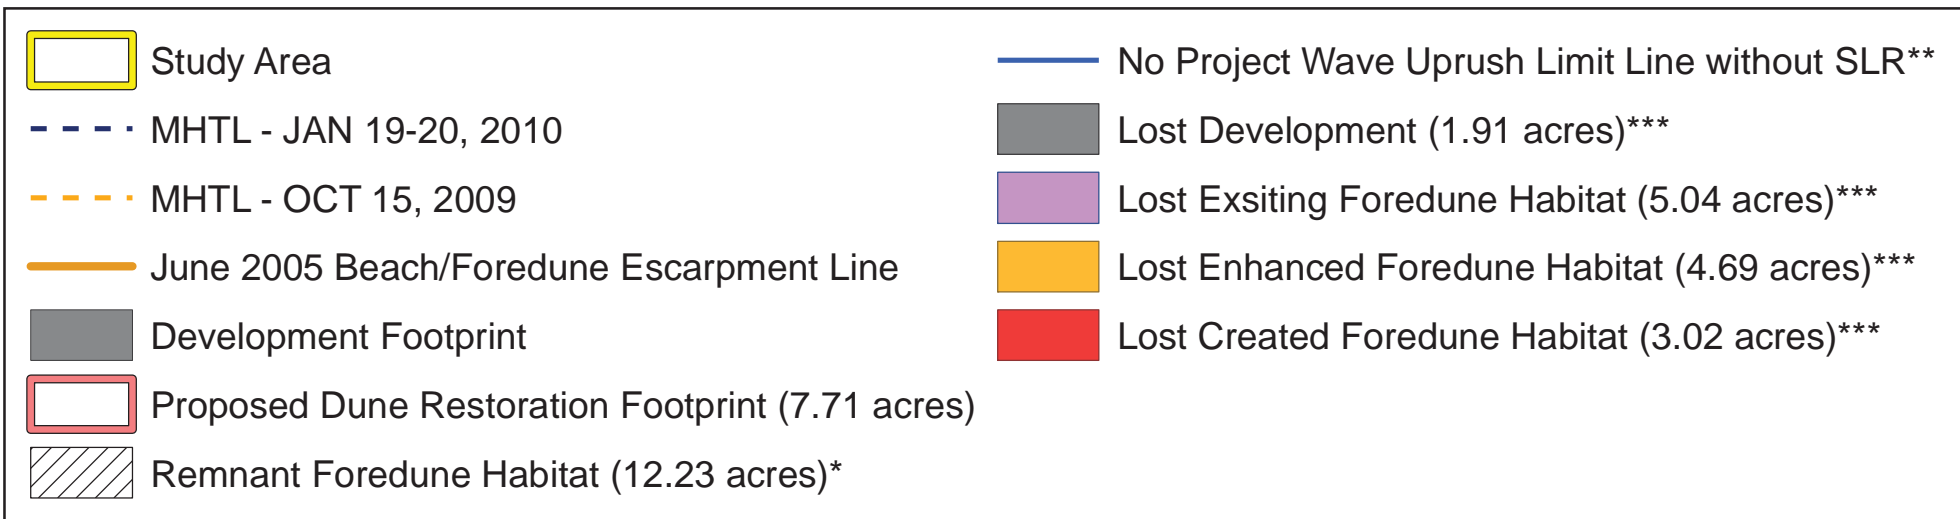
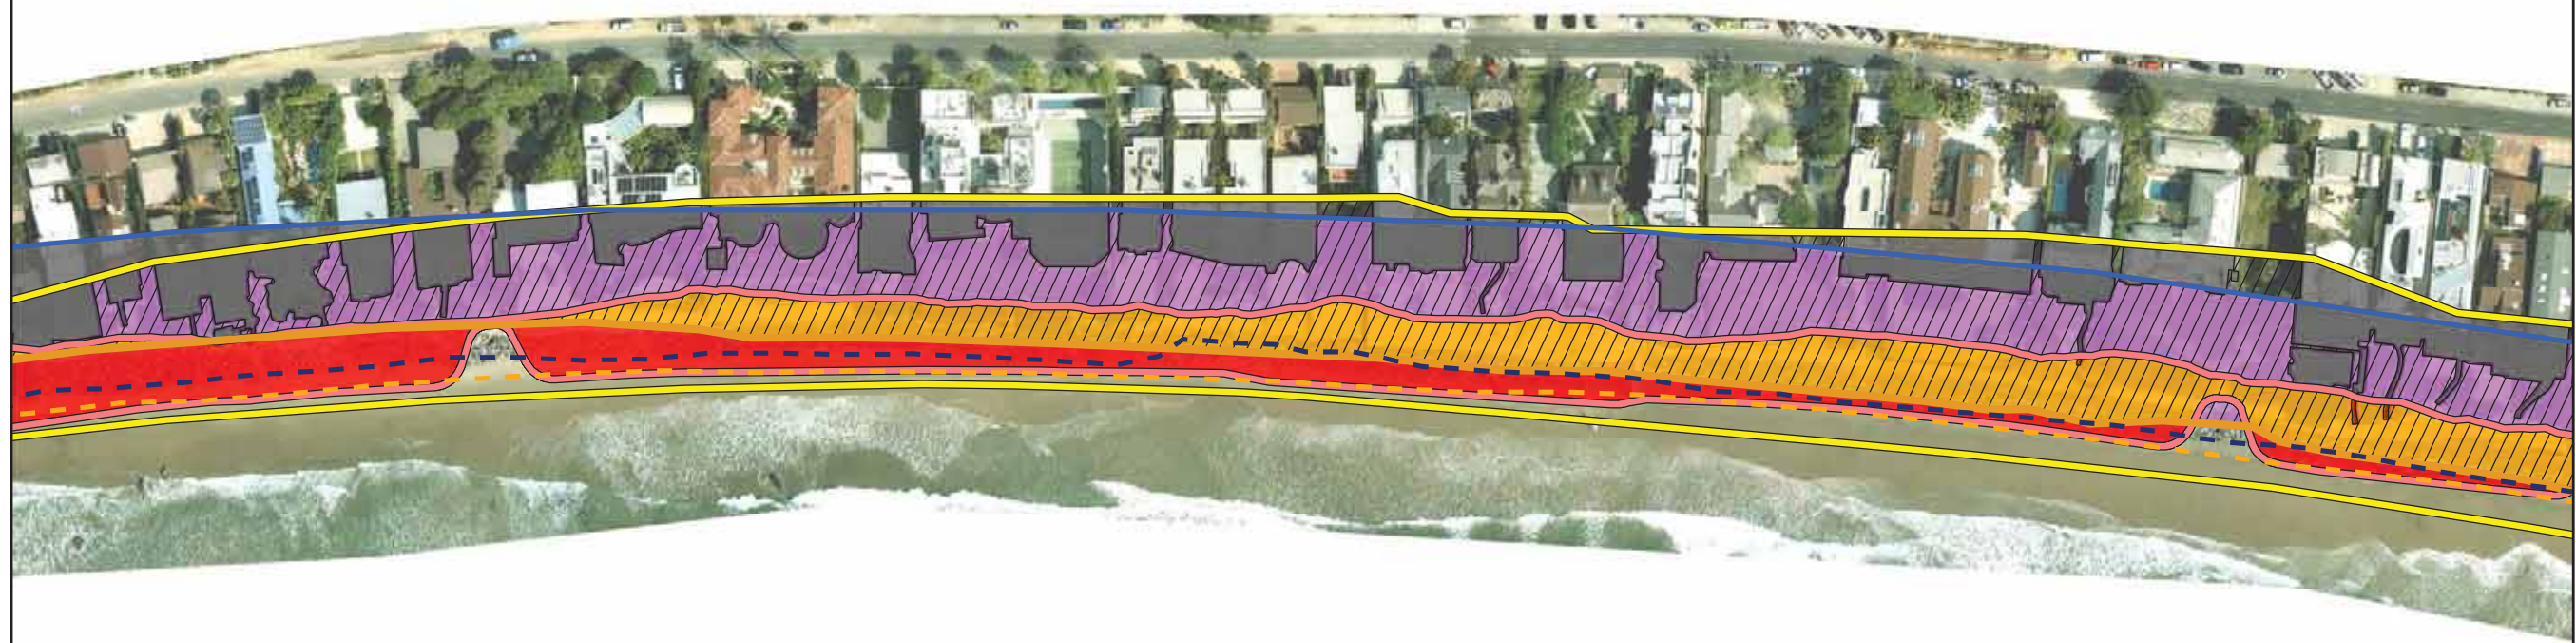
Figure 8-2c.

Potential Impacts to
Foredune Habitat from
the Proposed Project
Under Conditions of
Revetment Failure
Failure Relative to
2005 Baseline Conditions

* Remnant foredune habitat based on 2005 foredune extent shown in Figure 2.
 ** No Project Wave Uprush Limit provided by Moffatt and Nichol
 *** All habitat & development up to No Project Wave Uprush Limit may be lost. Additional losses may occur under conditions of sea level rise.

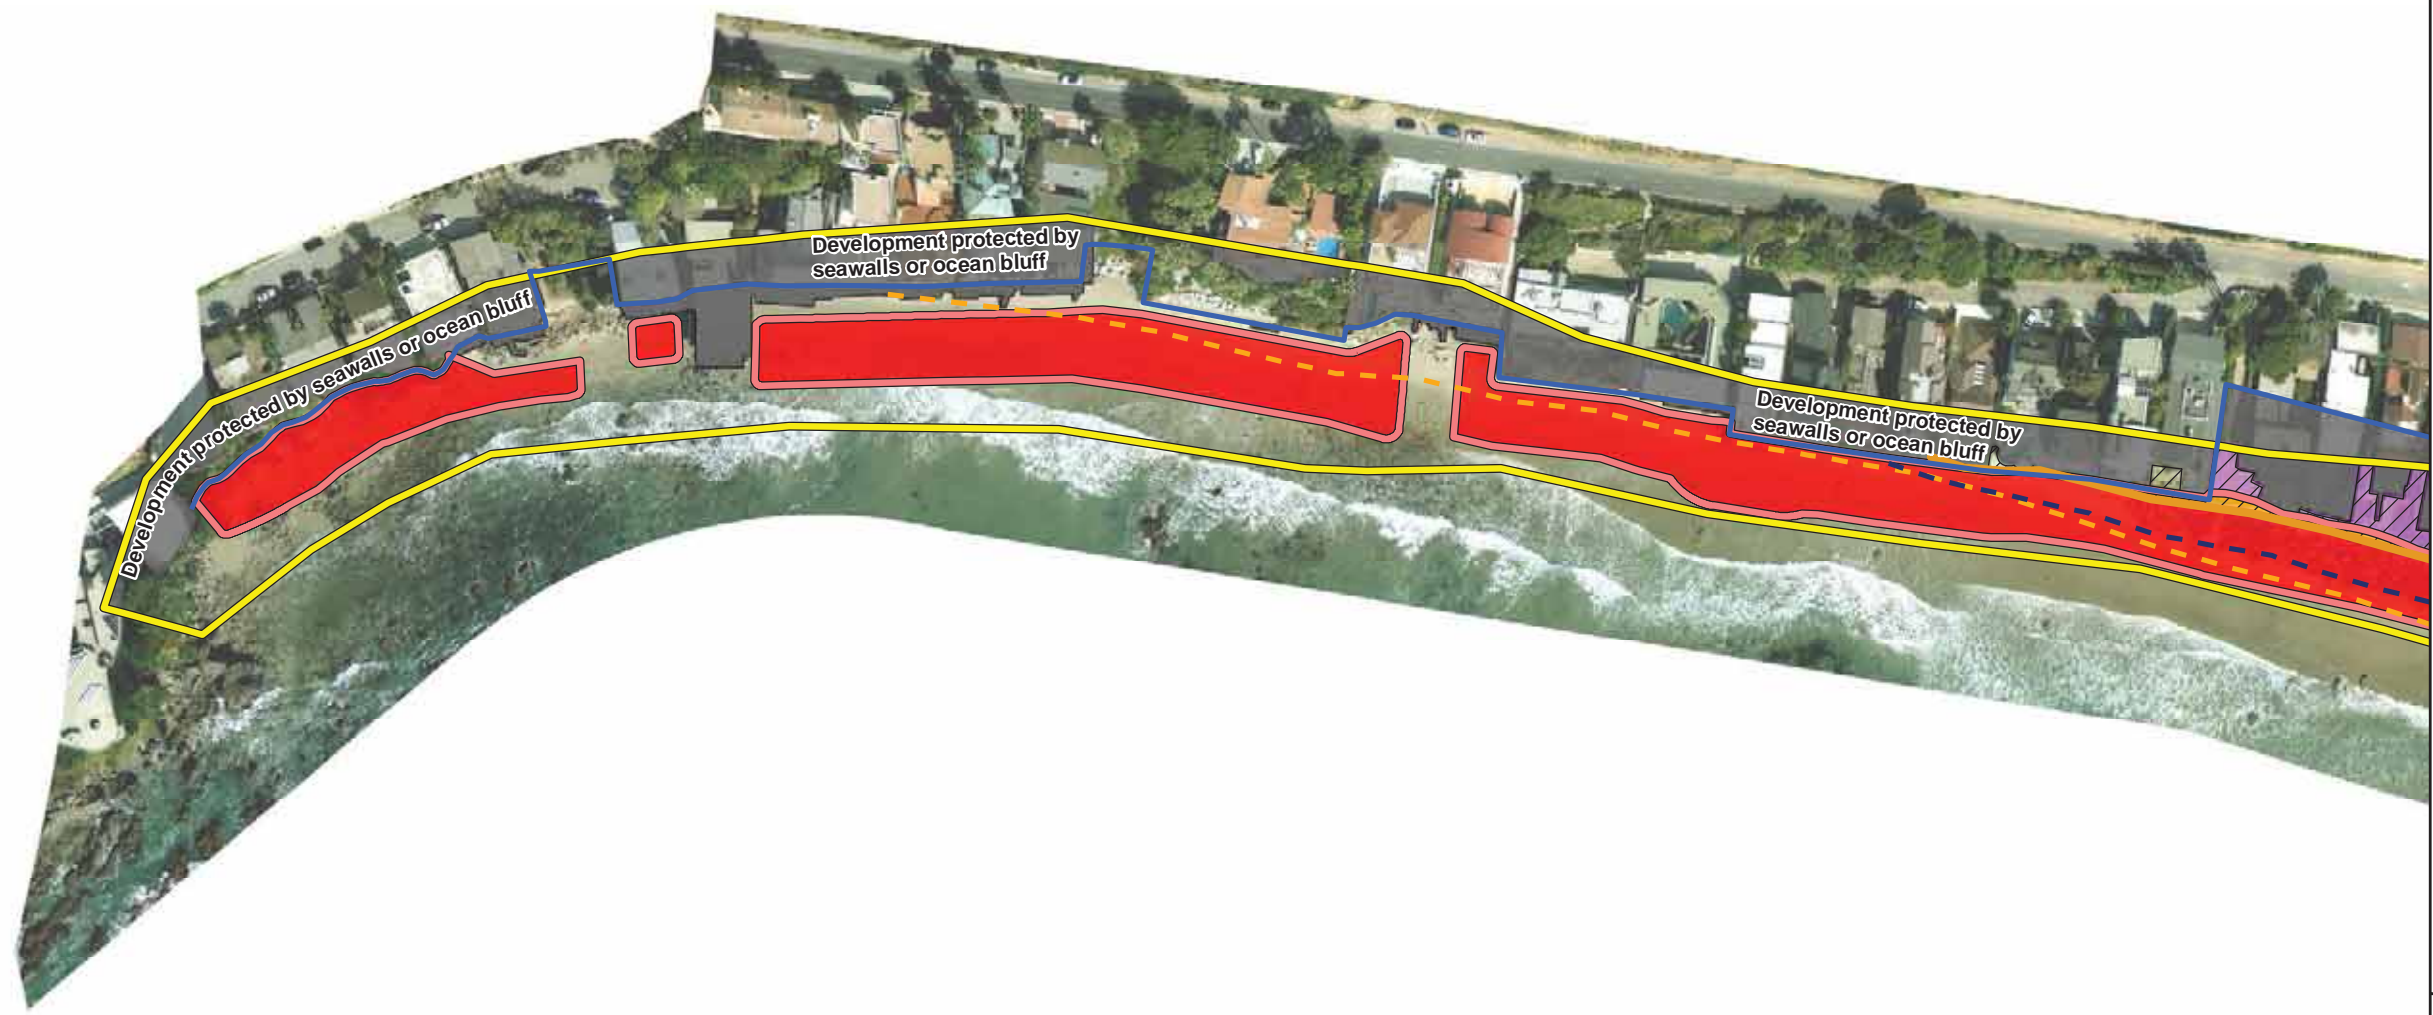
* Remnant foredune habitat based on 2005 foredune extent shown in Figure 2.
 ** No Project Wave Uprush Limit provided by Moffatt and Nichol
 *** All habitat & development up to No Project Wave Uprush Limit may be lost. Additional losses may occur under conditions of sea level rise.

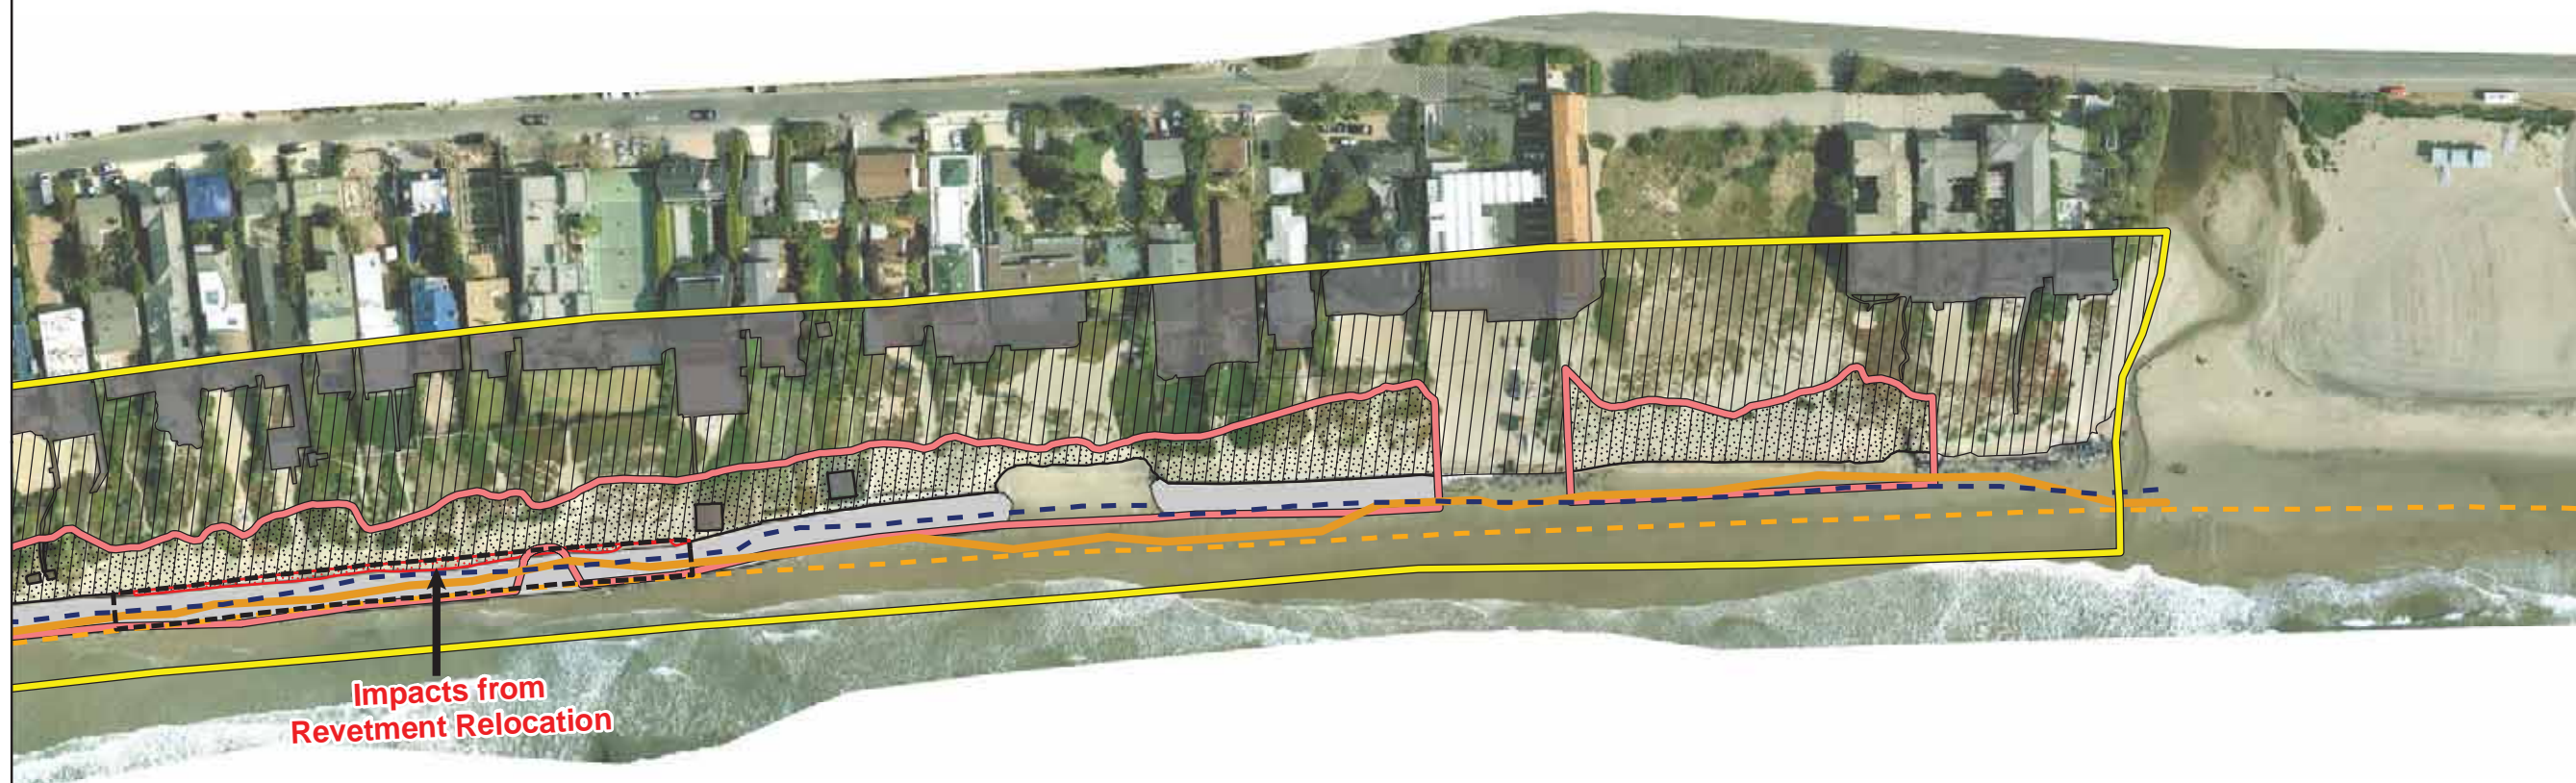
Figure 9-1a.

Potential Impacts to
Foredune Habitat
Under Alternative 1A
Relative to 2013
Existing Conditions

* Remnant foredune habitat remaining after installation of Pre-2010 Shoreline Protection Structures and 2010 Emergency Rock Revetment, including areas of pocket cove formation where revetment materials were not installed or were installed but failed.
 ** Temporary impacts are due to enhancement of existing degraded foredune habitat. Permanent impacts are due to relocation of revetment.

For the chronological assessment of foredune impacts, WRA used the existing foredune extent shown in Figure 5 and assumed that potential impacts to foredune habitat associated with this alternative include those areas where the revetment will be relocated landward of its current position as well as the area designated for foredune enhancement. These potential impacts are shown on Figure 9-1 and include approximately 0.05 acre of permanent impacts associated with the relocated revetment sections and 2.90 acres of temporary impacts associated with the foredune enhancement.

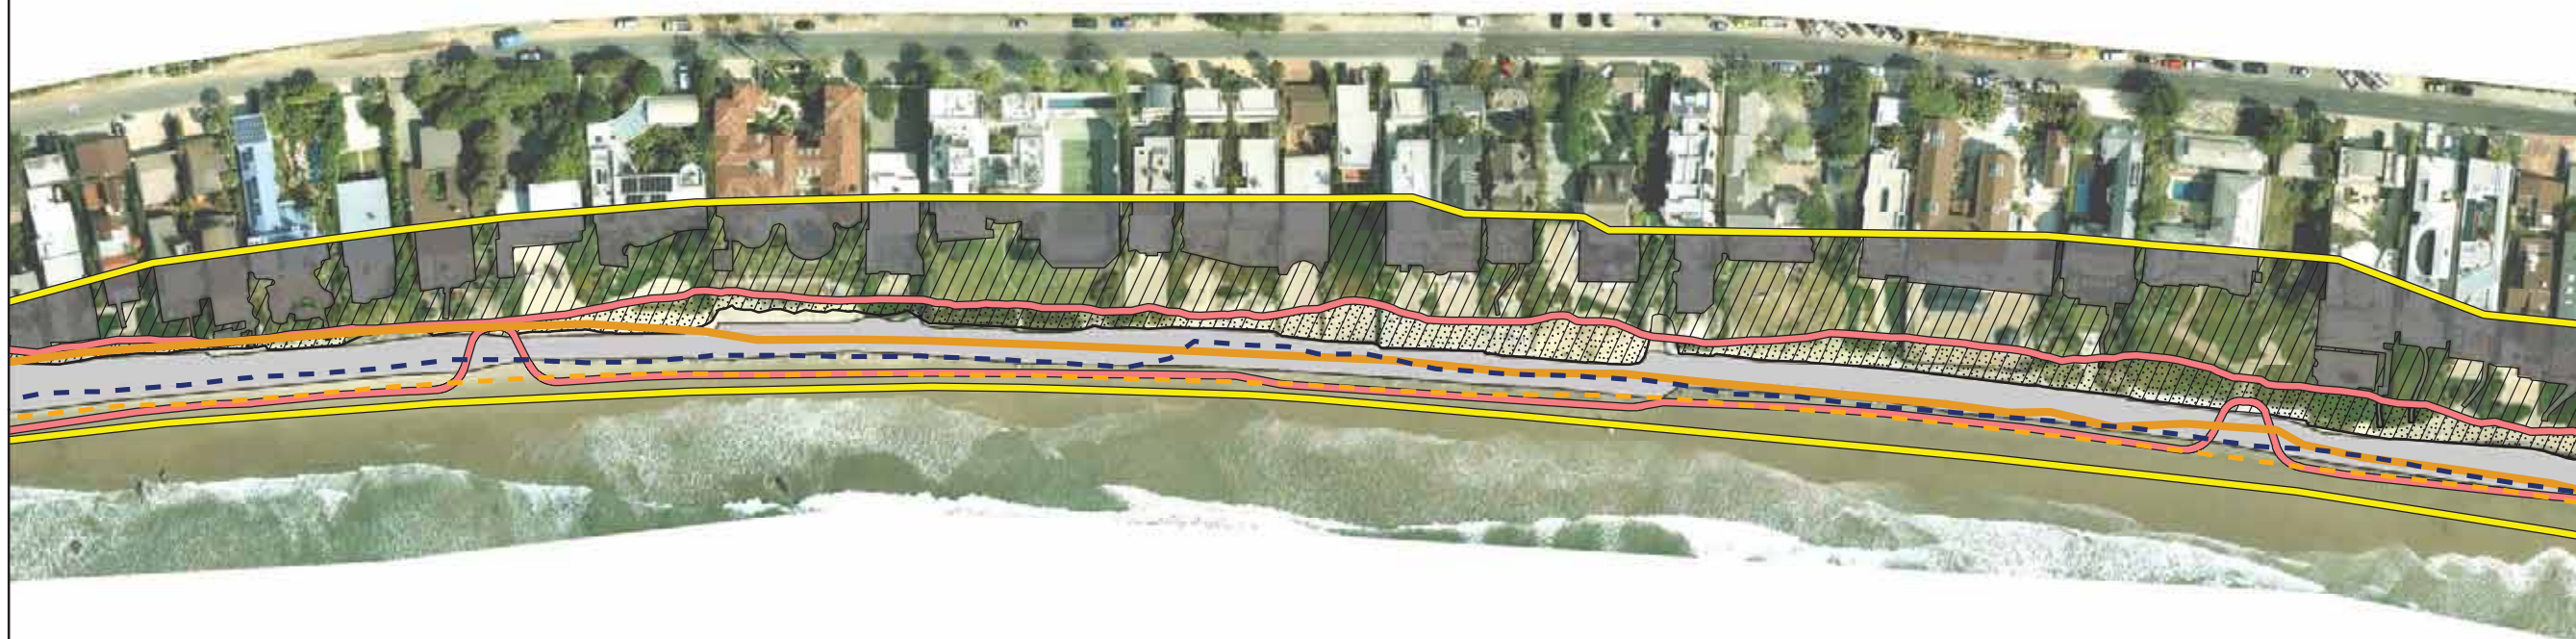
Figure 9-1c.

Potential Impacts to
Foredune Habitat
Under Alternative 1A
Relative to 2013
Existing Conditions

| Development Footprint | Temporary Impacts (2.90 acres) |
| 2010 Emergency Rock Revetment | Permanent Impacts (0.05 acre) |

** Temporary impacts are due to enhancement of existing degraded foredune habitat. Permanent impacts are due to relocation of revetment.

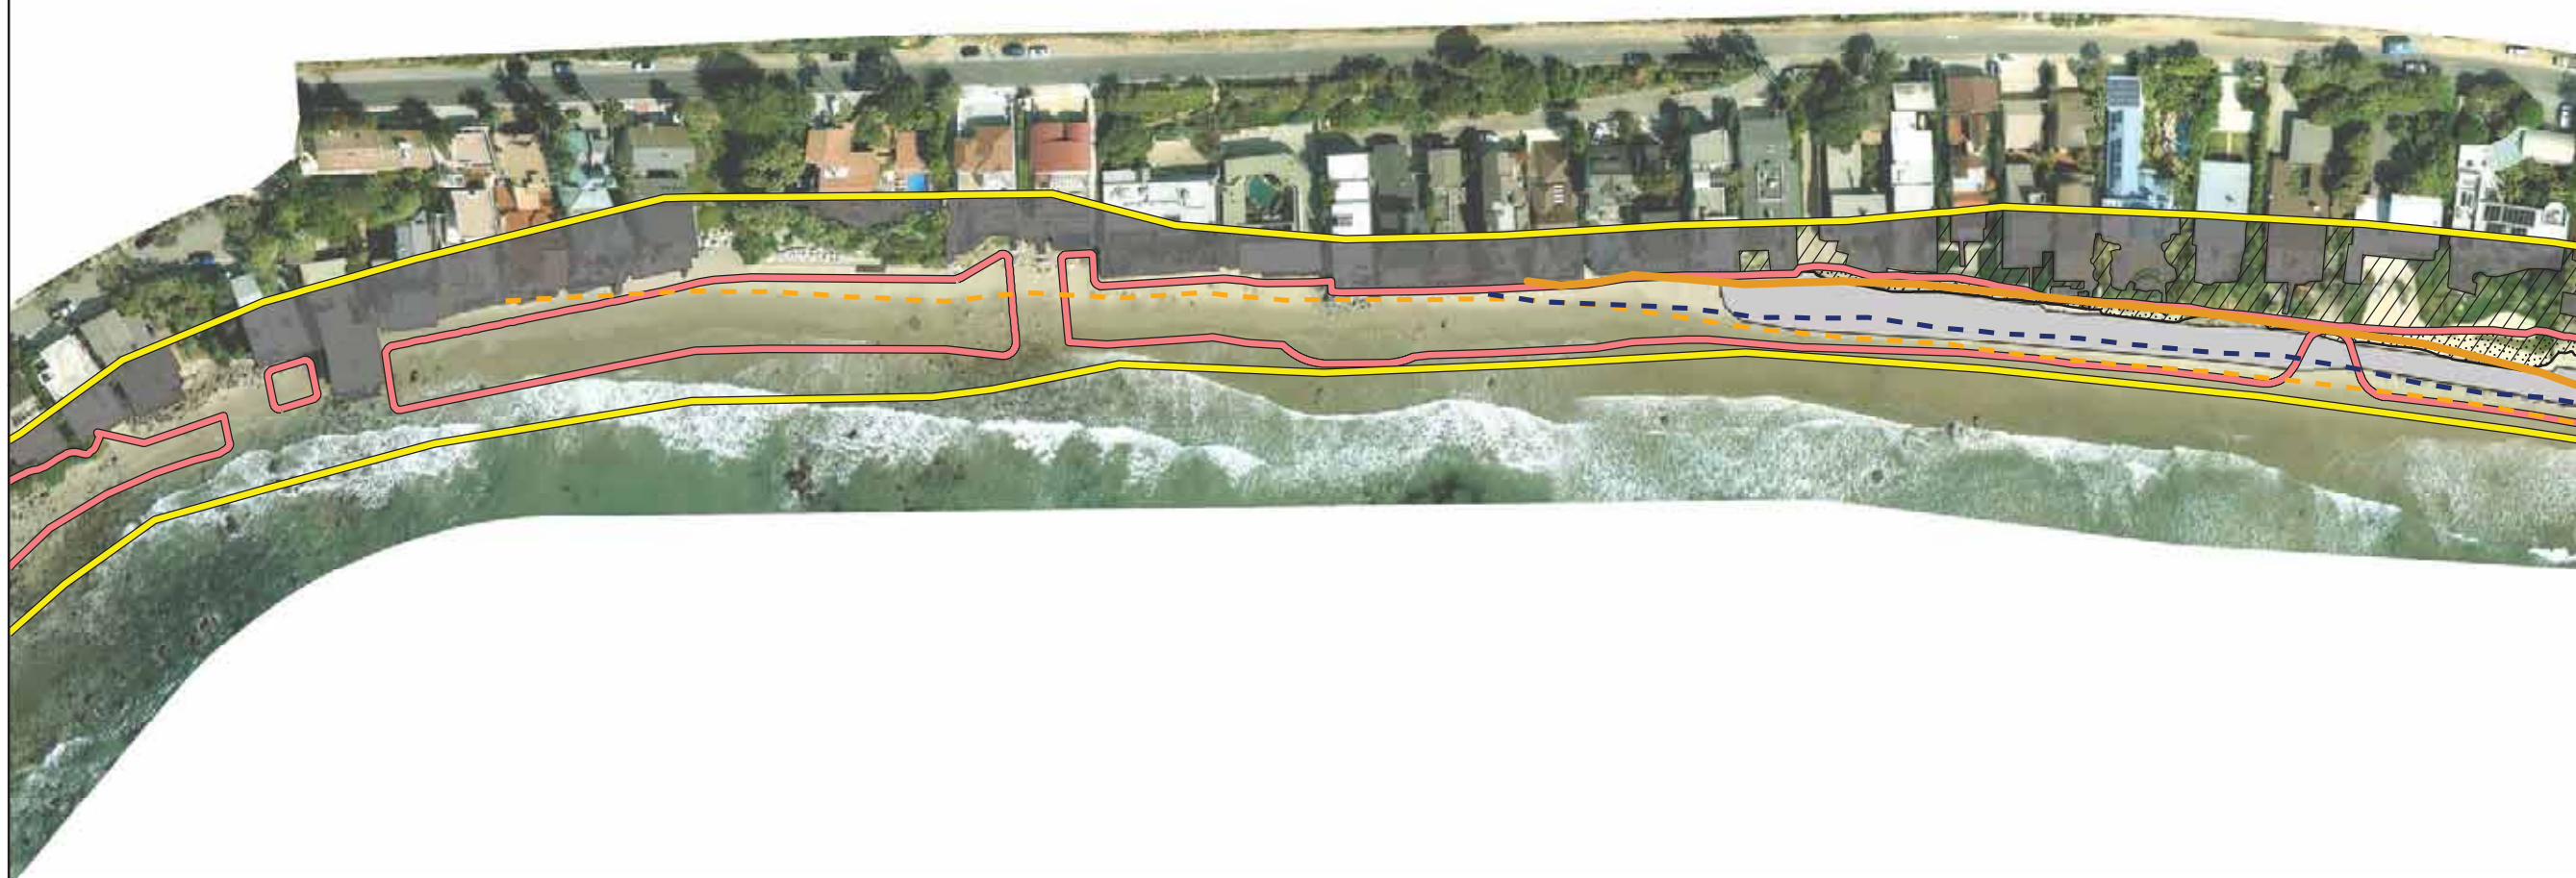
Figure 9-1d.

Potential Impacts to
Foredune Habitat
Under Alternative 1A
Relative to 2013
Existing Conditions

- Study Area
- MHTL - JAN 19-20, 2010
- MHTL - OCT 15, 2009
- June 2005 Beach/Foredune Escarpment Line
- Development Footprint
- 2010 Emergency Rock Revetment
- Proposed Dune Restoration Footprint (7.71 acres)
- Alternative 1A Revetment Relocation
- Remnant Foredune Habitat (10.09 acres)*
- Potential Impacts to Remnant Foredune Habitat****
- Temporary Impacts (2.90 acres)
- Permanent Impacts (0.05 acre)

** Temporary impacts are due to enhancement of existing degraded foredune habitat. Permanent impacts are due to relocation of revetment.
