Memorandum

Subject: Broad Beach Foredune Impact Analysis

This memorandum provides an assessment of the impacts to foredune habitat that may have occurred or that could occur as a result of previous and proposed shoreline stabilization efforts at Broad Beach. This material is intended to support the application for a California Coastal Commission (“CCC”) Coastal Development Permit (“CDP”) for the proposed Broad Beach Restoration Project located in Malibu, Los Angeles County, California (“Study Area”; Figure 1). The information included here is based on inferred historical conditions, observed current conditions, and predicted future conditions at Broad Beach. As noted in the previous CDP submittals for the project, detailed records of historical habitat conditions and shoreline stabilization efforts at Broad Beach are lacking, and much information had to be inferred from historic aerial imagery, a sporadic record of photographs from the site, and comparisons with similar habitats in the region. As such, the analysis presented here is subject to a number of caveats which are presented in the following sections. The analysis follows in six parts, each of which contains (1) an assess

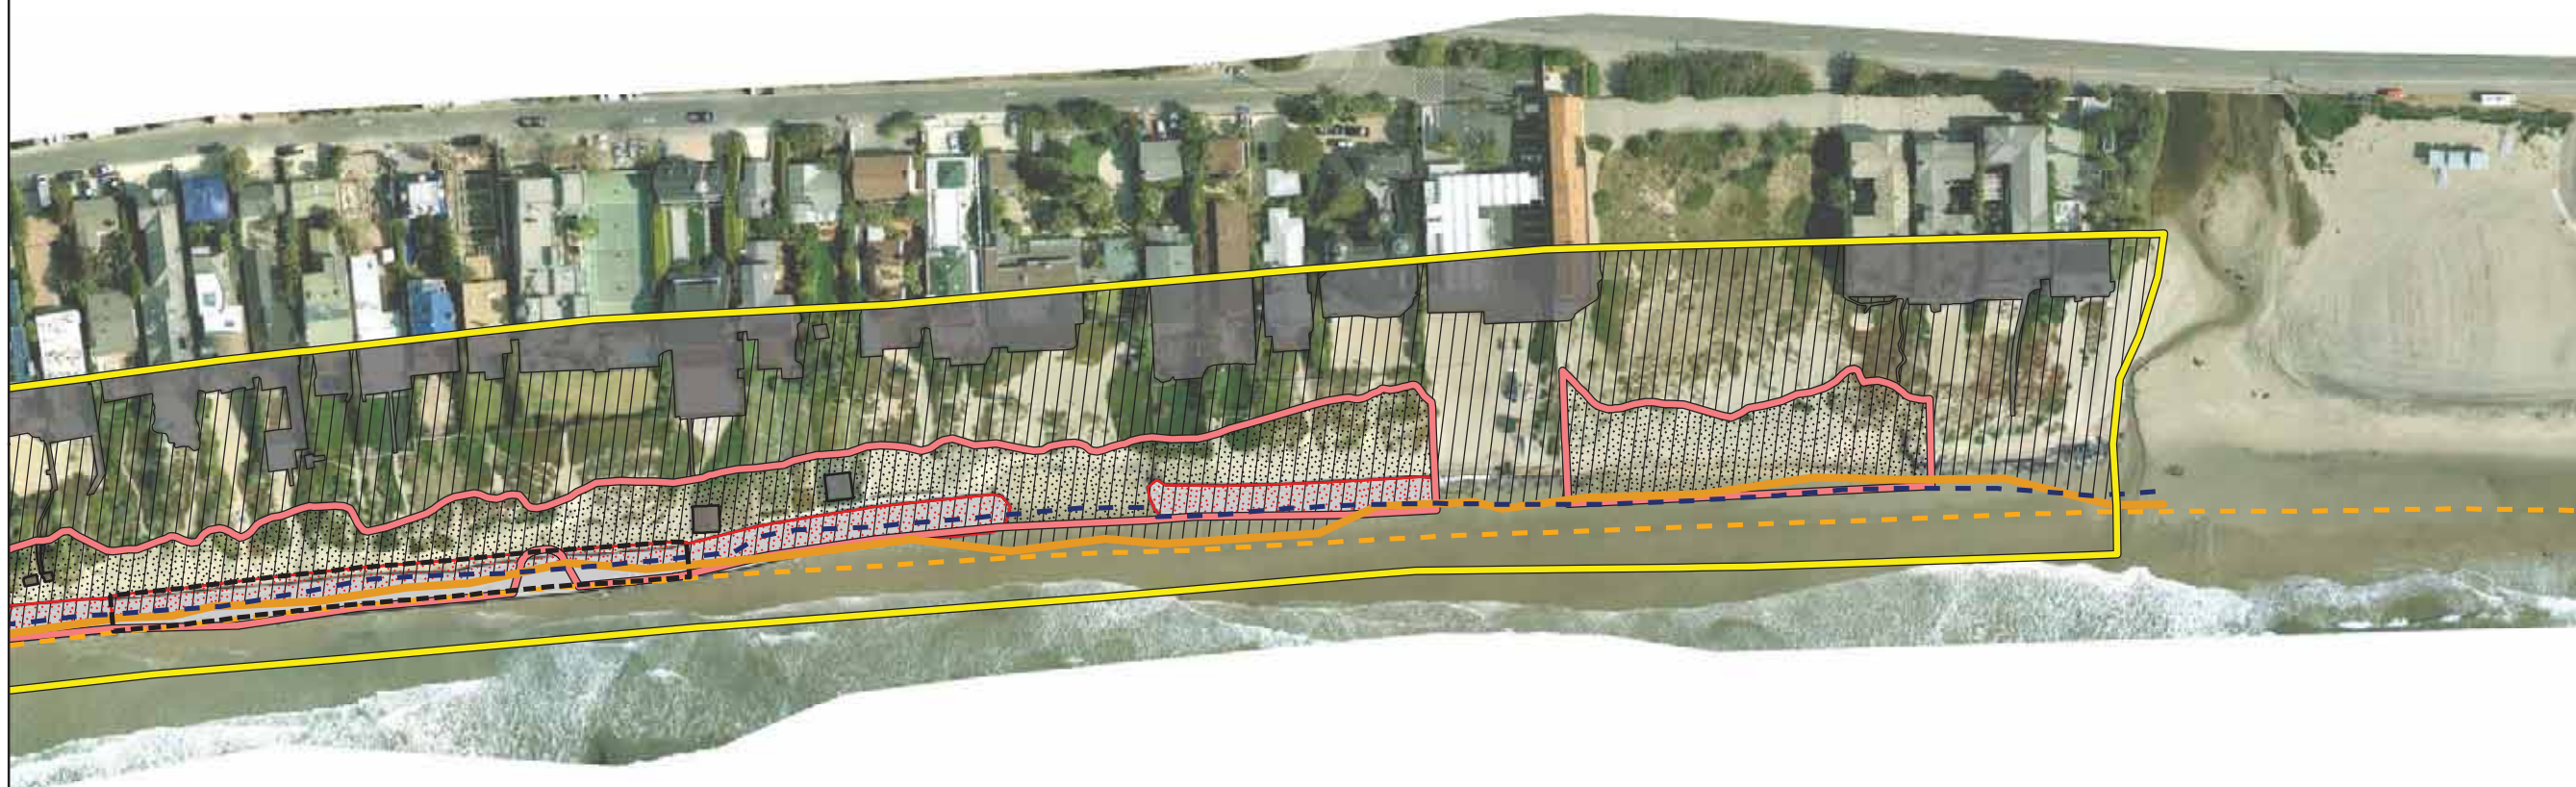
Potential Impacts to
Foredune Habitat
Under Alternative 1A
Relative to 2005
Baseline Conditions

- Study Area
- MHTL - JAN 19-20, 2010
- MHTL - OCT 15, 2009
- June 2005 Beach/Foredune Escarpment Line
- Development Footprint
- 2010 Emergency Rock Revetment
- Proposed Dune Restoration Footprint (7.71 acres)
- Alternative 1A Revetment Relocation
- Remnant Foredune Habitat (12.23 acres)*
- Potential Impacts to Remnant Foredune Habitat****
- Temporary Impacts (3.17 acres)
- Permanent Impacts (1.63 acres)

** Temporary impacts are due to revetment removal or enhancement of existing degraded foredune habitat. Permanent impacts are due to retained and relocated sections of revetment.

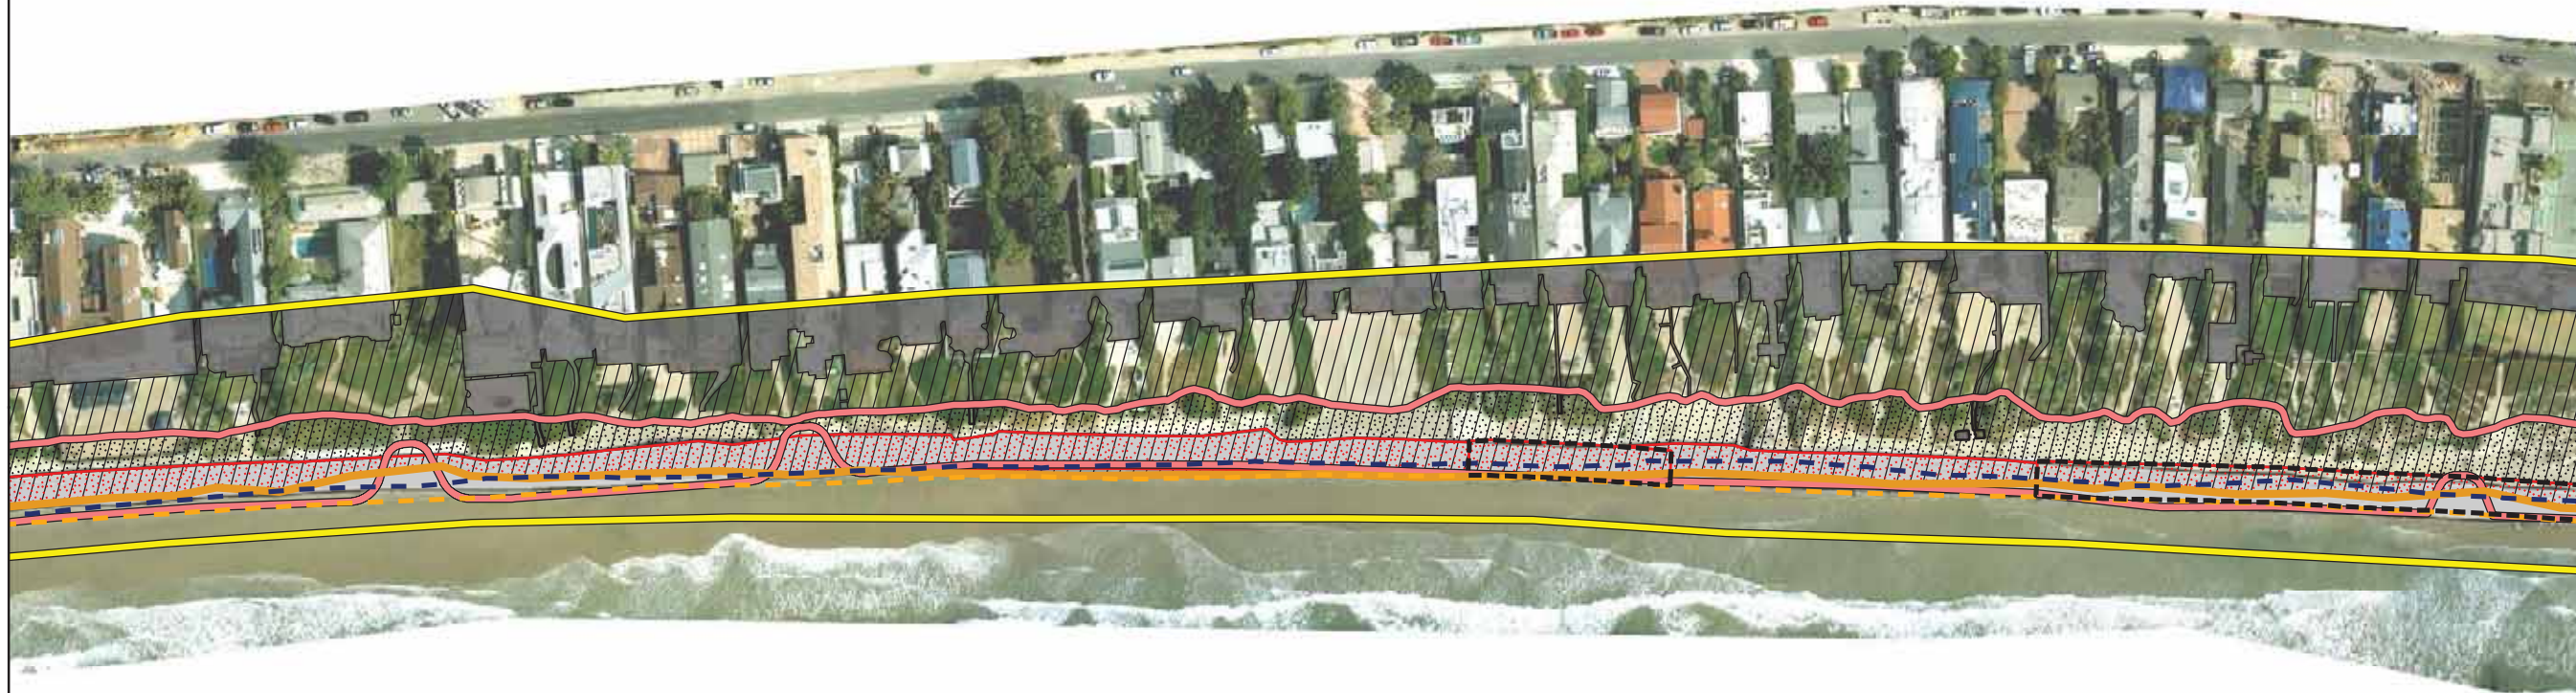
Potential Impacts to
Foredune Habitat
Under Alternative 1A
Relative to 2005
Baseline Conditions

- Study Area
- MHTL - JAN 19-20, 2010
- MHTL - OCT 15, 2009
- June 2005 Beach/Foredune Escarpment Line
- Development Footprint
- 2010 Emergency Rock Revetment
- Proposed Dune Restoration Footprint (7.71 acres)
- Alternative 1A Revetment Relocation
- Remnant Foredune Habitat (12.23 acres)*
- Potential Impacts to Remnant Foredune Habitat****
- Temporary Impacts (3.17 acres)
- Permanent Impacts (1.63 acres)

** Temporary impacts are due to revetment removal or enhancement of existing degraded foredune habitat. Permanent impacts are due to retained and relocated sections of revetment.

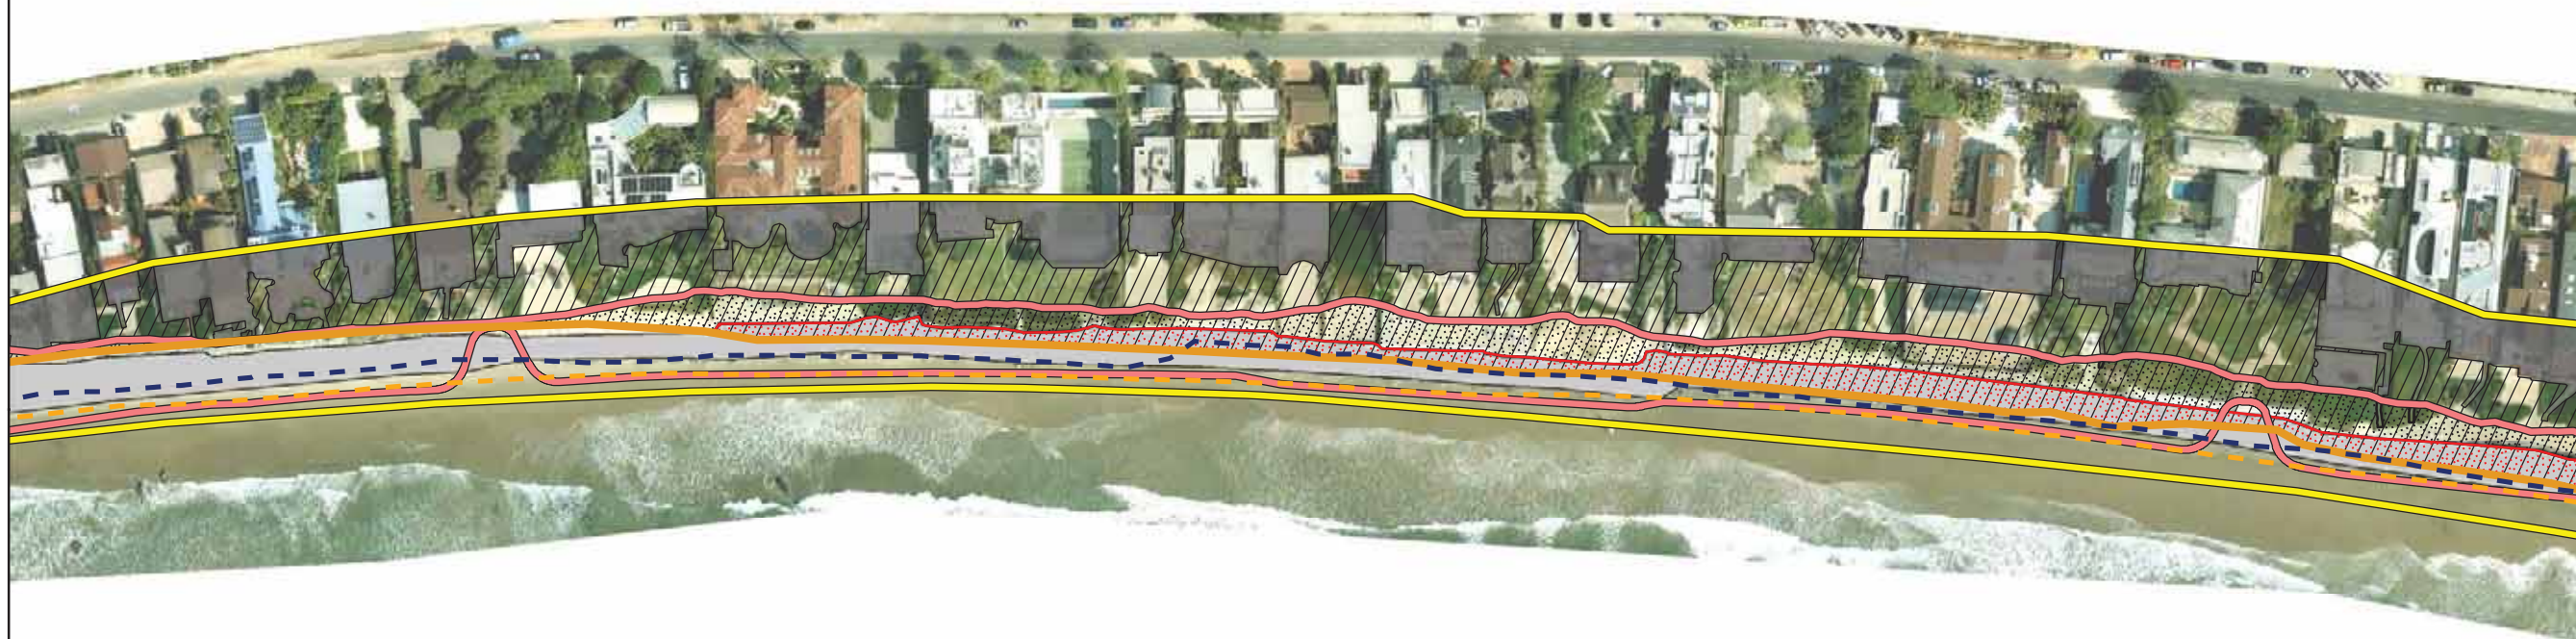
Potential Impacts to
Foredune Habitat
Under Alternative 1A
Relative to 2005
Baseline Conditions

| Development Footprint | Temporary Impacts (3.17 acres) |
| 2010 Emergency Rock Revetment | Permanent Impacts (1.63 acres) |

** Temporary impacts are due to revetment removal or enhancement of existing degraded foredune habitat. Permanent impacts are due to retained and relocated sections of revetment.

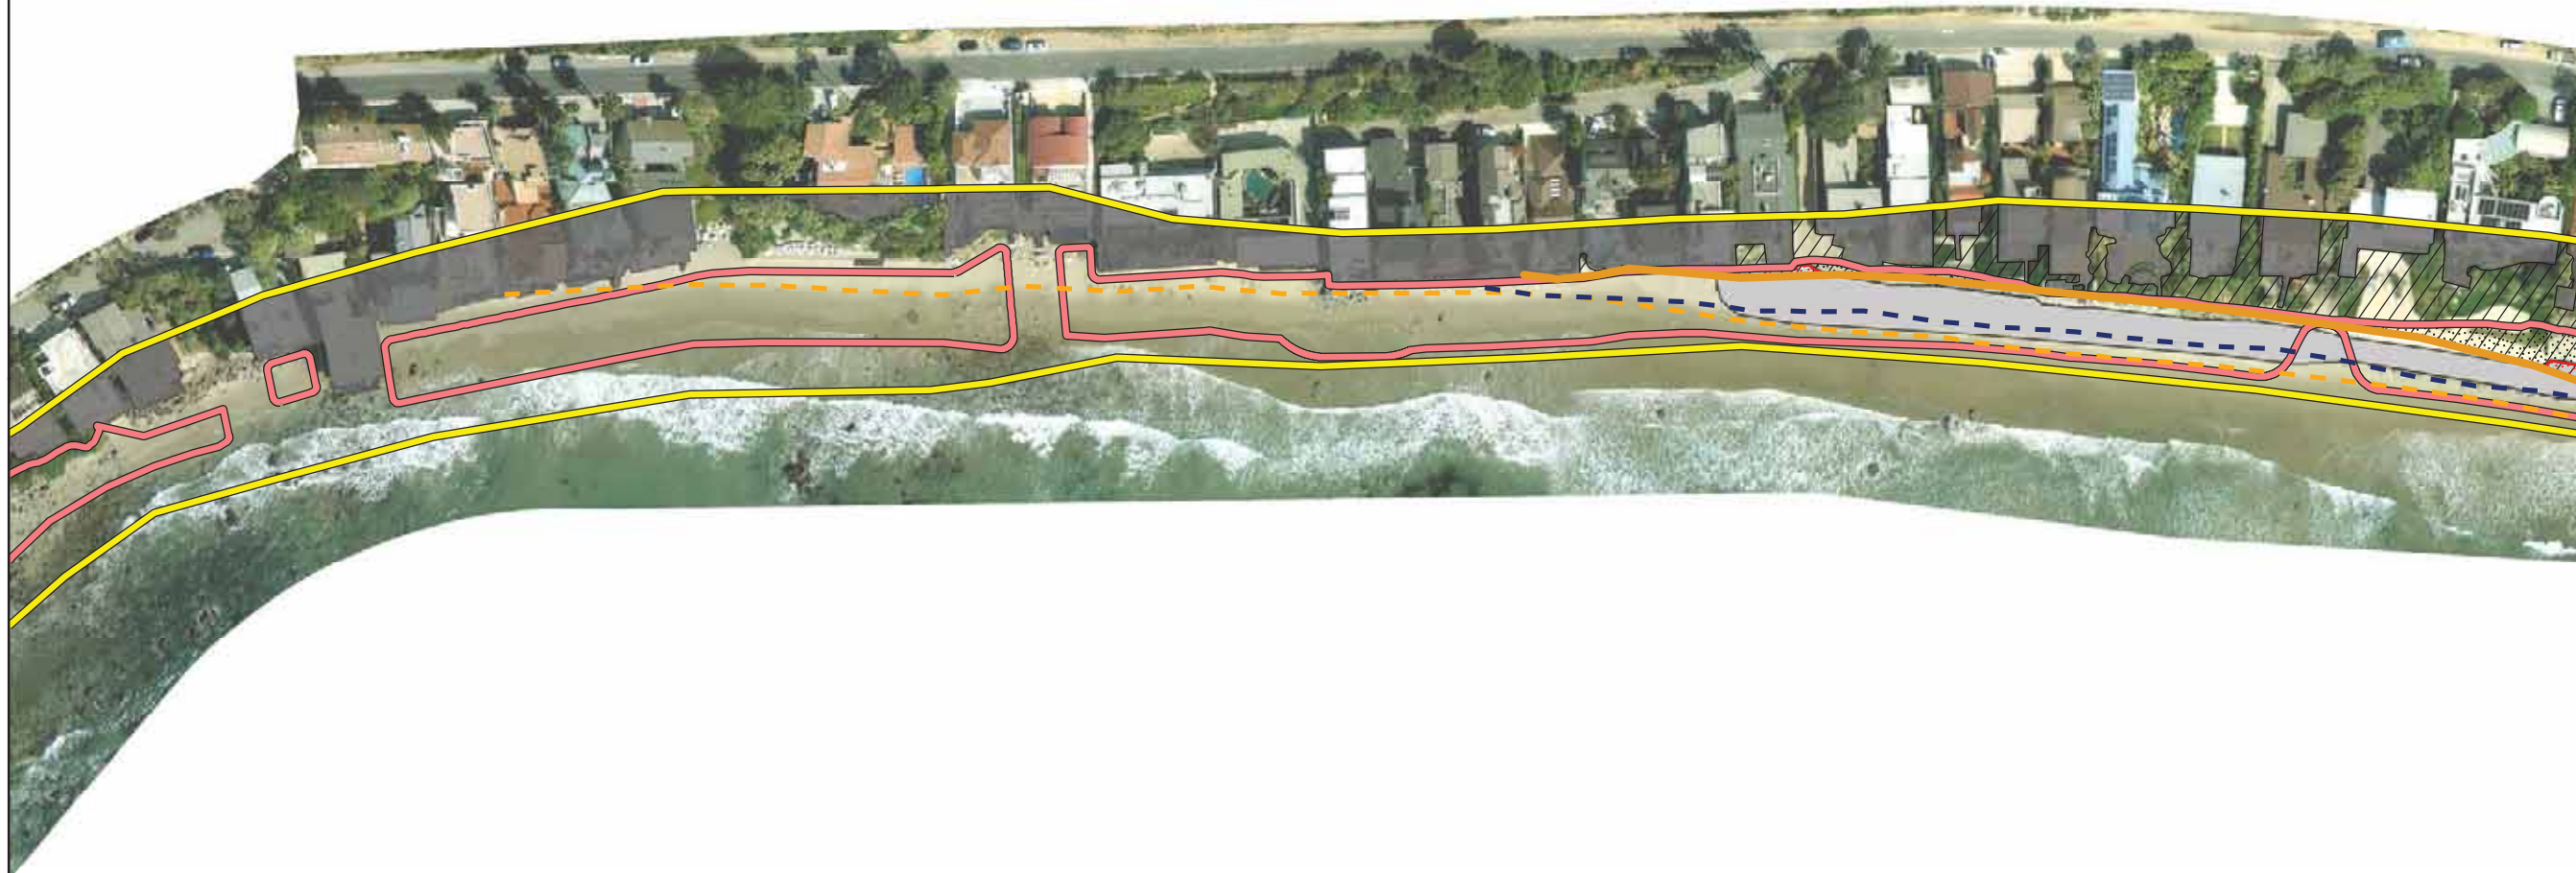
Potential Impacts to
Foredune Habitat
Under Alternative 1A
Relative to 2005
Baseline Conditions

| Development Footprint | Temporary Impacts (3.17 acres) |
| 2010 Emergency Rock Revetment | Permanent Impacts (1.63 acres) |

** Temporary impacts are due to revetment removal or enhancement of existing degraded foredune habitat. Permanent impacts are due to retained and relocated sections of revetment.

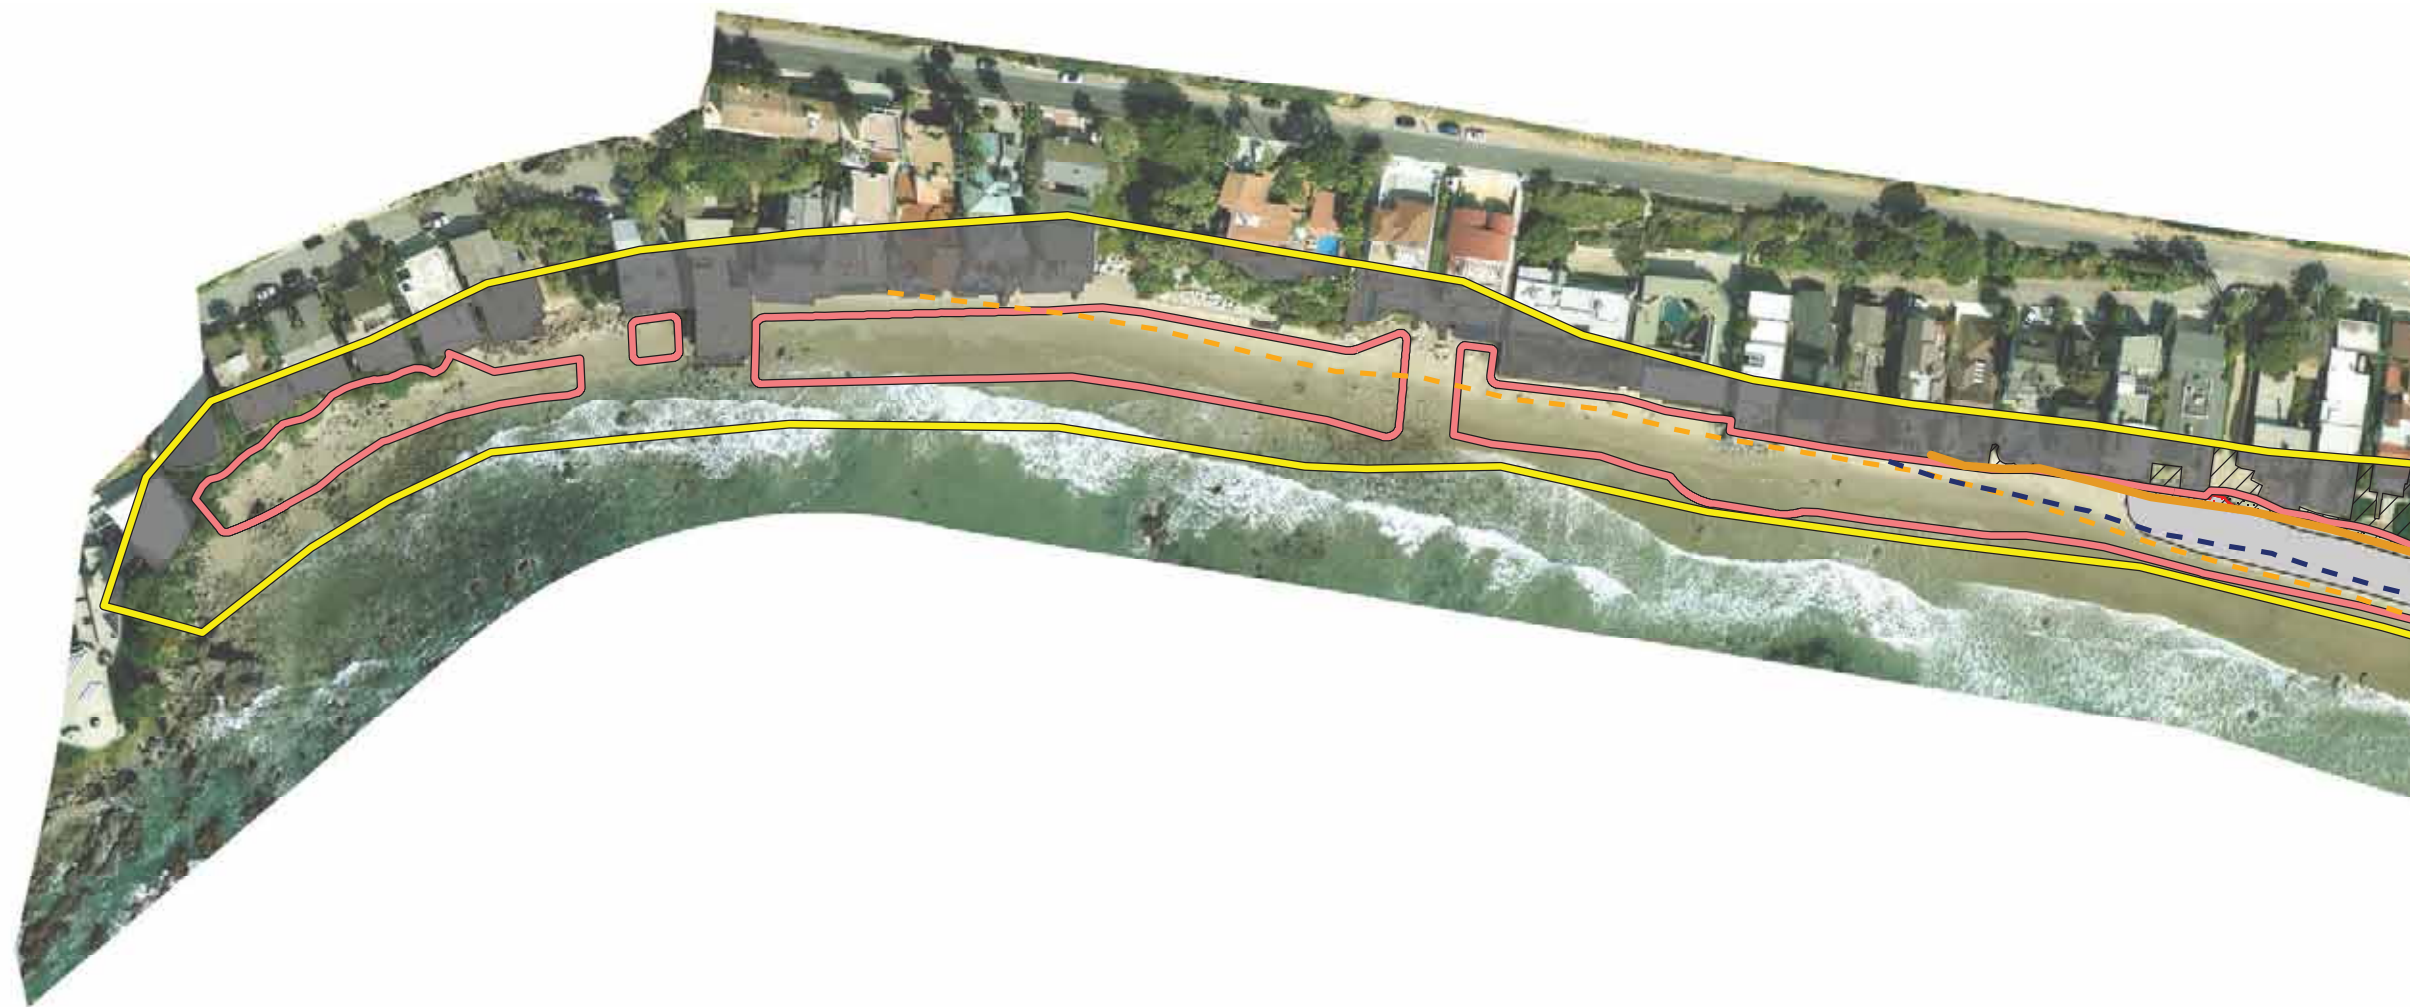
Potential Impacts to
Foredune Habitat
Under Alternative 1A
Relative to 2005
Baseline Conditions

| Development Footprint | Temporary Impacts (3.17 acres) |
| 2010 Emergency Rock Revetment | Permanent Impacts (1.63 acres) |

** Temporary impacts are due to revetment removal or enhancement of existing degraded foredune habitat. Permanent impacts are due to retained and relocated sections of revetment.

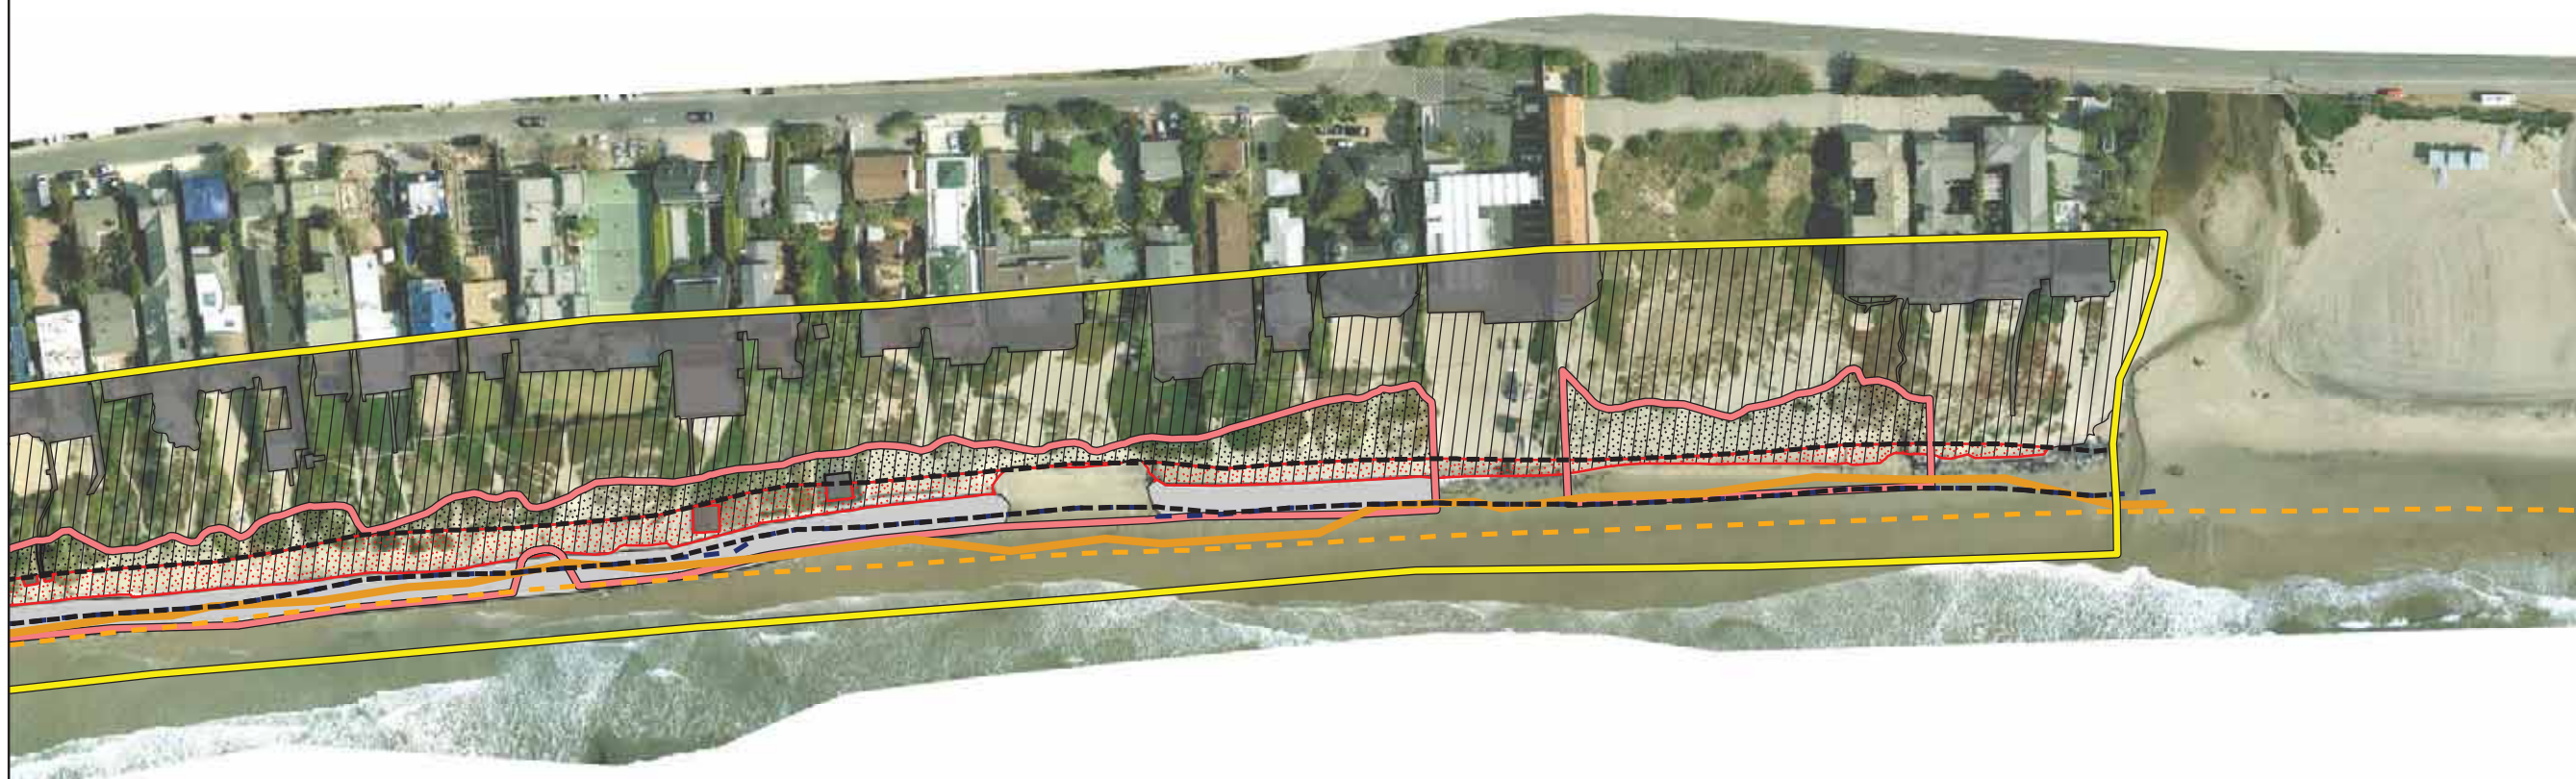
Figure 10-1a.

Potential Impacts to
Foredune Habitat
Under Alternative 1B
Relative to 2013
Existing Conditions

** Temporary impacts are due to enhancement of existing degraded foredune habitat. Permanent impacts are due to relocation of revetment.

For the chronological assessment of foredune impacts, WRA used the existing foredune extent shown in Figure 5 and assumed that potential impacts to foredune habitat associated with this alternative include those areas where the revetment will be relocated landward of its current position as well as the area designated for foredune enhancement. These potential impacts are shown on Figure 10-1 and include approximately 0.86 acre of permanent impacts associated with the relocated revetment sections and 2.14 acres of temporary impacts associated with the foredune enhancement.

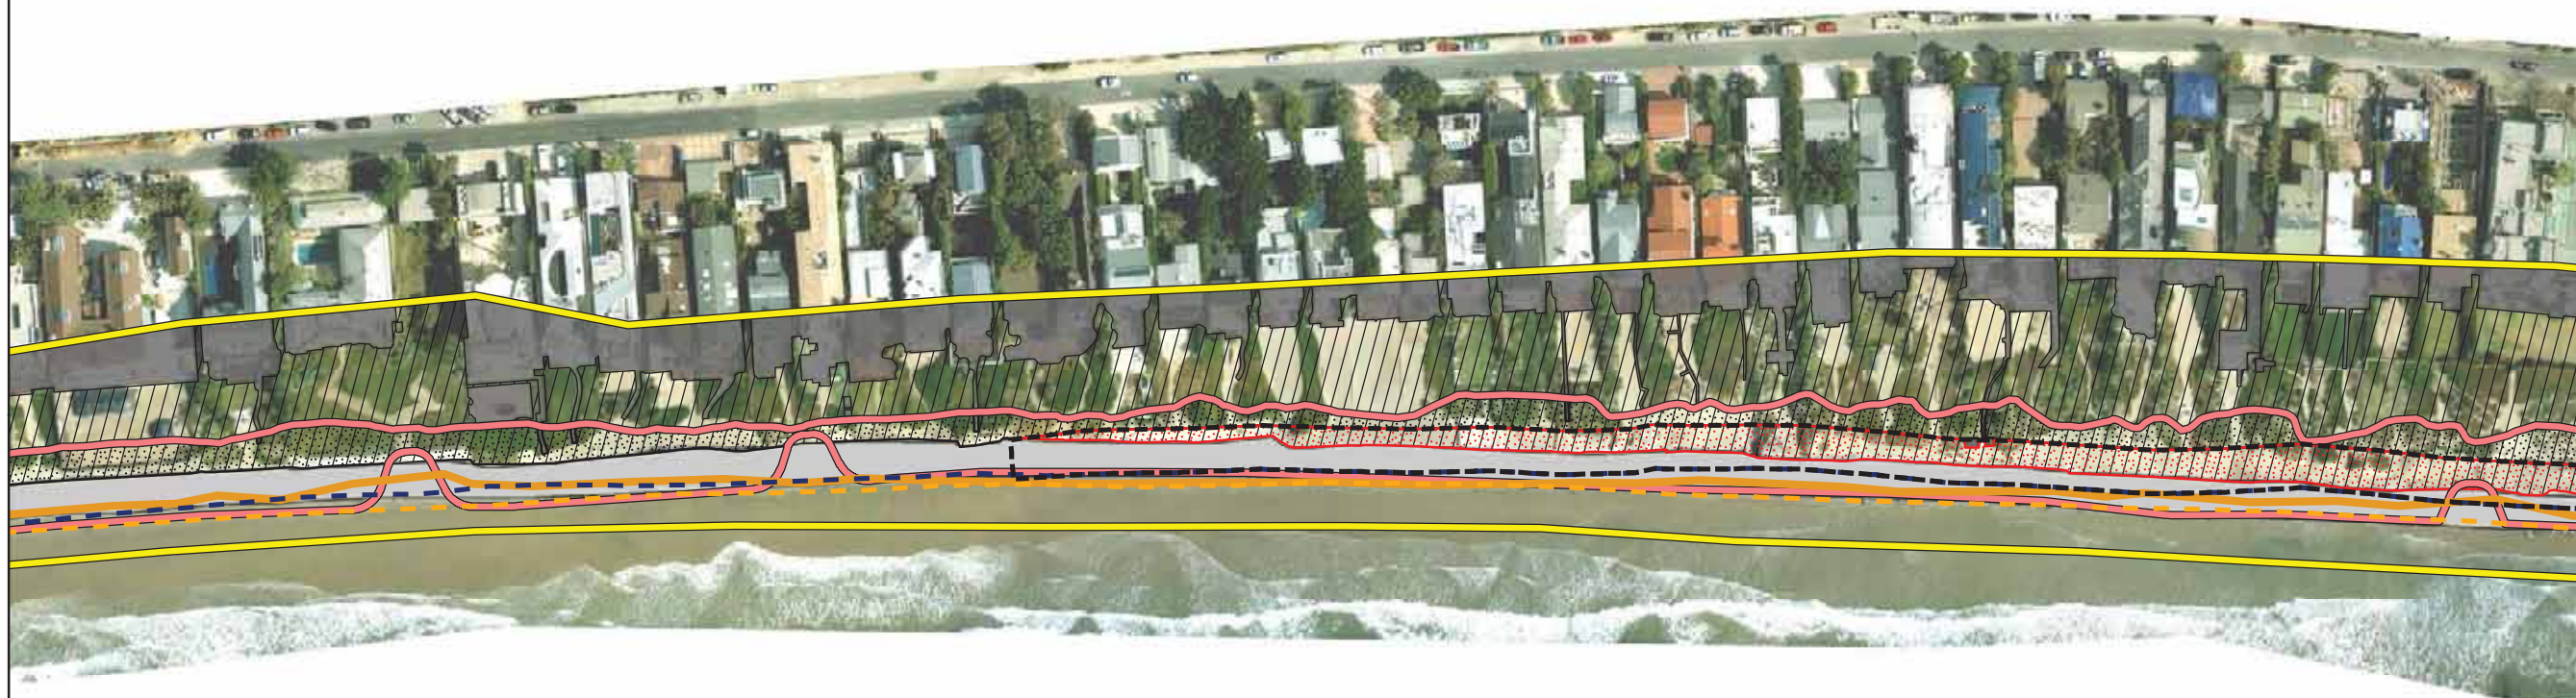
Figure 10-1b.

Potential Impacts to
Foredune Habitat
Under Alternative 1B
Relative to 2013
Existing Conditions

- Study Area
- MHTL - JAN 19-20, 2010
- MHTL - OCT 15, 2009
- June 2005 Beach/Foredune Escarpment Line
- Development Footprint
- 2010 Emergency Rock Revetment
- Proposed Dune Restoration Footprint (7.71 acres)
- Alternative 1B Revetment Relocation
- Remnant Foredune Habitat (10.09 acres)*
- Potential Impacts to Remnant Foredune Habitat****
- Temporary Impacts (2.14 acres)
- Permanent Impacts (0.86 acre)

** Temporary impacts are due to enhancement of existing degraded foredune habitat. Permanent impacts are due to relocation of revetment.

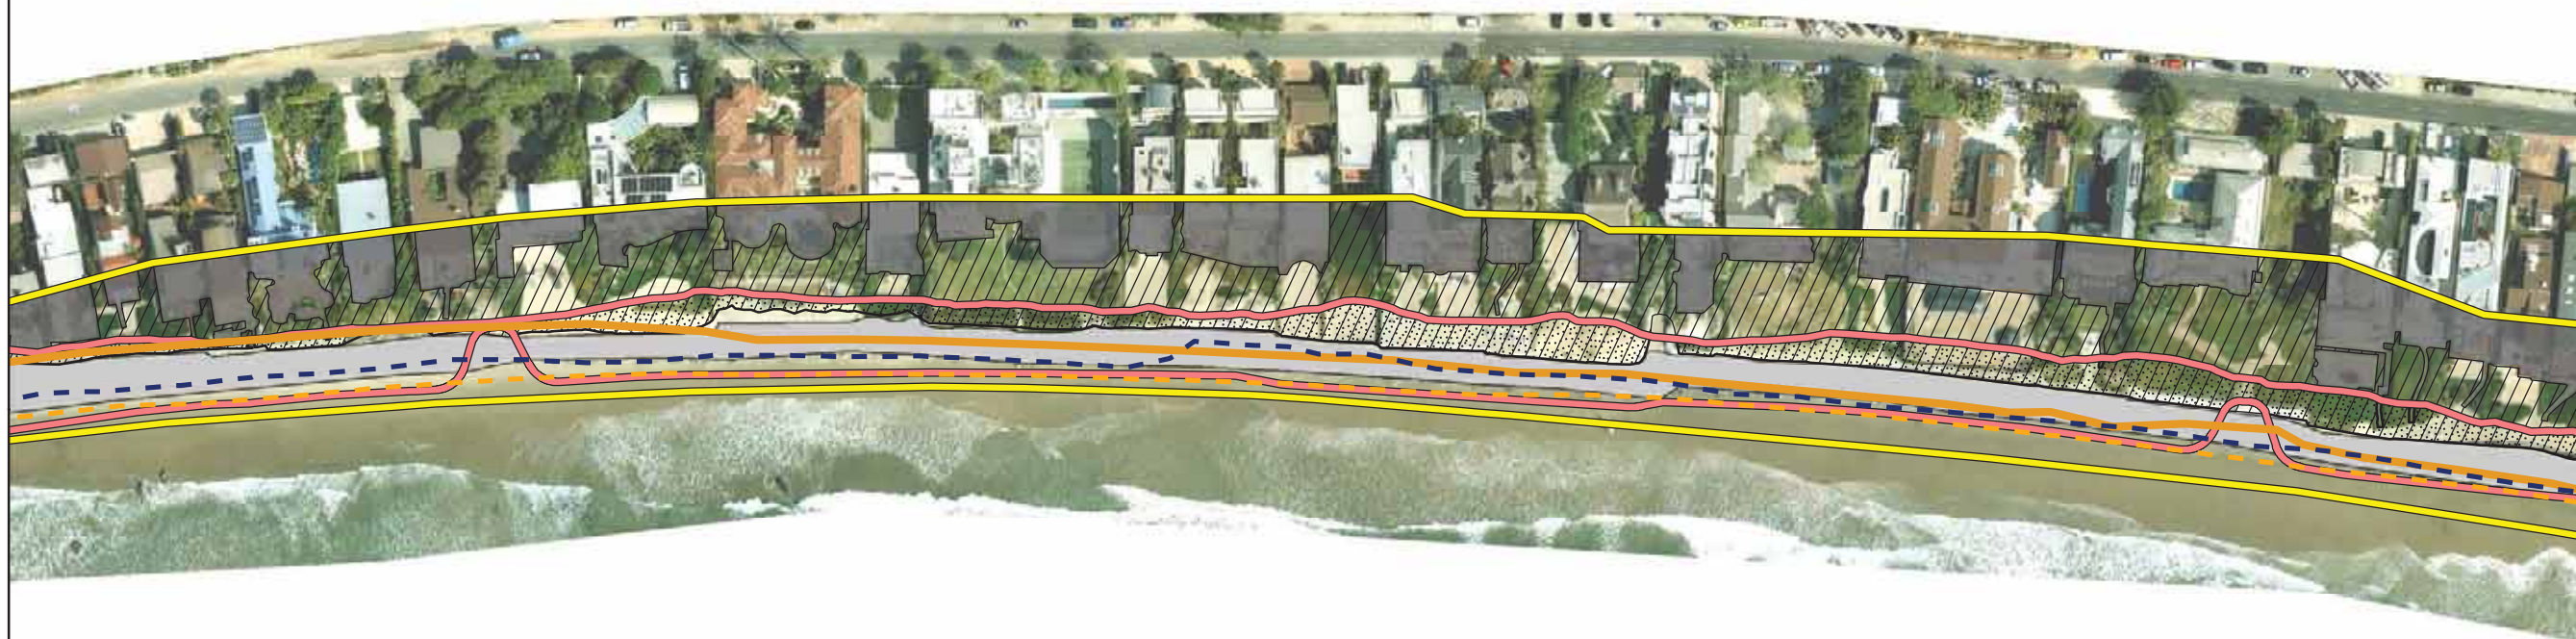
Figure 10-1c.

Potential Impacts to
Foredune Habitat
Under Alternative 1B
Relative to 2013
Existing Conditions

| Development Footprint | Temporary Impacts (2.14 acres) |
| 2010 Emergency Rock Revetment | Permanent Impacts (0.86 acre) |

** Temporary impacts are due to enhancement of existing degraded foredune habitat. Permanent impacts are due to relocation of revetment.

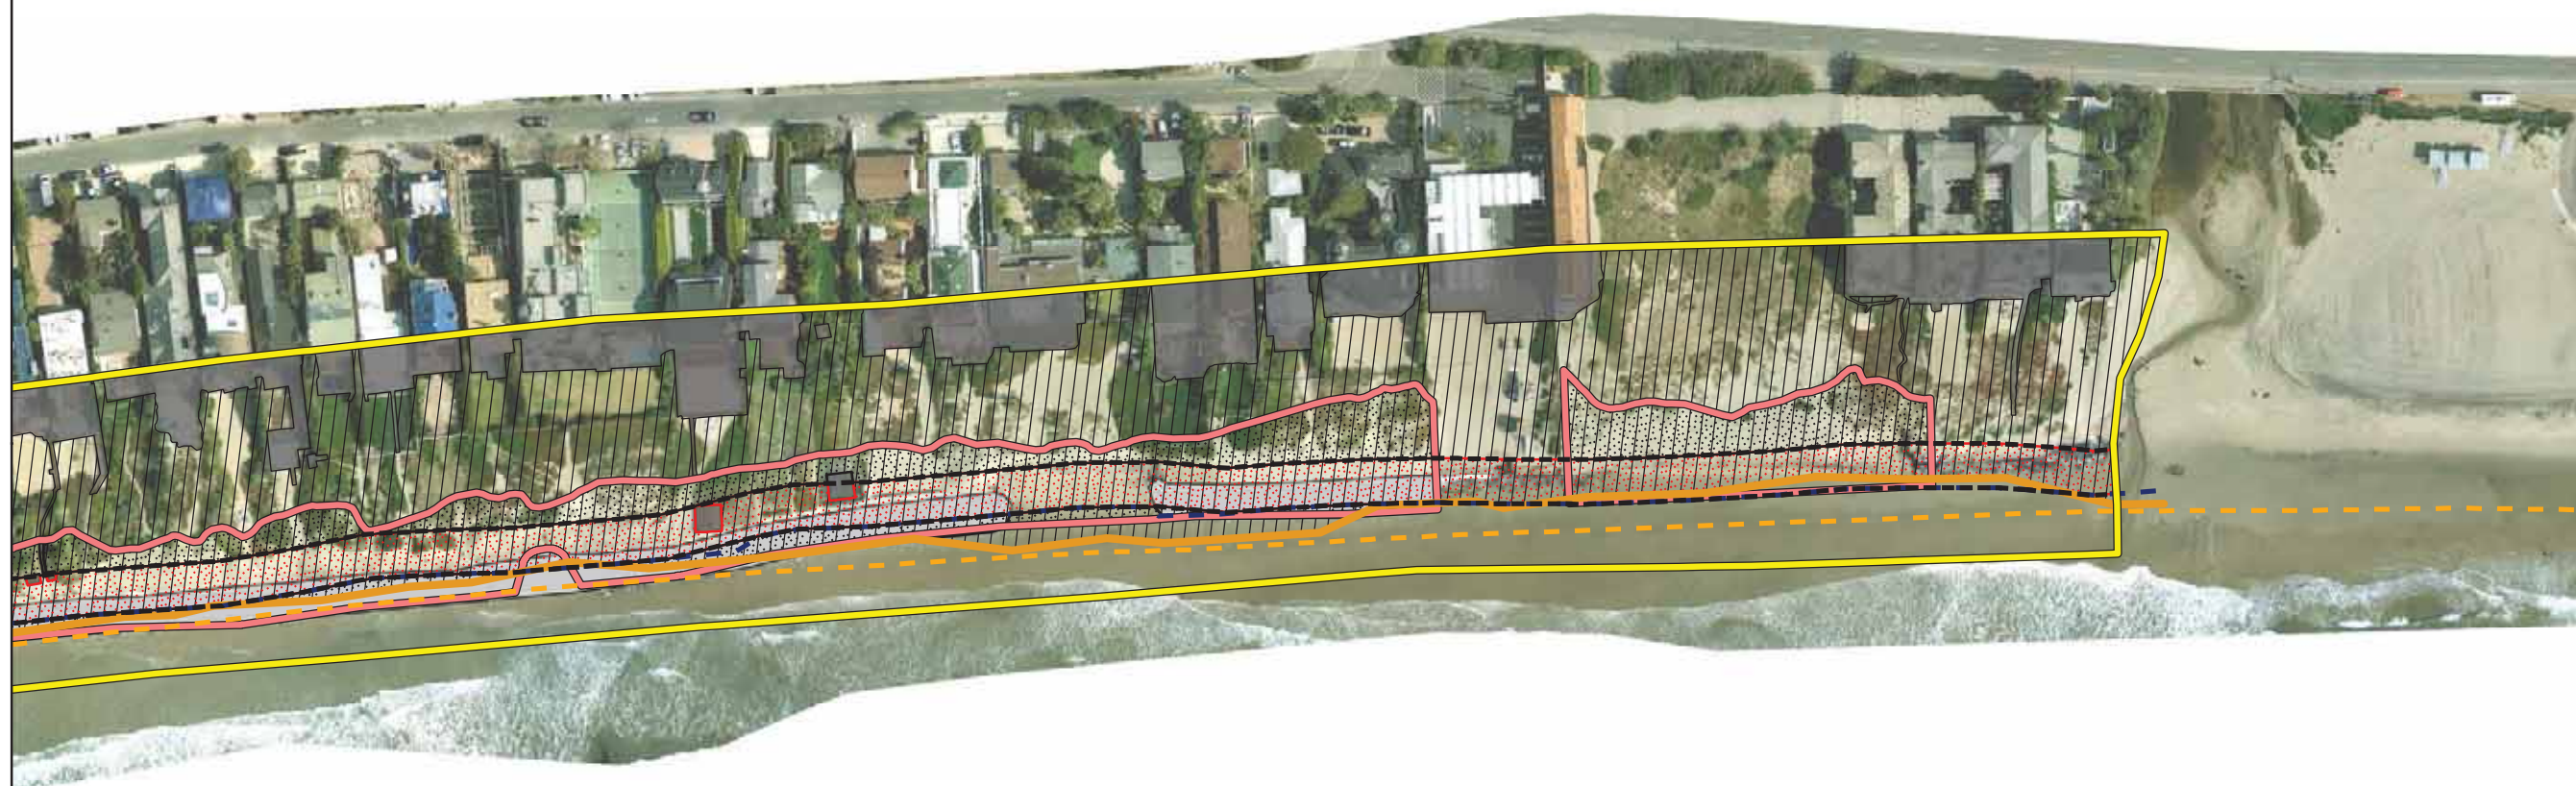
Figure 10-2a.

Potential Impacts to
Foredune Habitat
Under Alternative 1B
Relative to 2005
Baseline Conditions

** Temporary impacts are due to revetment removal or enhancement of existing degraded foredune habitat. Permanent impacts are due to retained and relocated sections of revetment.

For the assessment of impacts relative to the 2005 baseline condition, WRA assumed that the area landward of the 2005 beach/dune escarpment line shown in Figure 2 represents existing foredune habitat at the site. Using the 2005 baseline extent of foredune habitat, WRA assumed that areas of revetment removal and areas of foredune enhancement represent temporary impacts to foredune habitat and that areas where the revetment will be retained or relocated represent permanent impacts to foredune habitat. These impacts are shown in Figure 10-2 and include 2.48 acres of temporary impacts and 2.5 acres of permanent impacts.

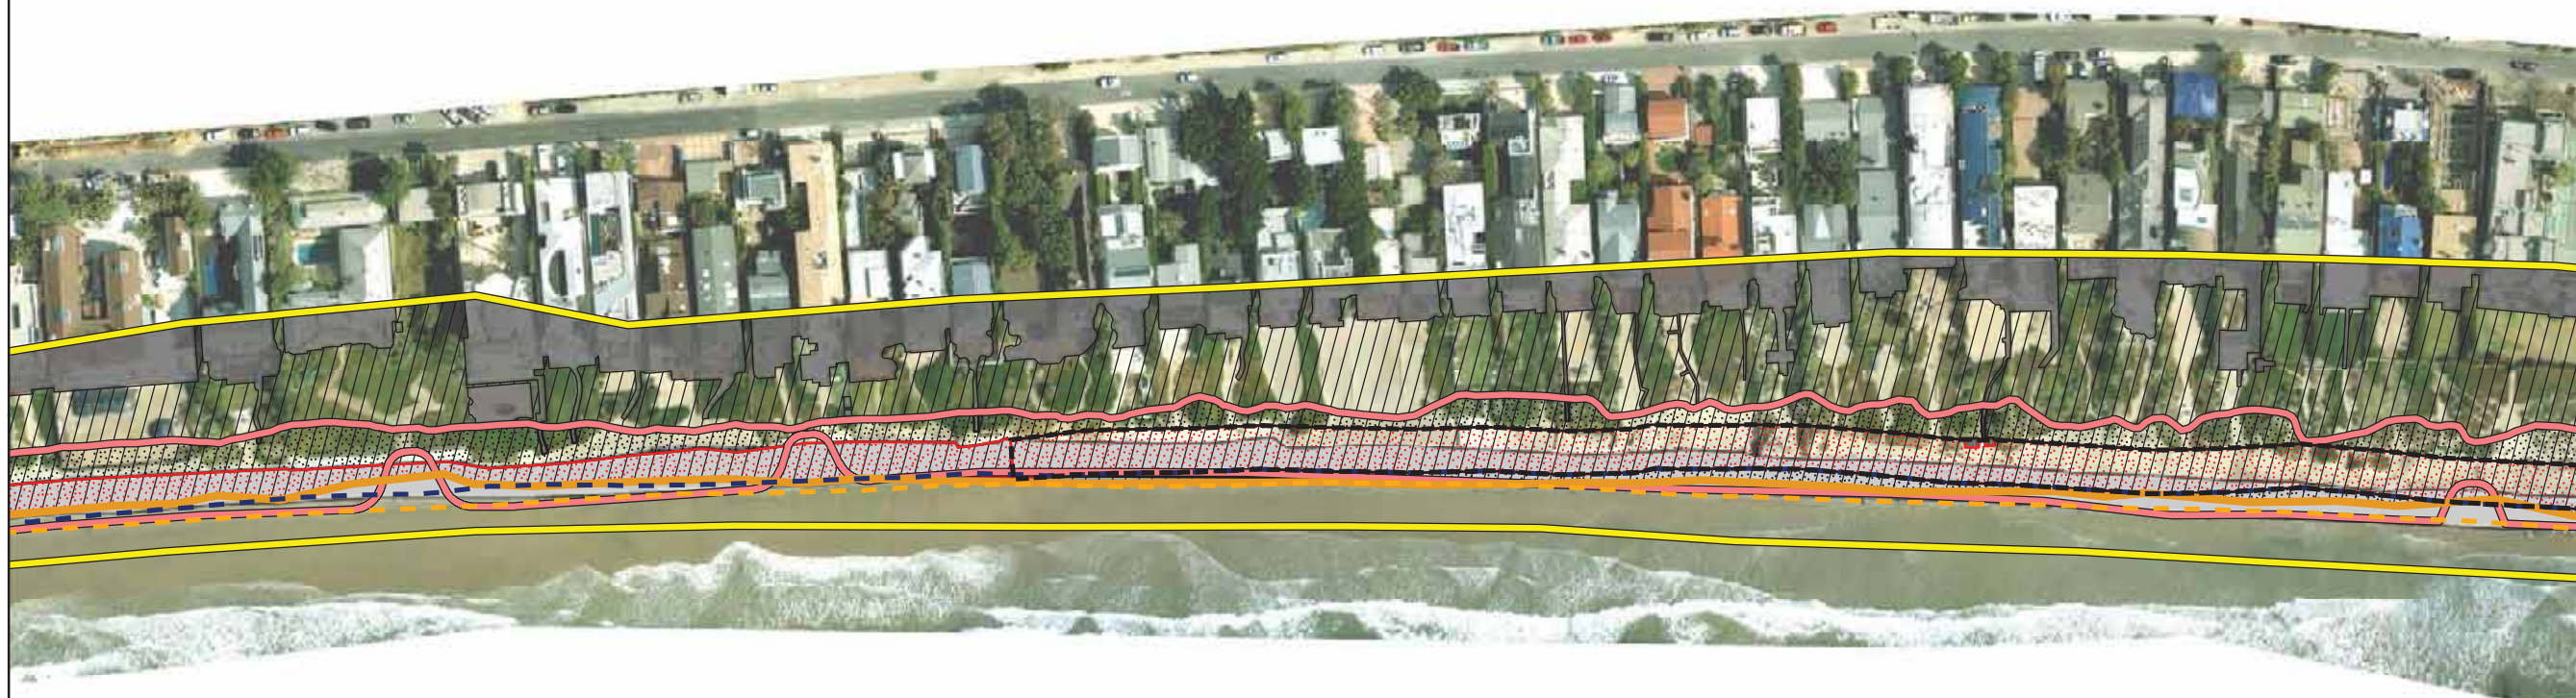
Figure 10-2b.

Potential Impacts to
Foredune Habitat
Under Alternative 1B
Relative to 2005
Baseline Conditions

Permanent Impacts (2.50 acres)

** Temporary impacts are due to revetment removal or enhancement of existing degraded foredune habitat. Permanent impacts are due to retained and relocated sections of revetment.

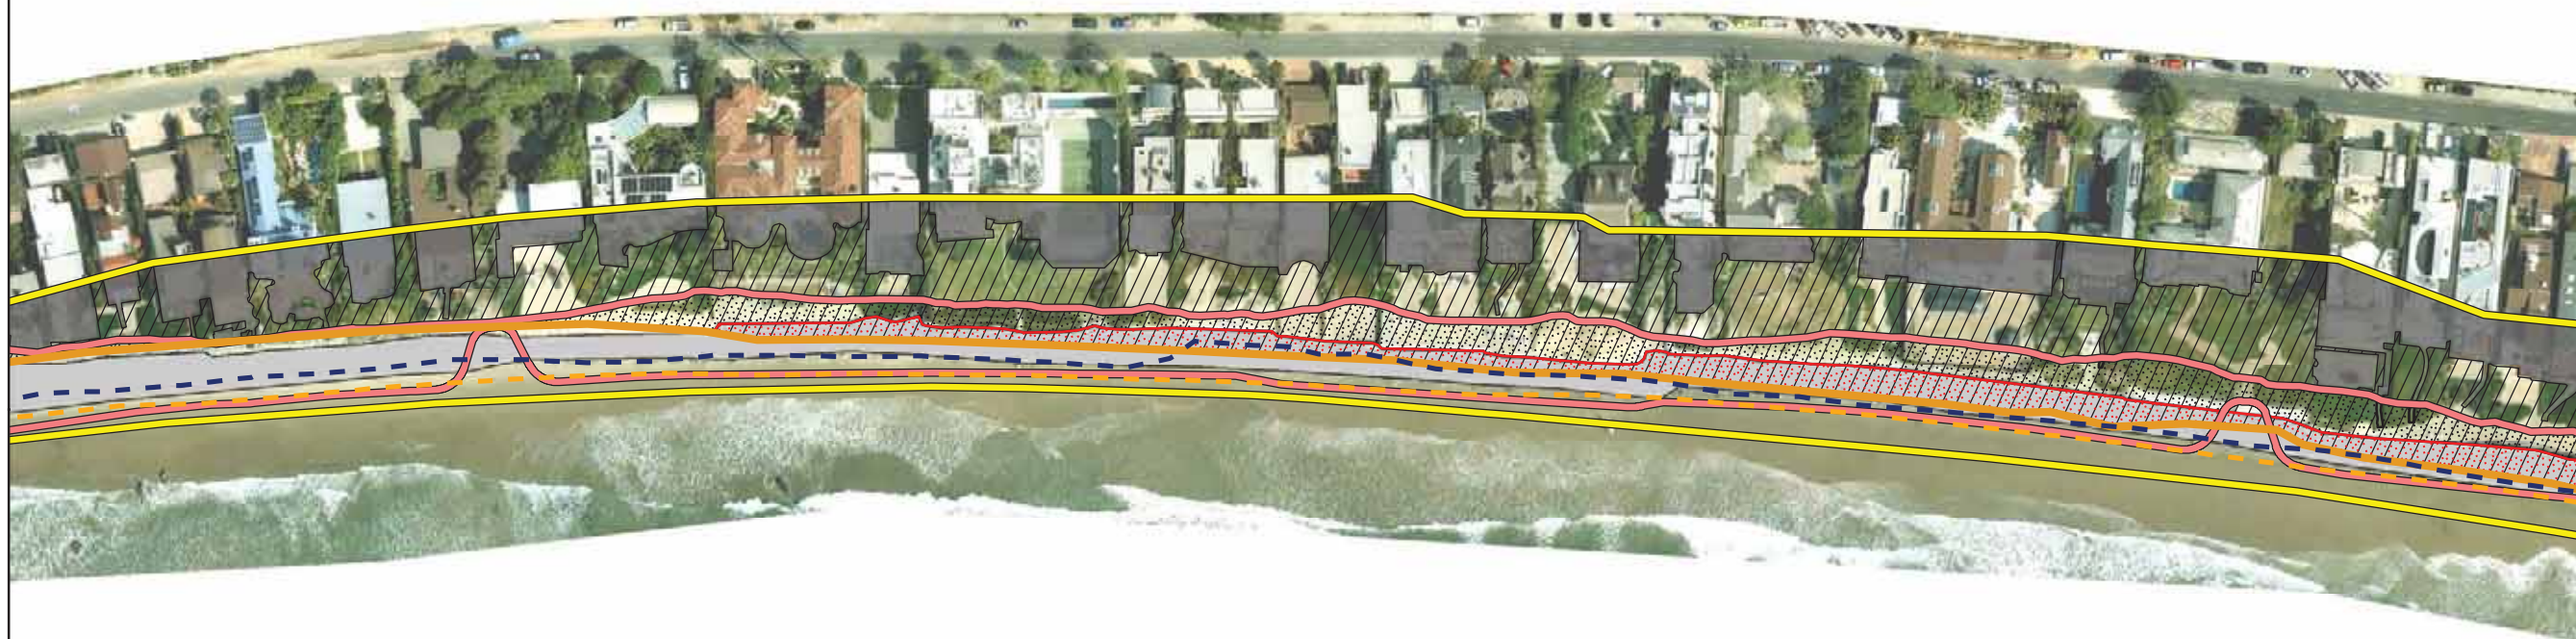
Figure 10-2c.

Potential Impacts to
Foredune Habitat
Under Alternative 1B
Relative to 2005
Baseline Conditions

** Temporary impacts are due to revetment removal or enhancement of existing degraded foredune habitat. Permanent impacts are due to retained and relocated sections of revetment.
