Memorandum

Subject: Broad Beach Foredune Impact Analysis

This memorandum provides an assessment of the impacts to foredune habitat that may have occurred or that could occur as a result of previous and proposed shoreline stabilization efforts at Broad Beach. This material is intended to support the application for a California Coastal Commission (“CCC”) Coastal Development Permit (“CDP”) for the proposed Broad Beach Restoration Project located in Malibu, Los Angeles County, California (“Study Area”; Figure 1). The information included here is based on inferred historical conditions, observed current conditions, and predicted future conditions at Broad Beach. As noted in the previous CDP submittals for the project, detailed records of historical habitat conditions and shoreline stabilization efforts at Broad Beach are lacking, and much information had to be inferred from historic aerial imagery, a sporadic record of photographs from the site, and comparisons with similar habitats in the region. As such, the analysis presented here is subject to a number of caveats which are presented in the following sections. The analysis follows in six parts, each of which contains (1) an assess

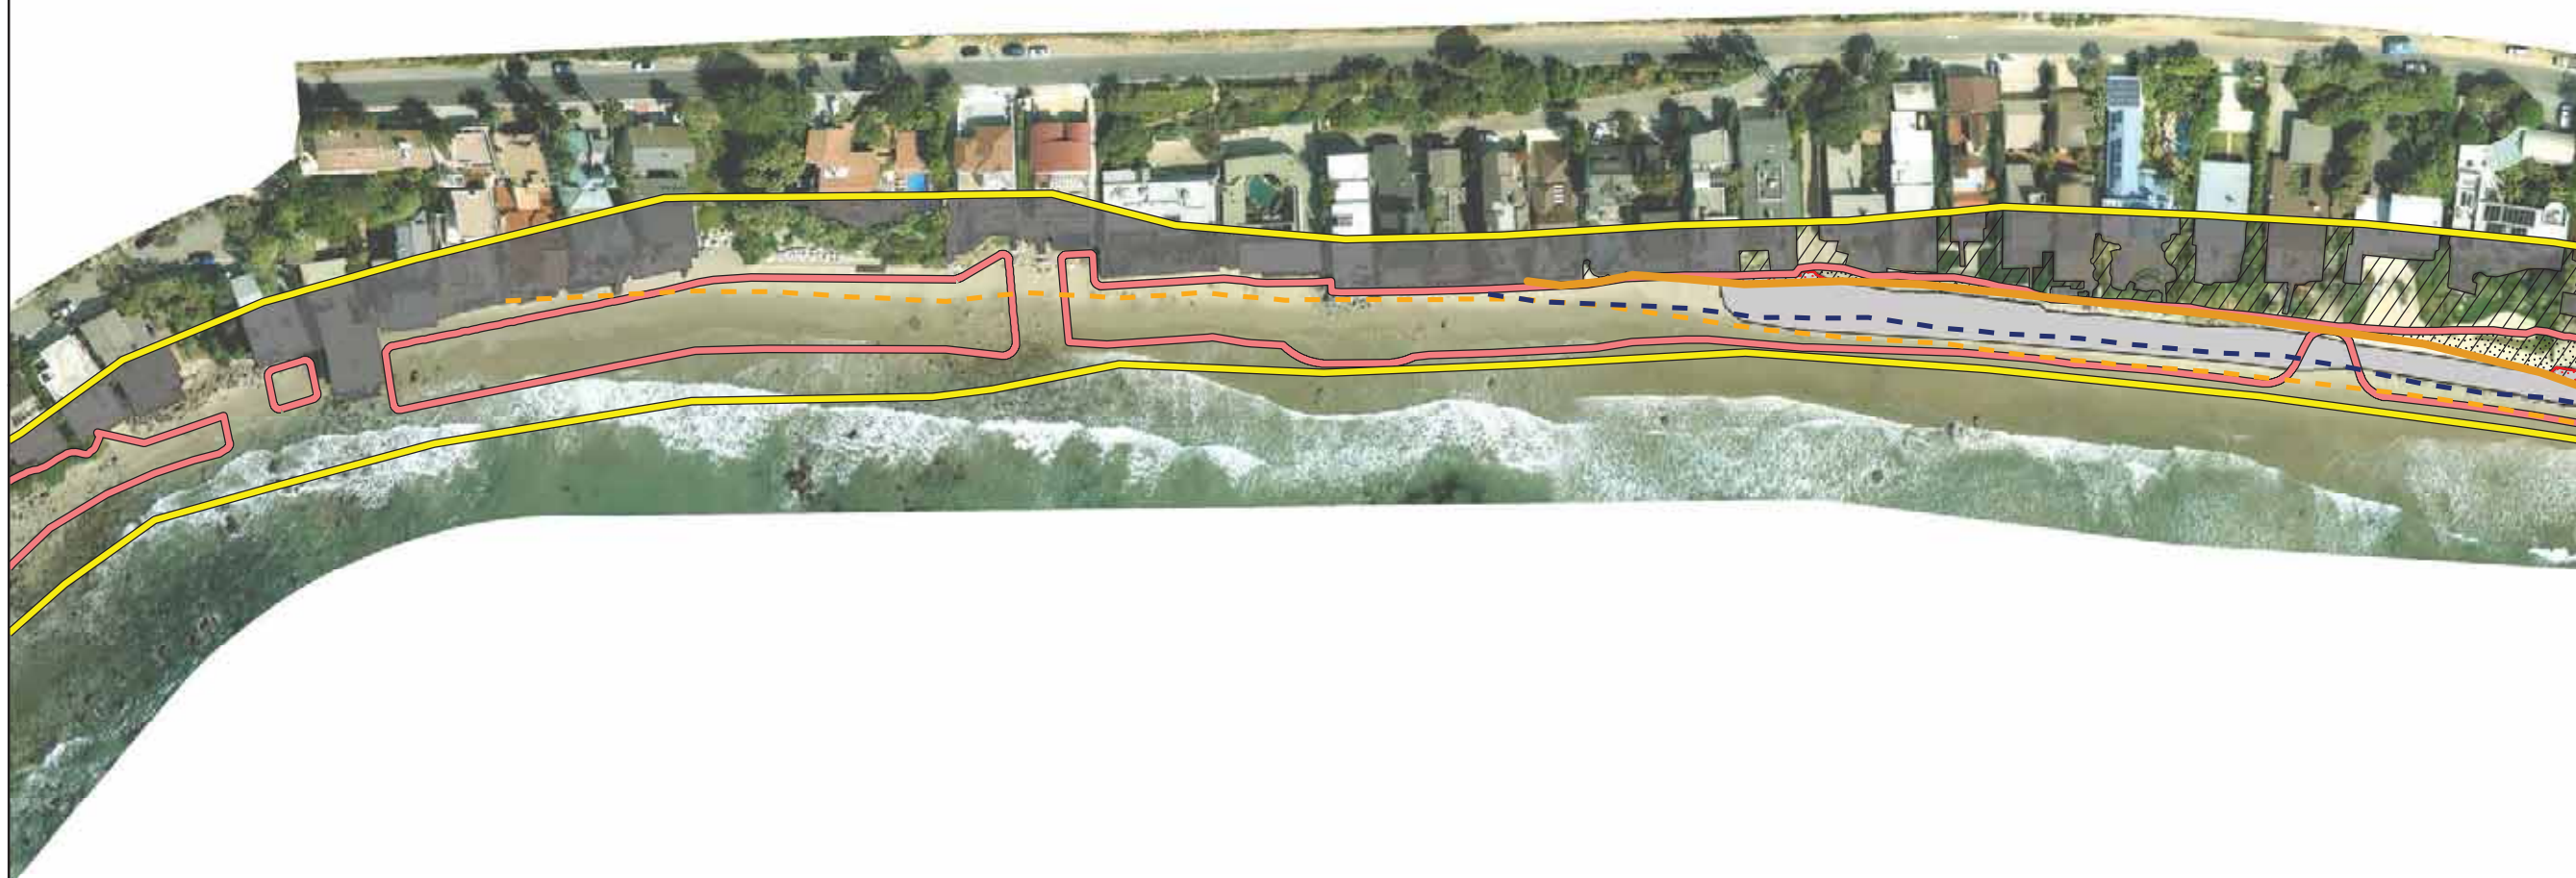
Figure 10-2d.

Potential Impacts to
Foredune Habitat
Under Alternative 1B
Relative to 2005
Baseline Conditions

** Temporary impacts are due to revetment removal or enhancement of existing degraded foredune habitat. Permanent impacts are due to retained and relocated sections of revetment.

For the assessment of impacts relative to the 2005 baseline condition, WRA assumed that the area landward of the 2005 beach/dune escarpment line shown in Figure 2 represents existing foredune habitat at the site. Using the 2005 baseline extent of foredune habitat, WRA assumed that areas of revetment removal and areas of foredune enhancement represent temporary impacts to foredune habitat and that areas where the revetment will be retained or relocated represent permanent impacts to foredune habitat. These impacts are shown in Figure 10-2 and include 2.48 acres of temporary impacts and 2.5 acres of permanent impacts.

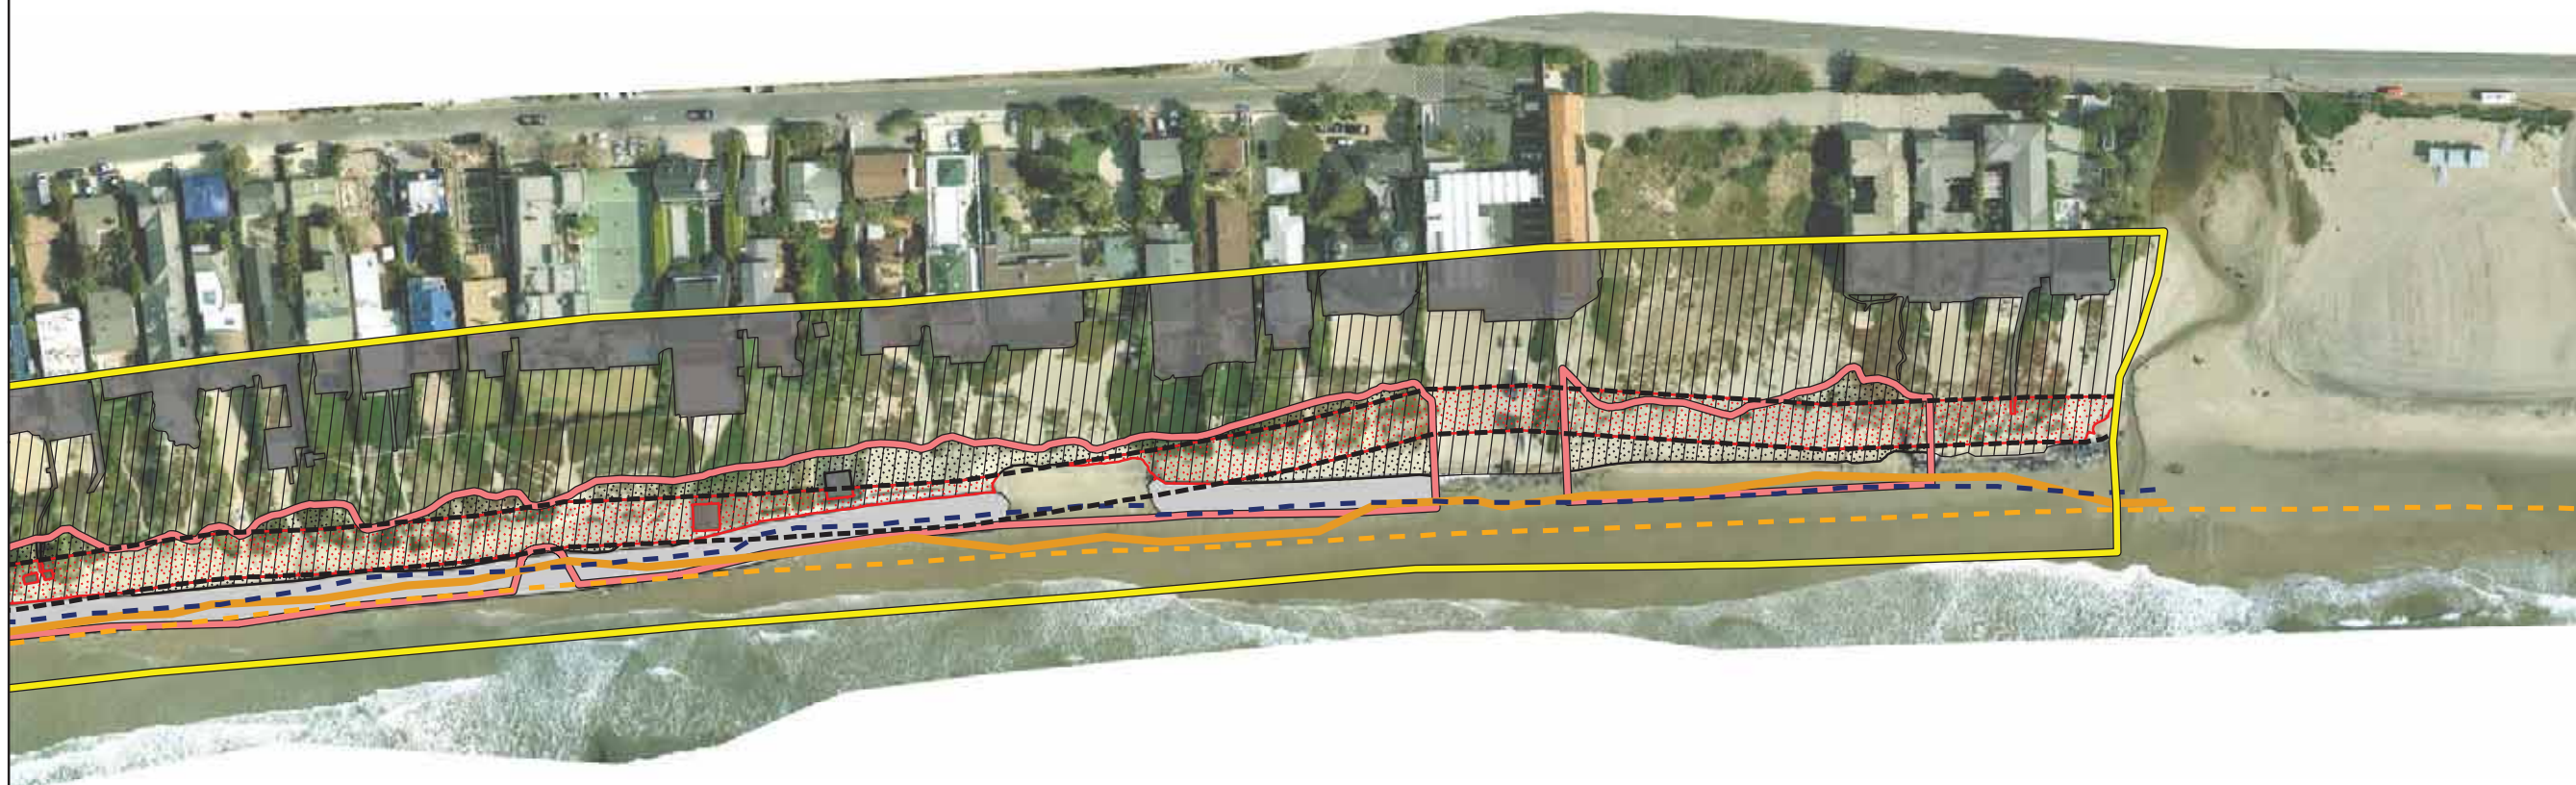
Figure 11-1a.

Potential Impacts to
Foredune Habitat
Under Alternative 2
Relative to 2013
Existing Conditions

| Development Footprint | Temporary Impacts (1.86 acres) |
| 2010 Emergency Rock Revetment | Permanent Impacts (1.31 acres) |

** Temporary impacts are due to enhancement of existing degraded foredune habitat. Permanent impacts are due to relocation of revetment.

For the chronological assessment of foredune impacts, WRA used the existing foredune extent shown in Figure 5 and assumed that potential impacts to foredune habitat associated with this alternative include those areas where the revetment will be relocated landward of its current position as well as the area designated for foredune enhancement. These potential impacts are shown on Figure 11-1 and include approximately 1.31 acres of permanent impacts associated with the relocated revetment sections and 1.86 acres of temporary impacts associated with the foredune enhancement.

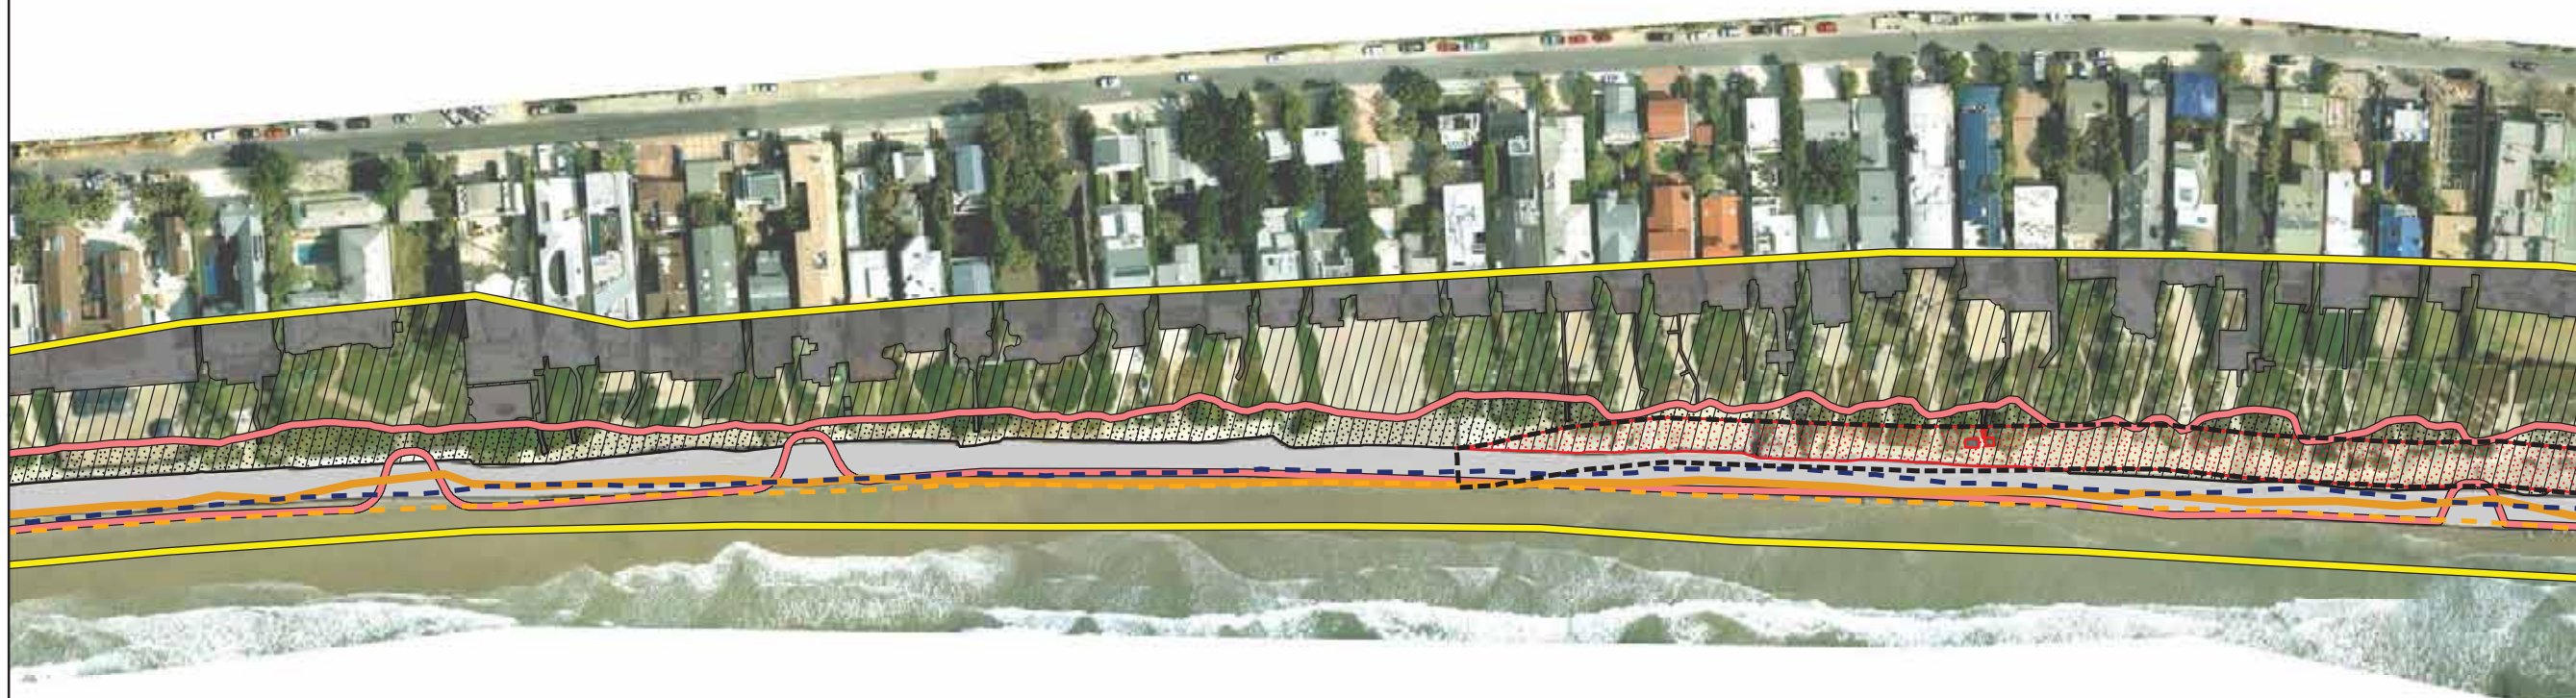
Figure 11-1b.

Potential Impacts to
Foredune Habitat
Under Alternative 2
Relative to 2013
Existing Conditions

** Temporary impacts are due to enhancement of existing degraded foredune habitat. Permanent impacts are due to relocation of revetment.

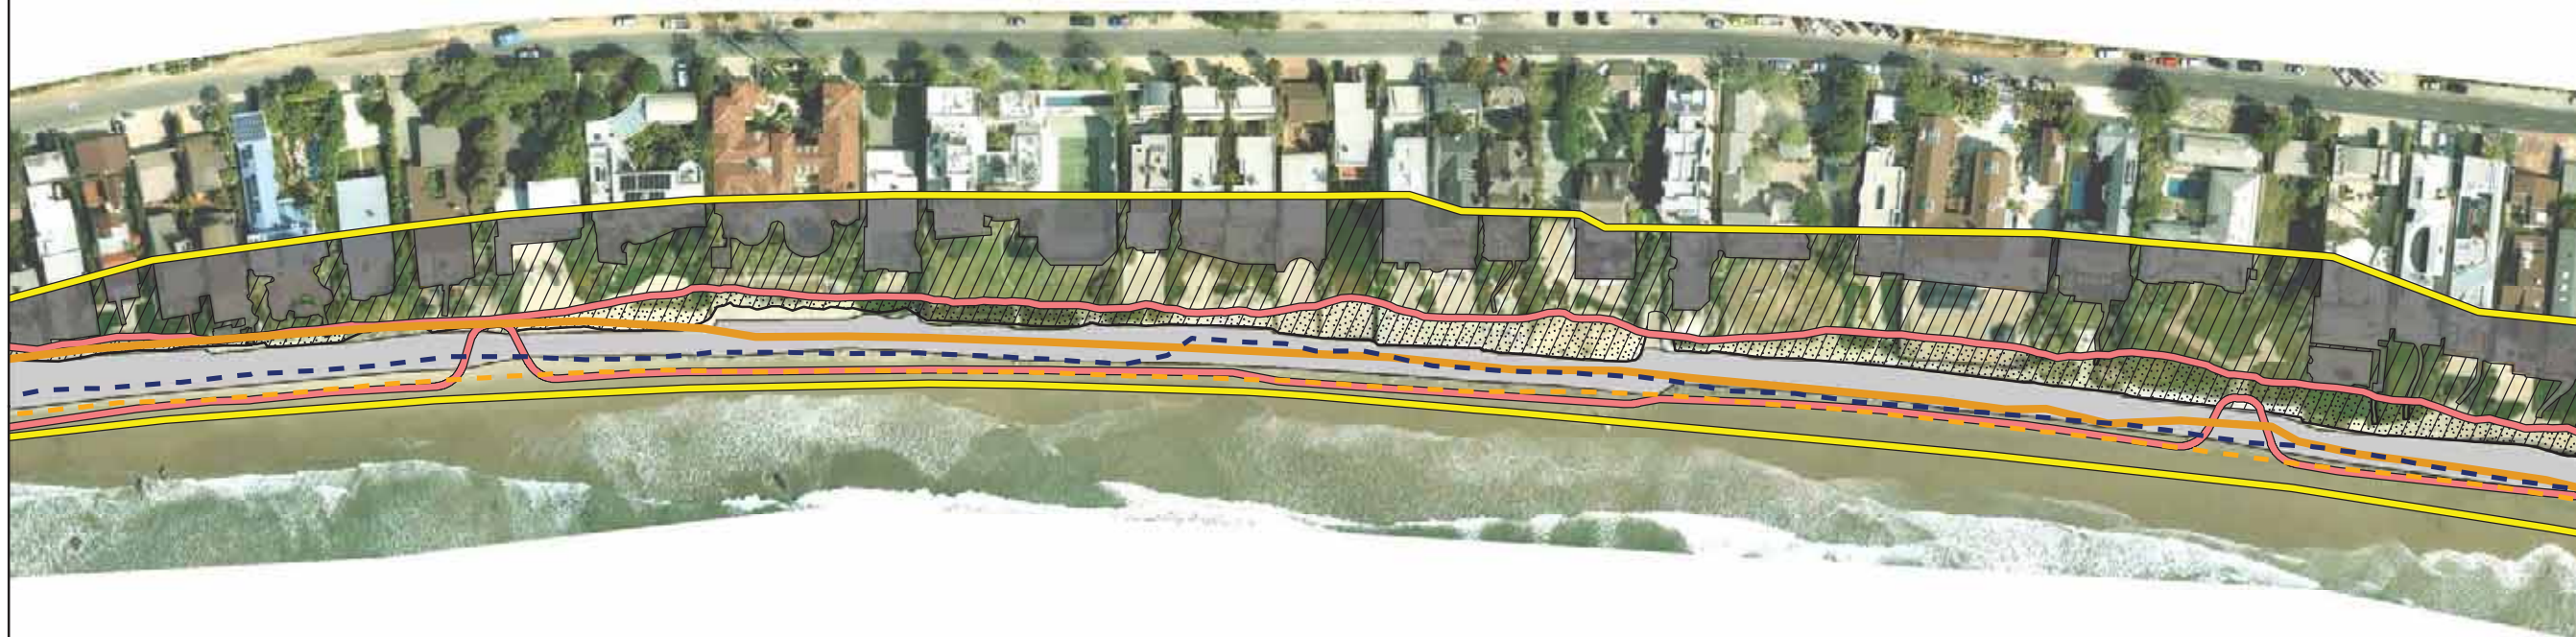
Figure 11-1c.

Potential Impacts to
Foredune Habitat
Under Alternative 2
Relative to 2013
Existing Conditions

| Development Footprint | Temporary Impacts (1.86 acres) |
| 2010 Emergency Rock Revetment | Permanent Impacts (1.31 acres) |

** Temporary impacts are due to enhancement of existing degraded foredune habitat. Permanent impacts are due to relocation of revetment.

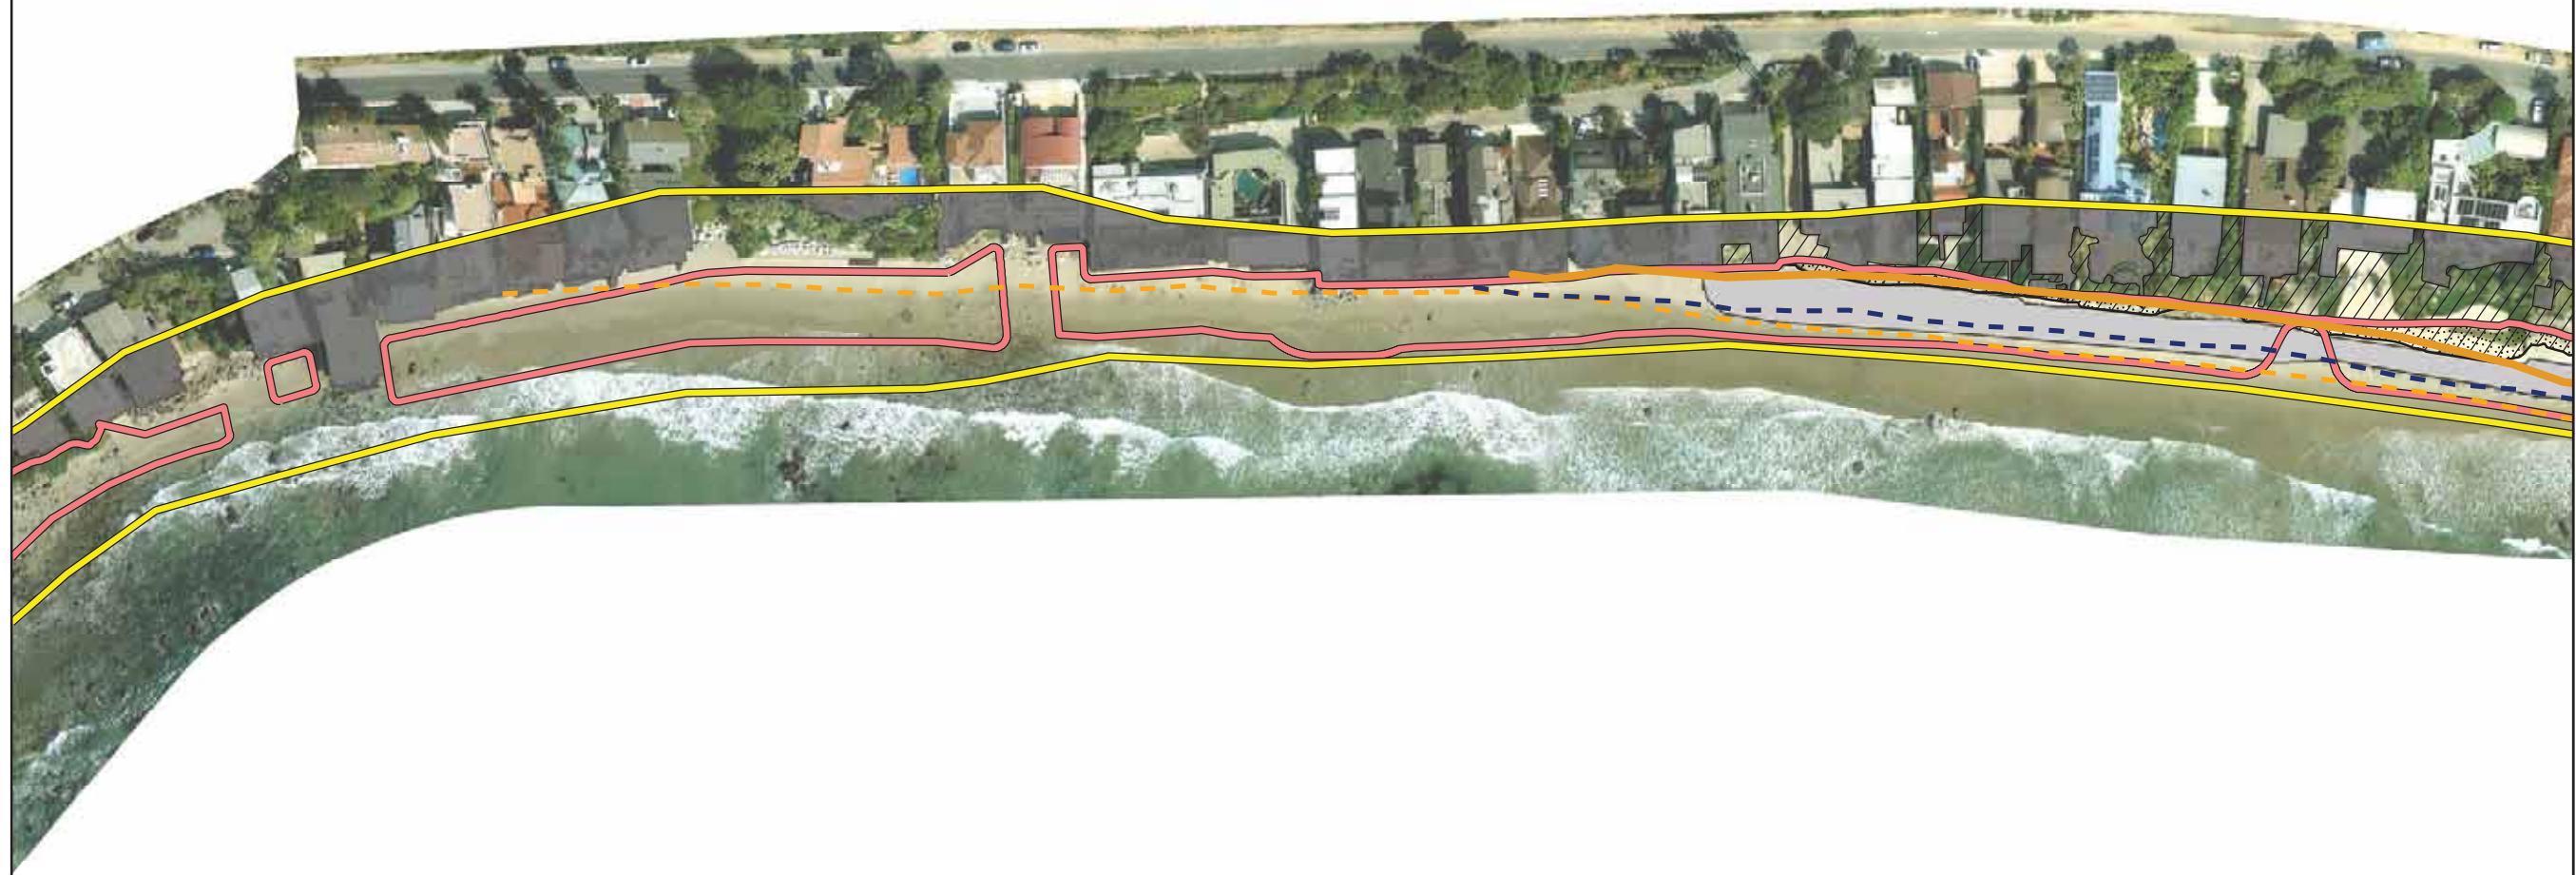
Figure 11-1d.

Potential Impacts to
Foredune Habitat
Under Alternative 2
Relative to 2013
Existing Conditions

** Temporary impacts are due to enhancement of existing degraded foredune habitat. Permanent impacts are due to relocation of revetment.

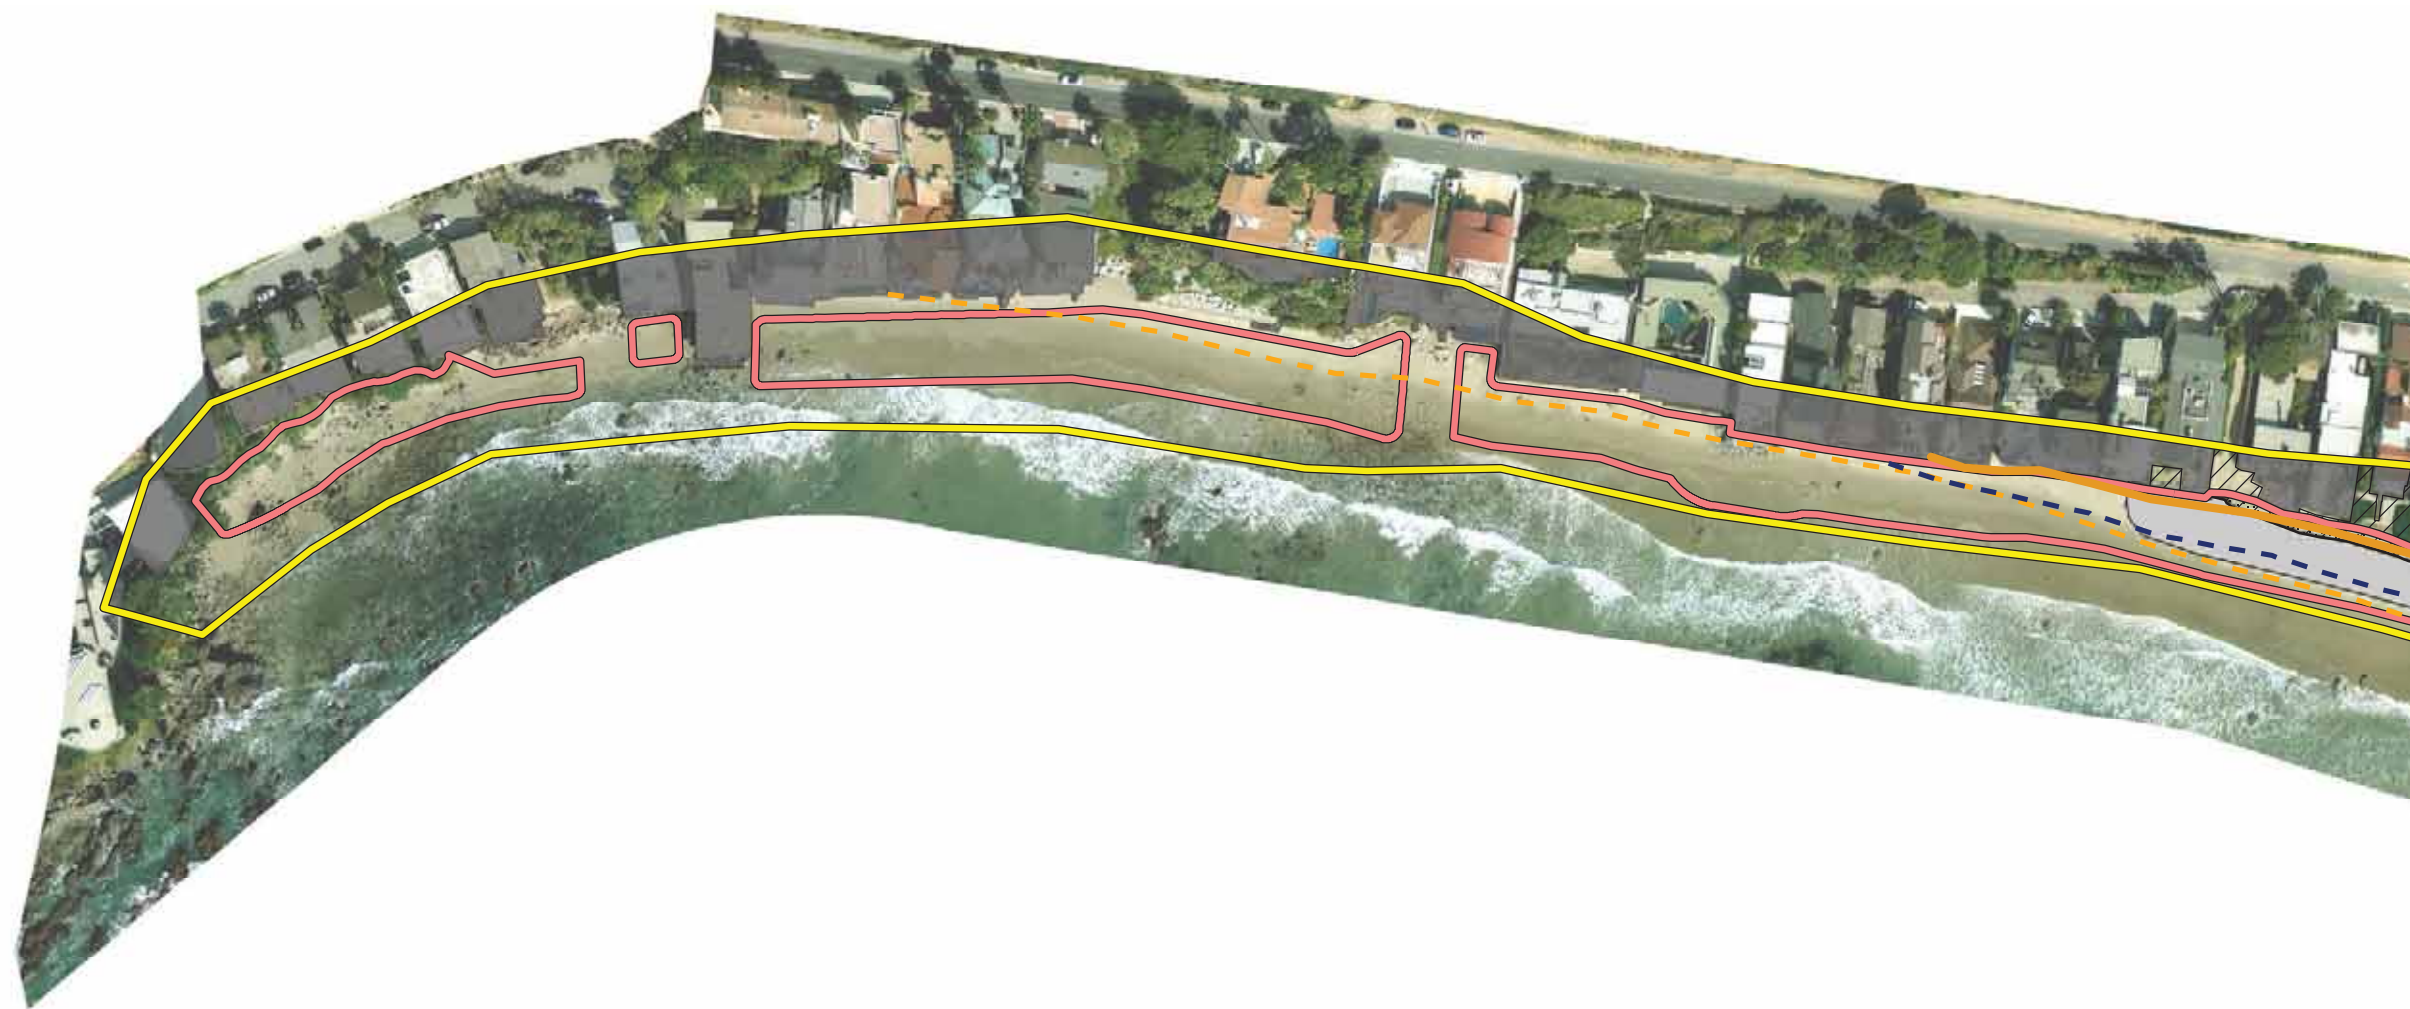
Figure 11-1e.

Potential Impacts to
Foredune Habitat
Under Alternative 2
Relative to 2013
Existing Conditions

| Development Footprint | Temporary Impacts (1.86 acres) |
| 2010 Emergency Rock Revetment | Permanent Impacts (1.31 acres) |

** Temporary impacts are due to enhancement of existing degraded foredune habitat. Permanent impacts are due to relocation of revetment.

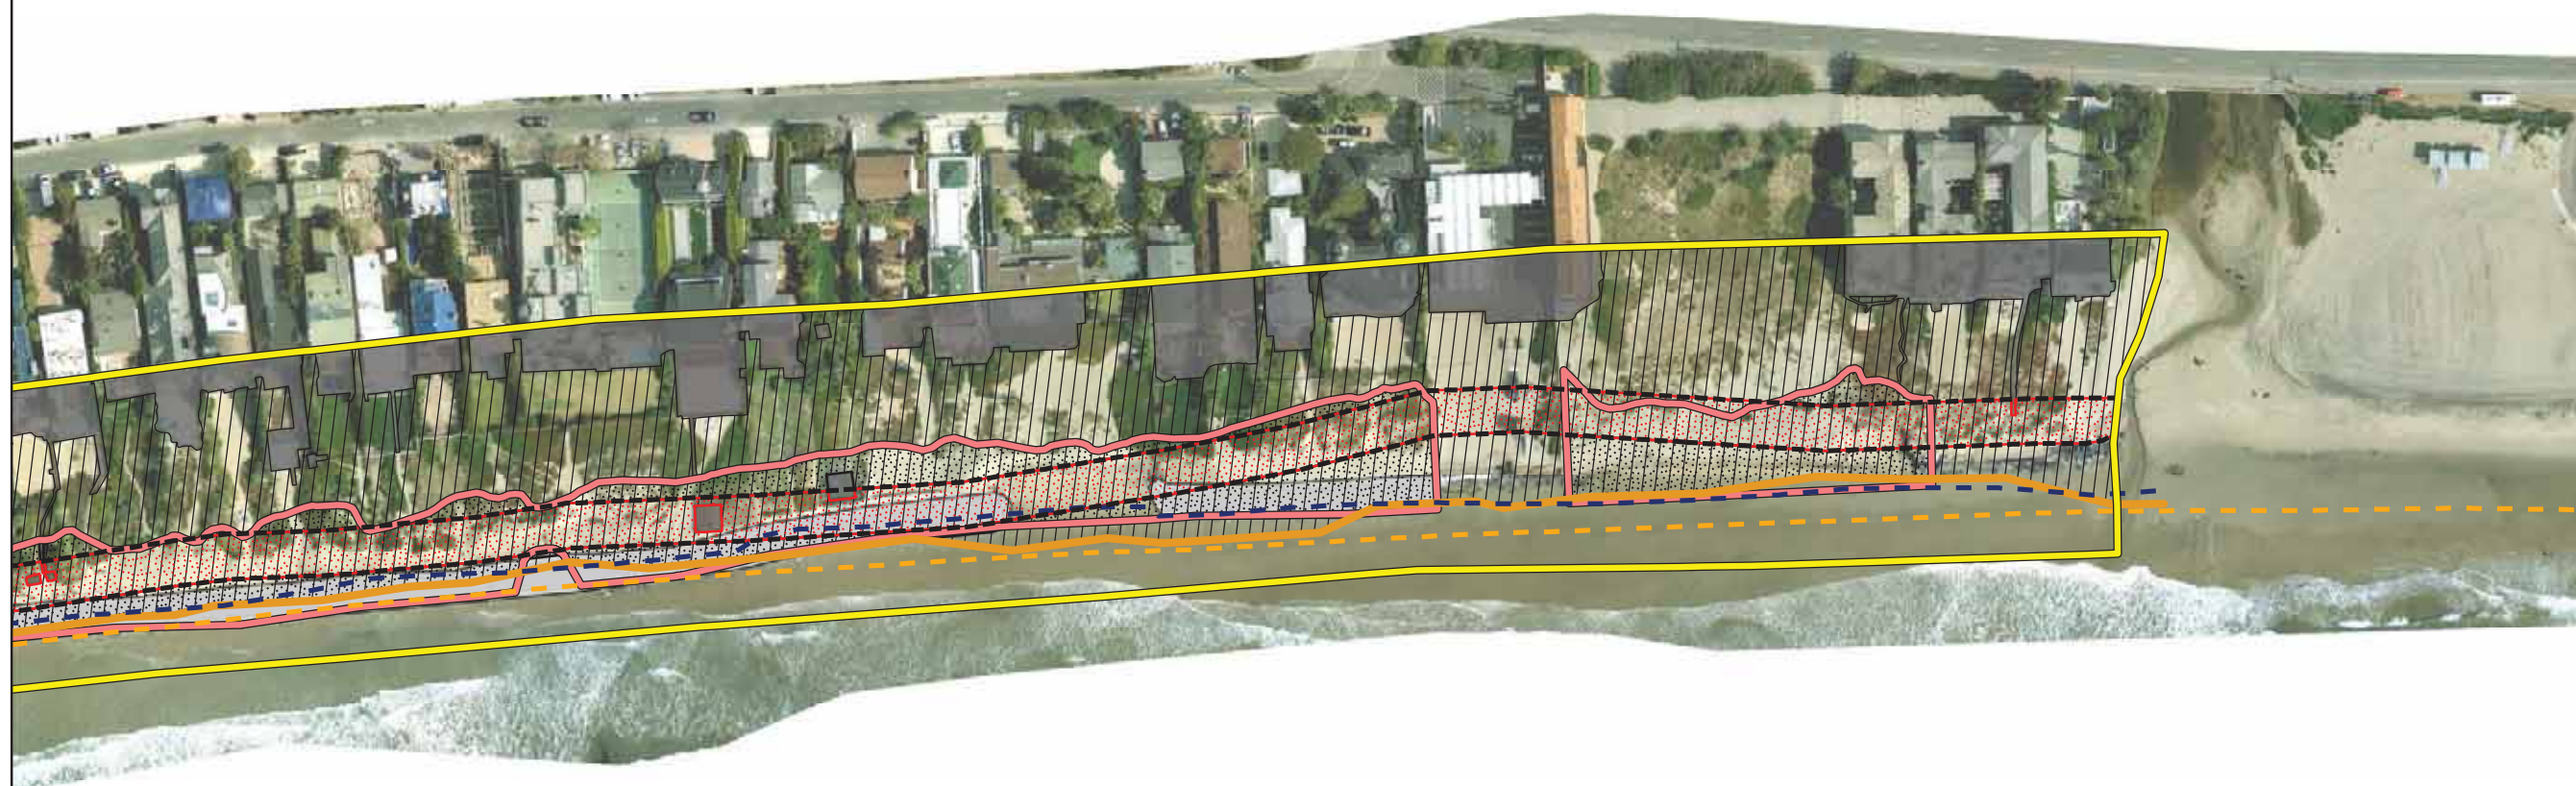
Figure 11-2a.

Potential Impacts to
Foredune Habitat
Under Alternative 2
Relative to 2005
Baseline Conditions

* Remnant foredune habitat based on 2005 foredune extent shown in Figure 2.

** Temporary impacts are due to revetment removal or enhancement of existing degraded foredune habitat. Permanent impacts are due to retained and relocated sections of revetment.

represent permanent impacts to foredune habitat. These impacts are shown in Figure 11-2 and include 2.48 acres of temporary impacts and 2.54 acres of permanent impacts.

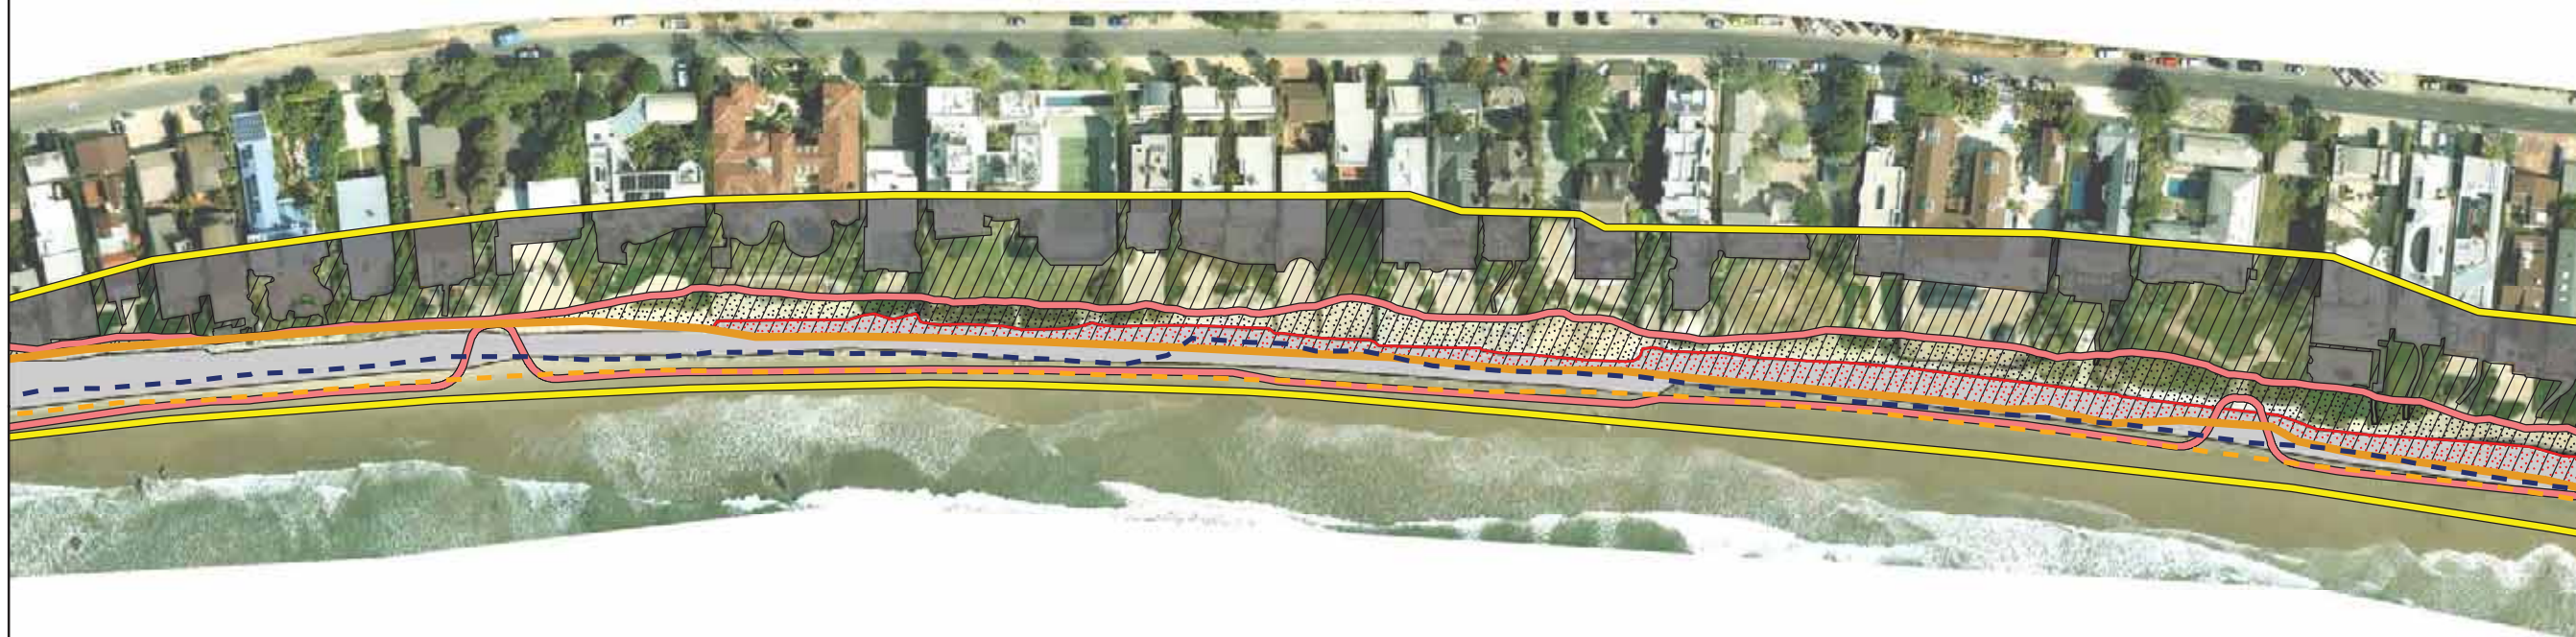
Figure 11-2c.

Potential Impacts to
Foredune Habitat
Under Alternative 2
Relative to 2005
Baseline Conditions

* Remnant foredune habitat based on 2005 foredune extent shown in Figure 2.

** Temporary impacts are due to revetment removal or enhancement of existing degraded foredune habitat. Permanent impacts are due to retained and relocated sections of revetment.

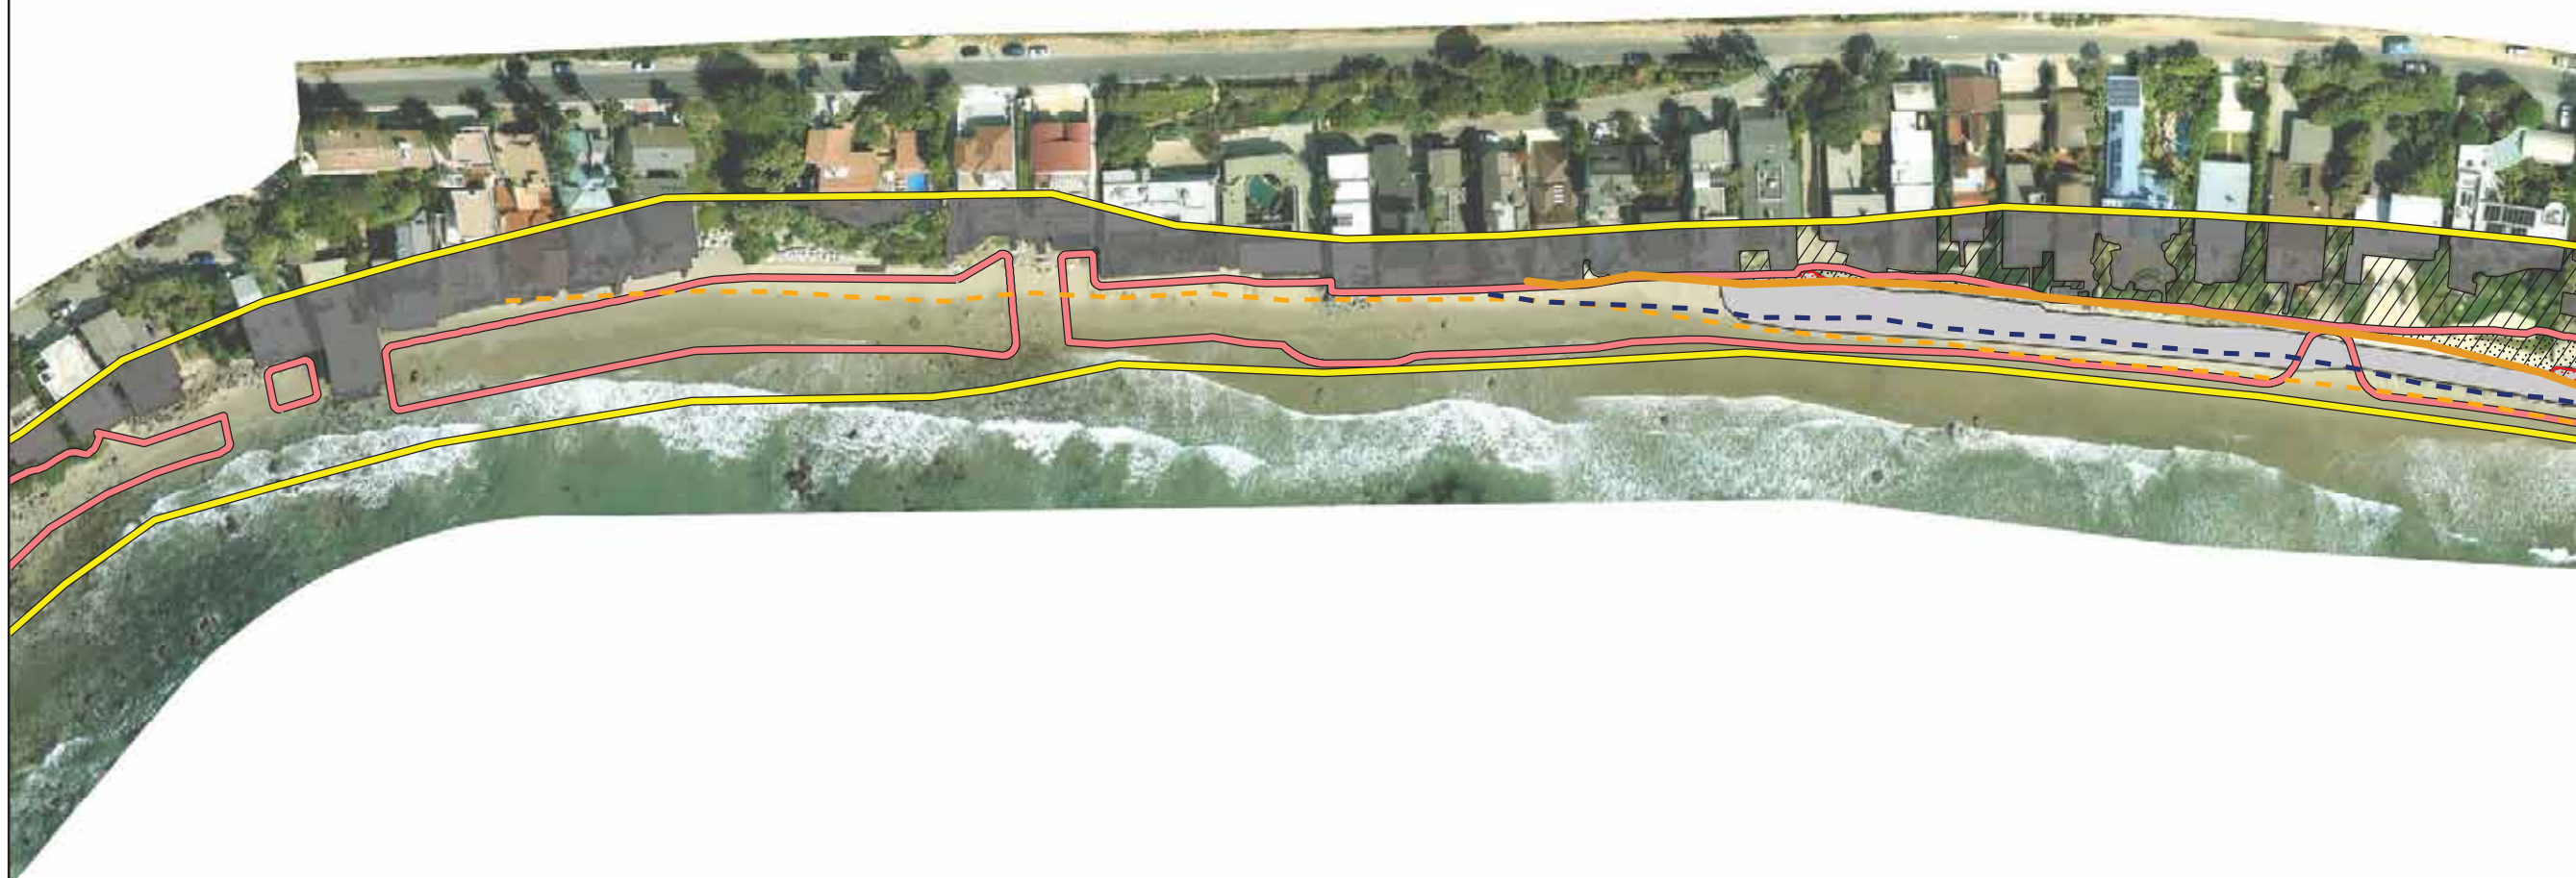
Figure 11-2d.

Potential Impacts to
Foredune Habitat
Under Alternative 2
Relative to 2005
Baseline Conditions

- Study Area
- MHTL - JAN 19-20, 2010
- MHTL - OCT 15, 2009
- June 2005 Beach/Foredune Escarpment Line
- Development Footprint
- 2010 Emergency Rock Revetment
- Proposed Dune Restoration Footprint (7.71 acres)
- Alternative 2 Revetment Relocation
- Remnant Foredune Habitat (12.23 acres)*
- Potential Impacts to Remnant Foredune Habitat****
- Temporary Impacts (2.48 acres)
- Permanent Impacts (2.54 acres)

* Remnant foredune habitat based on 2005 foredune extent shown in Figure 2.

** Temporary impacts are due to revetment removal or enhancement of existing degraded foredune habitat. Permanent impacts are due to retained and relocated sections of revetment.

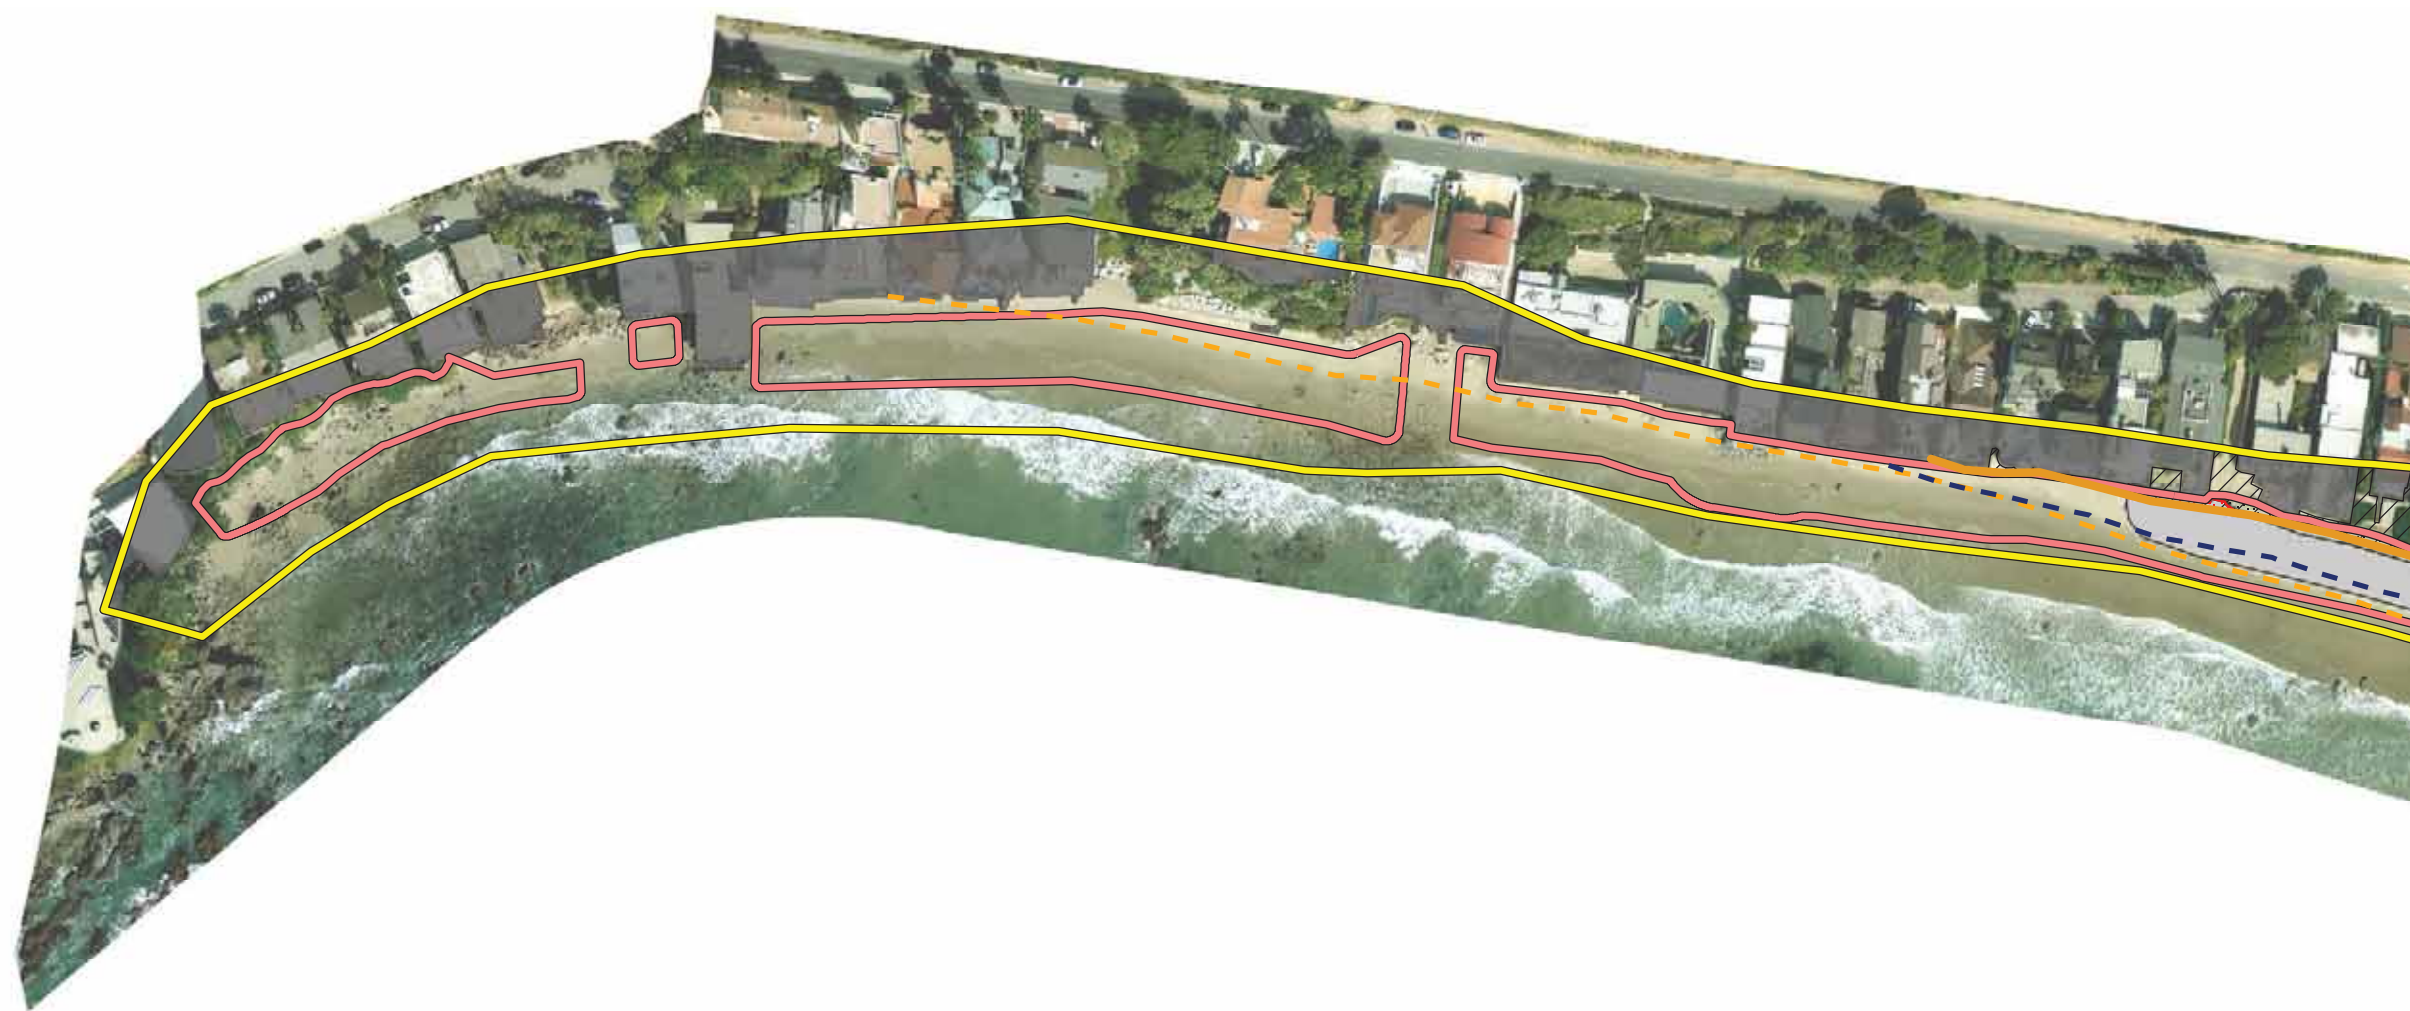
Figure 11-2e.

Potential Impacts to
Foredune Habitat
Under Alternative 2
Relative to 2005
Baseline Conditions

* Remnant foredune habitat based on 2005 foredune extent shown in Figure 2.

** Temporary impacts are due to revetment removal or enhancement of existing degraded foredune habitat. Permanent impacts are due to retained and relocated sections of revetment.
