Memorandum

Subject: Broad Beach Foredune Impact Analysis

This memorandum provides an assessment of the impacts to foredune habitat that may have occurred or that could occur as a result of previous and proposed shoreline stabilization efforts at Broad Beach. This material is intended to support the application for a California Coastal Commission (“CCC”) Coastal Development Permit (“CDP”) for the proposed Broad Beach Restoration Project located in Malibu, Los Angeles County, California (“Study Area”; Figure 1). The information included here is based on inferred historical conditions, observed current conditions, and predicted future conditions at Broad Beach. As noted in the previous CDP submittals for the project, detailed records of historical habitat conditions and shoreline stabilization efforts at Broad Beach are lacking, and much information had to be inferred from historic aerial imagery, a sporadic record of photographs from the site, and comparisons with similar habitats in the region. As such, the analysis presented here is subject to a number of caveats which are presented in the following sections. The analysis follows in six parts, each of which contains (1) an assess

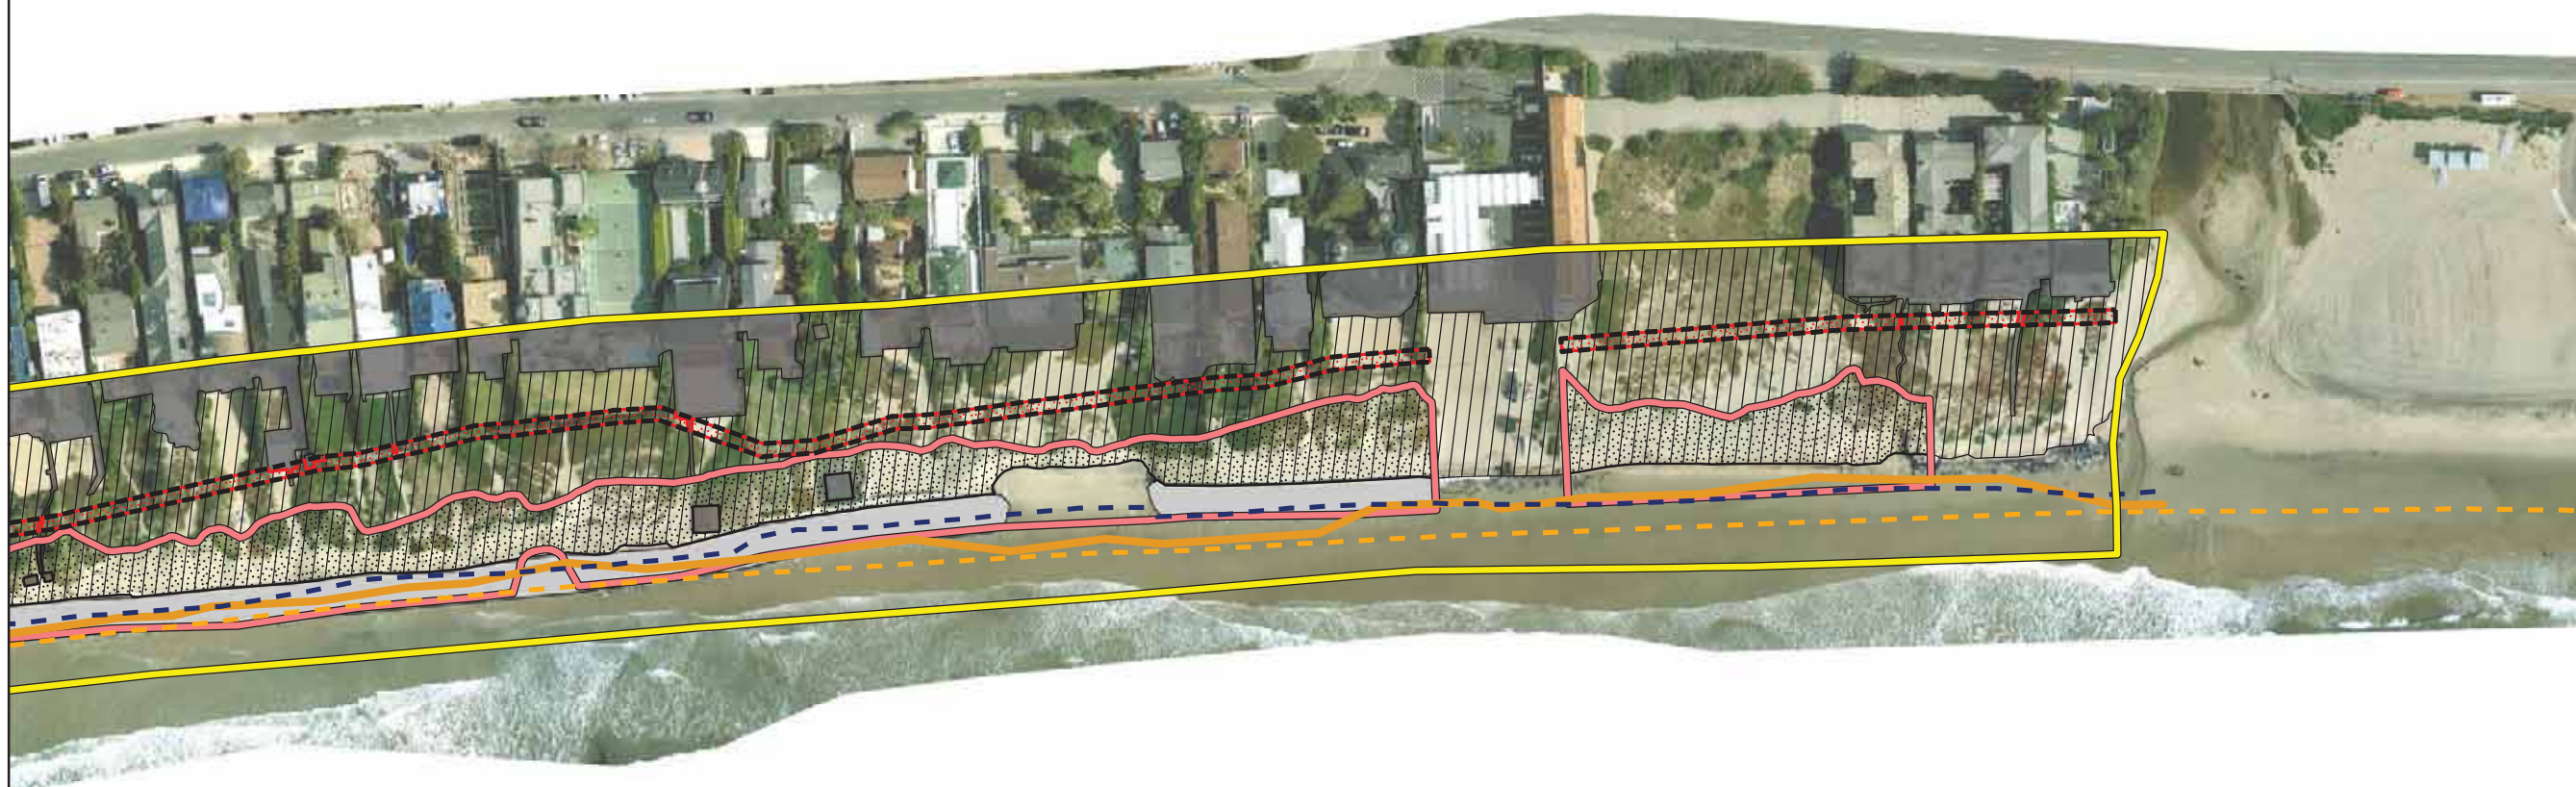
Figure 12-1a.

Potential Impacts to
Foredune Habitat
Under Alternative 3A
Relative to 2013
Existing Conditions

- Study Area
- MHTL - JAN 19-20, 2010
- MHTL - OCT 15, 2009
- June 2005 Beach/Foredune Escarpment Line
- Development Footprint
- 2010 Emergency Rock Revetment
- Proposed Dune Restoration Footprint (7.71 acres)
- Alternative 3A Seawall Pull-back Location
- Remnant Foredune Habitat (10.09 acres)*
- Potential Impacts to Remnant Foredune Habitat****
- Temporary Impacts (2.58 acres)
- Permanent Impacts (0.90 acre)

* Remnant foredune habitat remaining after installation of Pre-2010 Shoreline Protection Structures and 2010 Emergency Rock Revetment, including areas of pocket cove formation where revetment materials were not installed or were installed but failed.
 **Temporary impacts are due to enhancement of existing degraded foredune habitat. Permanent impacts are due to installation of seawall and associated rock apron in existing degraded foredune habitat (2010 extent).

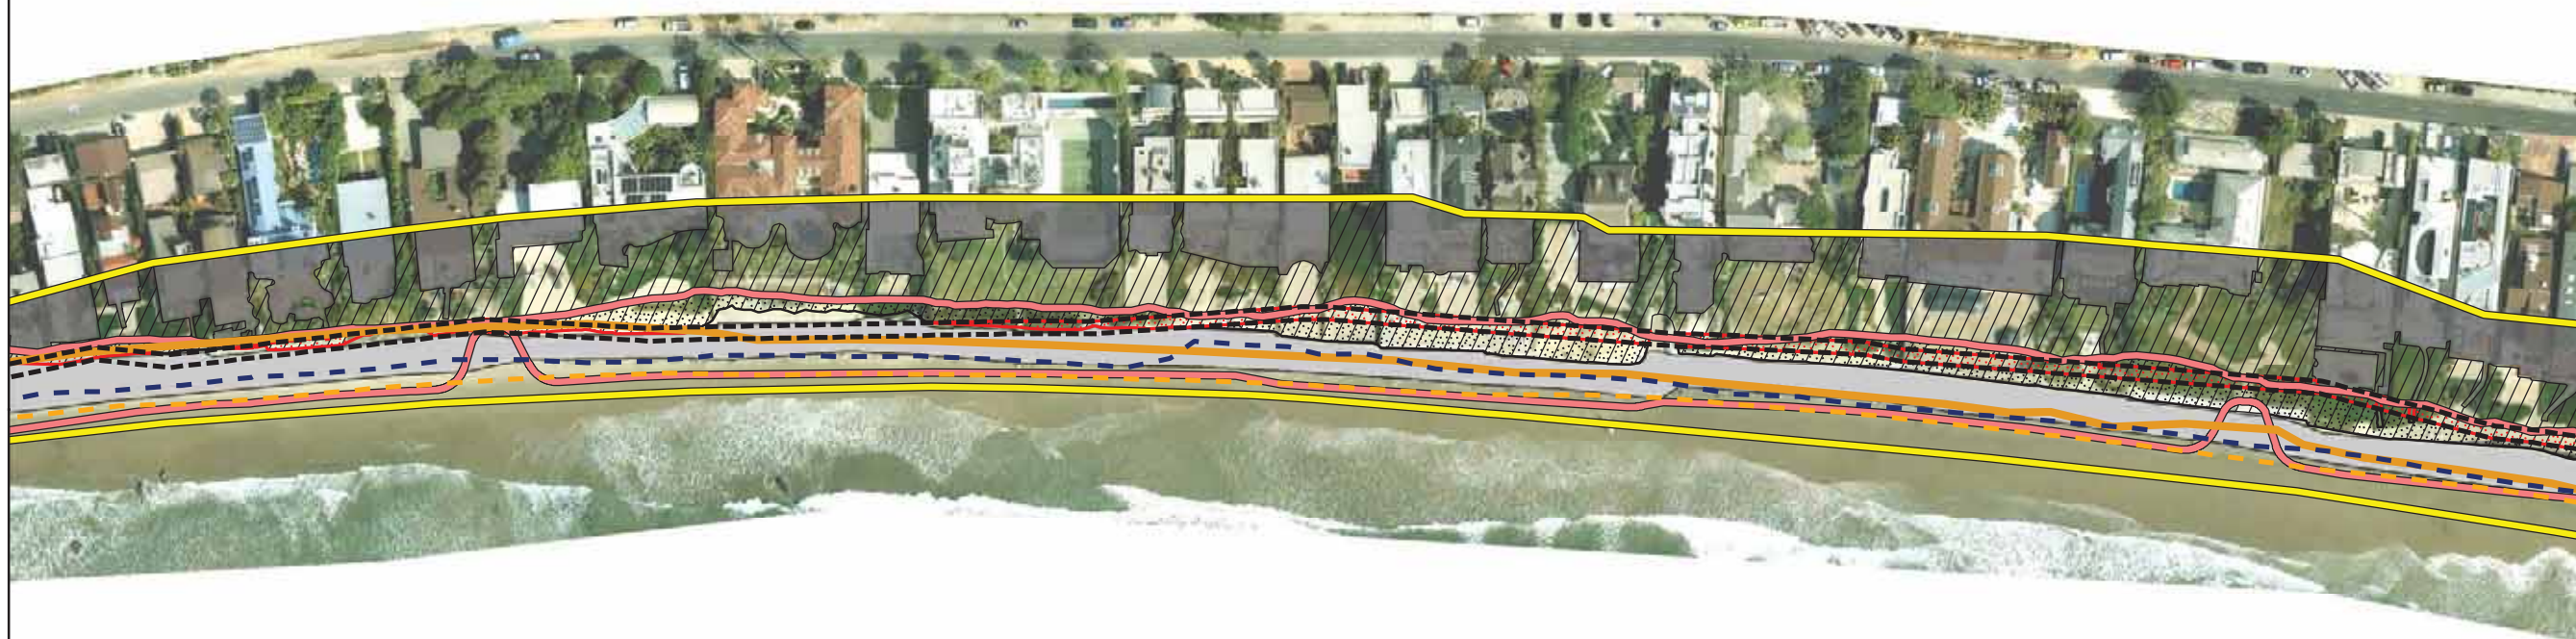
Figure 12-1c.

Potential Impacts to
Foredune Habitat
Under Alternative 3A
Relative to 2013
Existing Conditions

* Remnant foredune habitat remaining after installation of Pre-2010 Shoreline Protection Structures and 2010 Emergency Rock Revetment, including areas of pocket cove formation where revetment materials were not installed or were installed but failed.
 **Temporary impacts are due to enhancement of existing degraded foredune habitat. Permanent impacts are due to installation of seawall and associated rock apron in existing degraded foredune habitat (2010 extent).

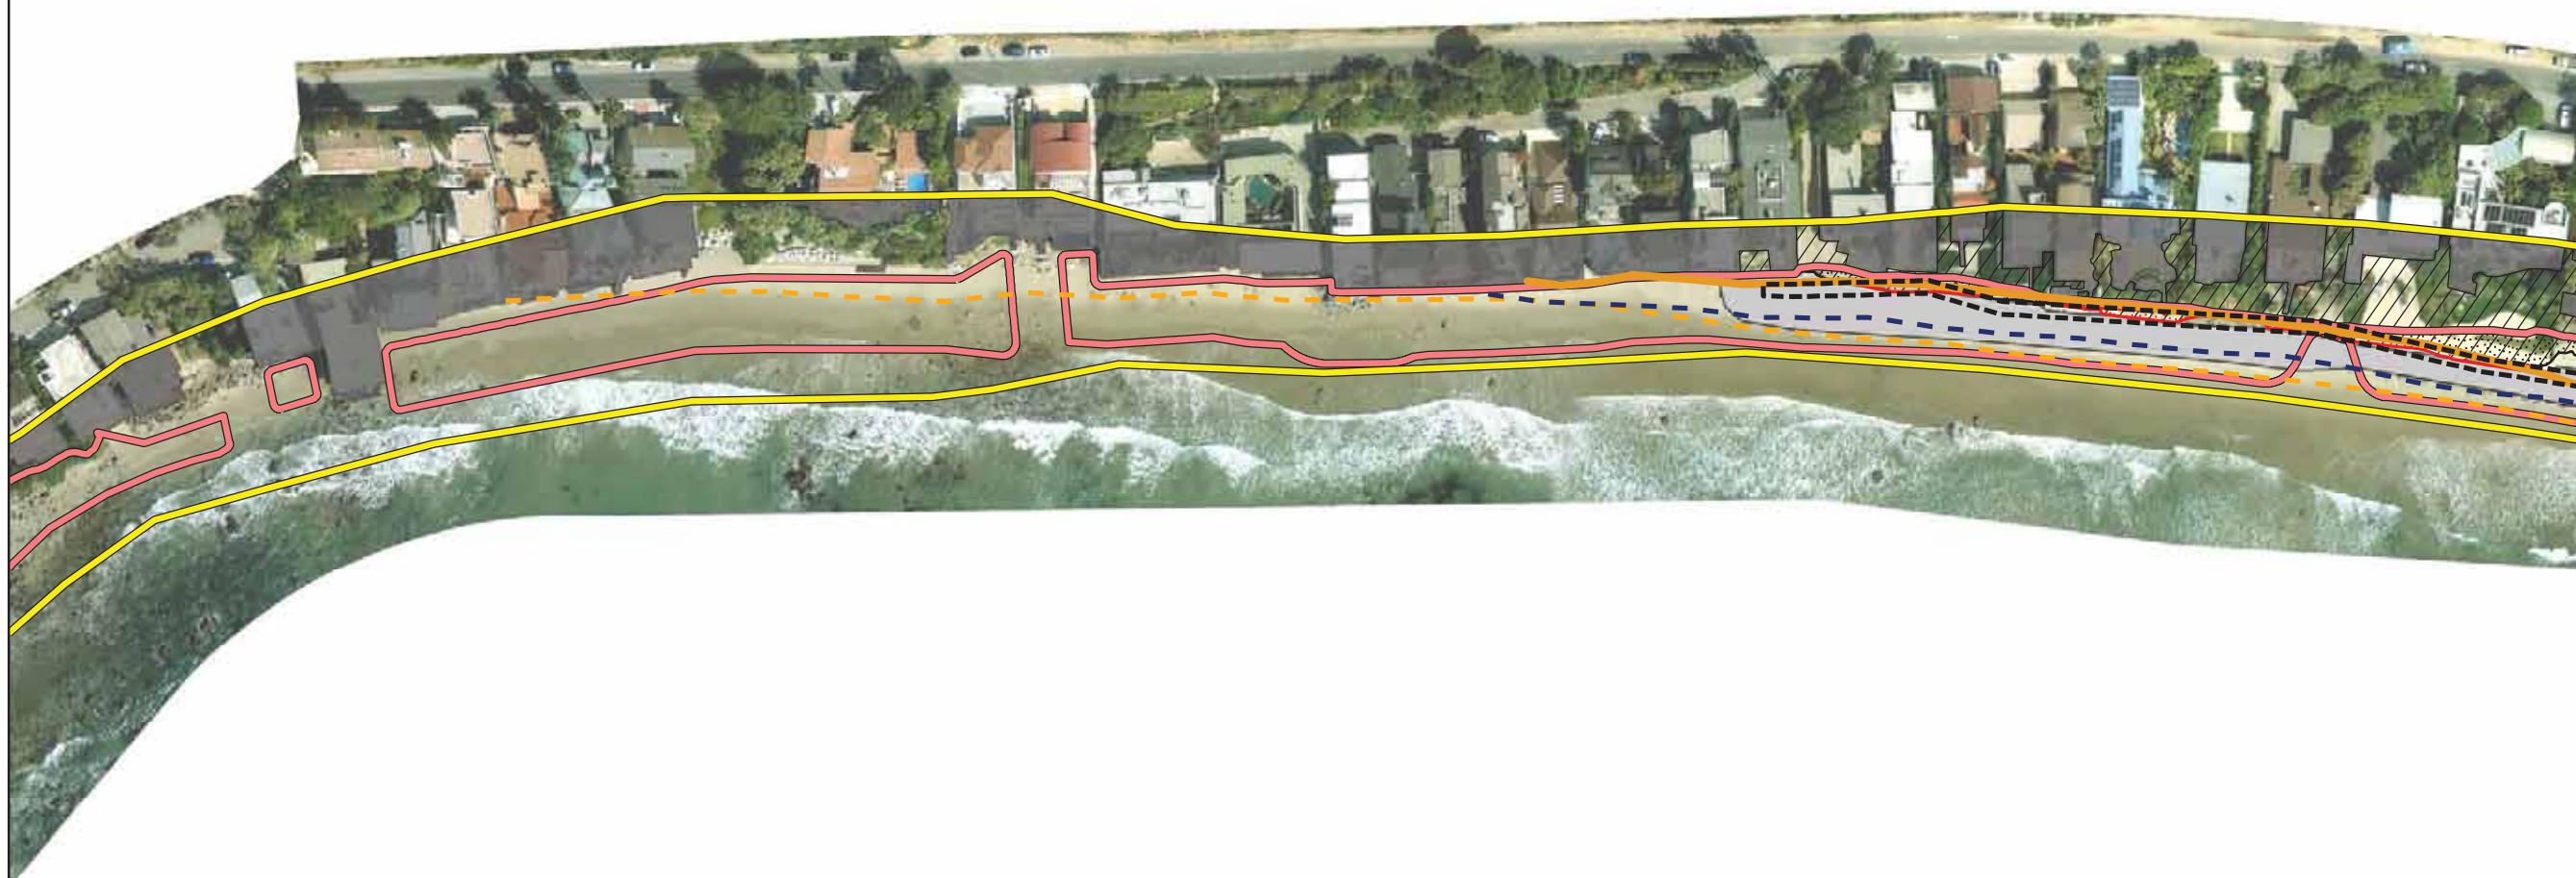
Figure 12-1d.

Potential Impacts to
Foredune Habitat
Under Alternative 3A
Relative to 2013
Existing Conditions

- Study Area
- MHTL - JAN 19-20, 2010
- MHTL - OCT 15, 2009
- June 2005 Beach/Foredune Escarpment Line
- Development Footprint
- 2010 Emergency Rock Revetment
- Proposed Dune Restoration Footprint (7.71 acres)
- Alternative 3A Seawall Pull-back Location
- Remnant Foredune Habitat (10.09 acres)*
- Potential Impacts to Remnant Foredune Habitat****
- Temporary Impacts (2.58 acres)
- Permanent Impacts (0.90 acre)

* Remnant foredune habitat remaining after installation of Pre-2010 Shoreline Protection Structures and 2010 Emergency Rock Revetment, including areas of pocket cove formation where revetment materials were not installed or were installed but failed.
 **Temporary impacts are due to enhancement of existing degraded foredune habitat. Permanent impacts are due to installation of seawall and associated rock apron in existing degraded foredune habitat (2010 extent).

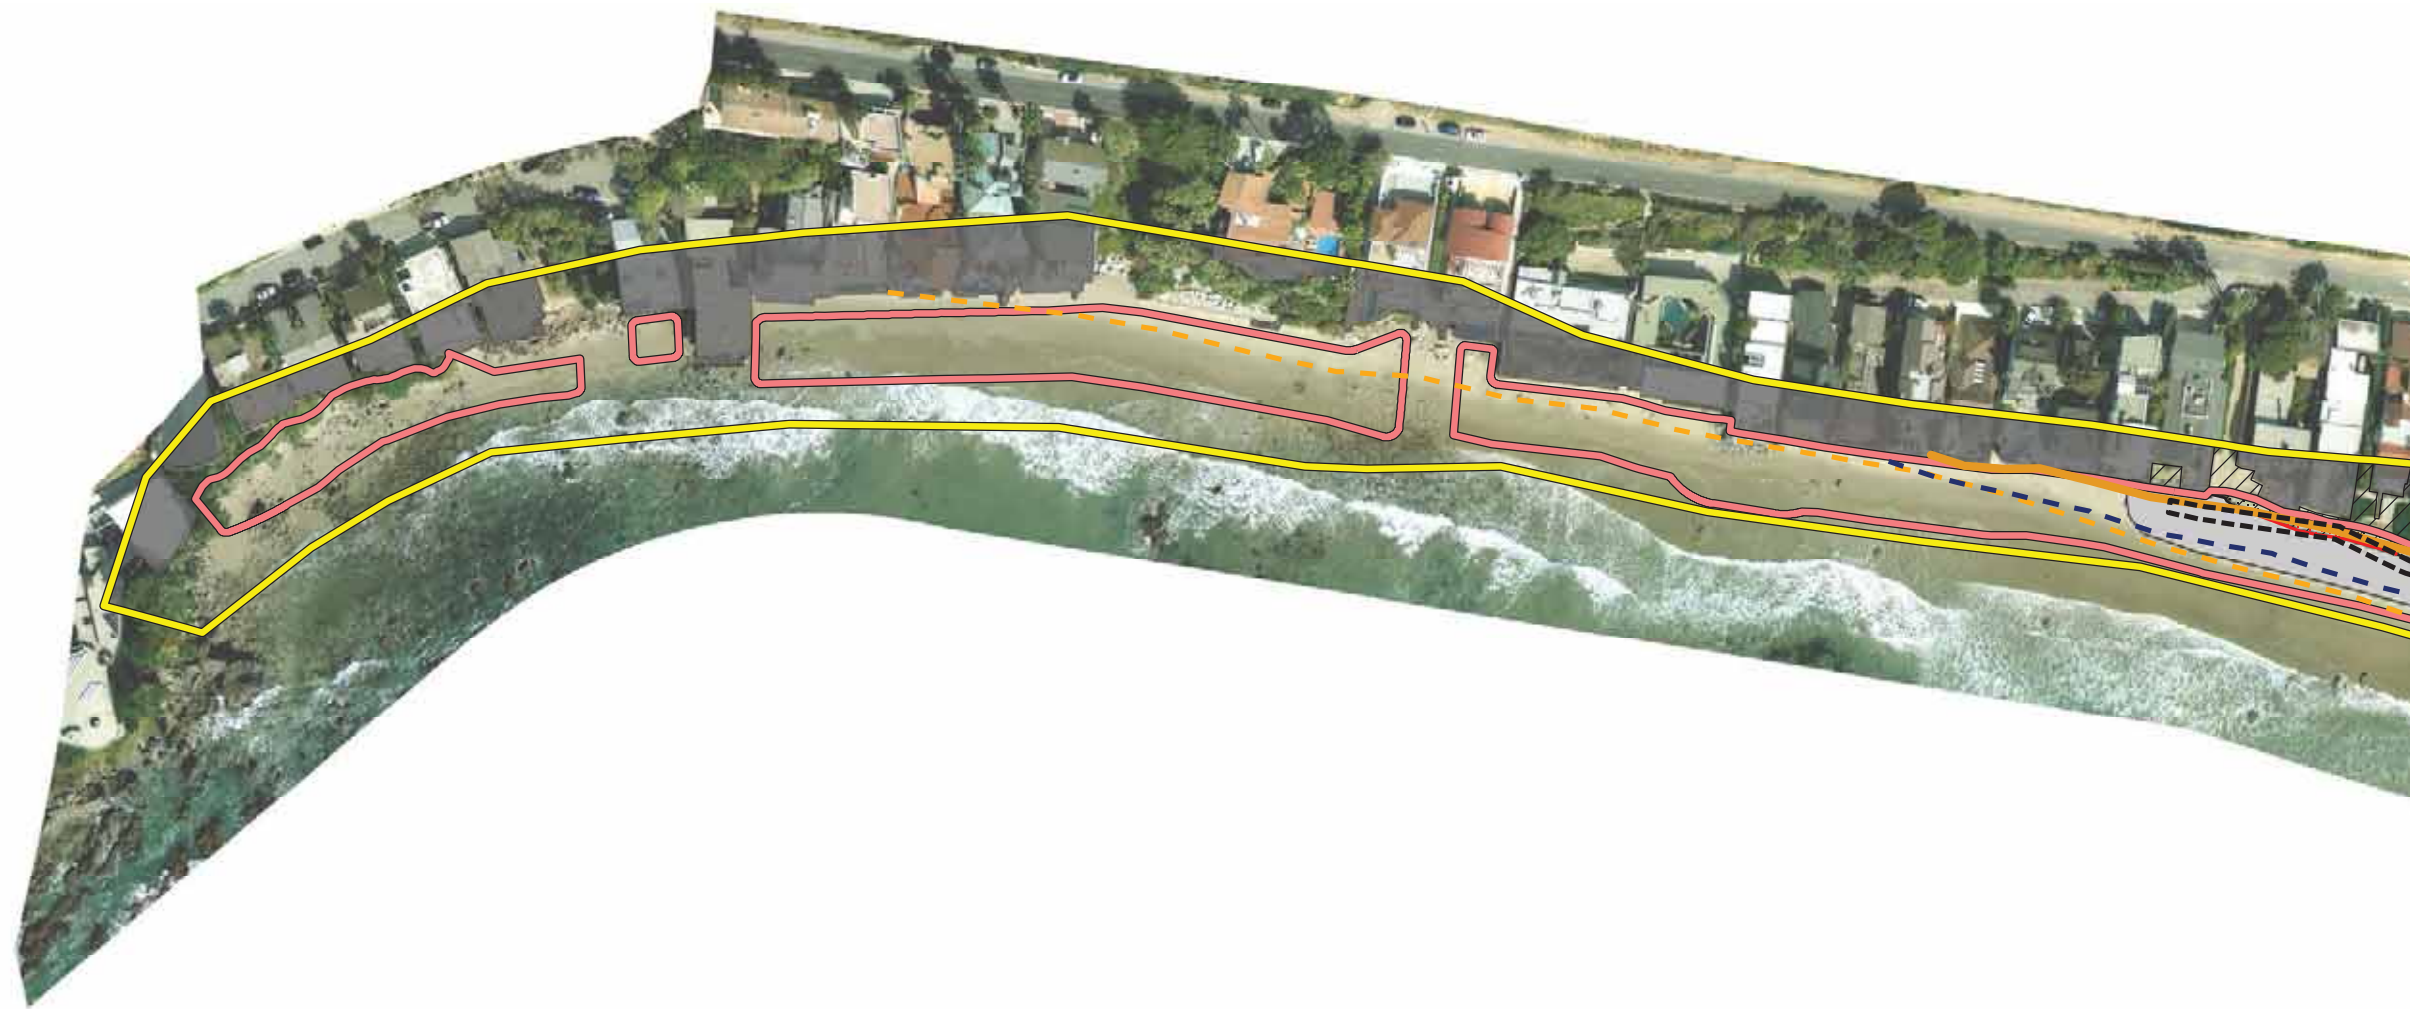
Figure 12-1e.

Potential Impacts to
Foredune Habitat
Under Alternative 3A
Relative to 2013
Existing Conditions

* Remnant foredune habitat remaining after installation of Pre-2010 Shoreline Protection Structures and 2010 Emergency Rock Revetment, including areas of pocket cove formation where revetment materials were not installed or were installed but failed.

**Temporary impacts are due to enhancement of existing degraded foredune habitat. Permanent impacts are due to installation of seawall and associated rock apron in existing degraded foredune habitat (2010 extent).

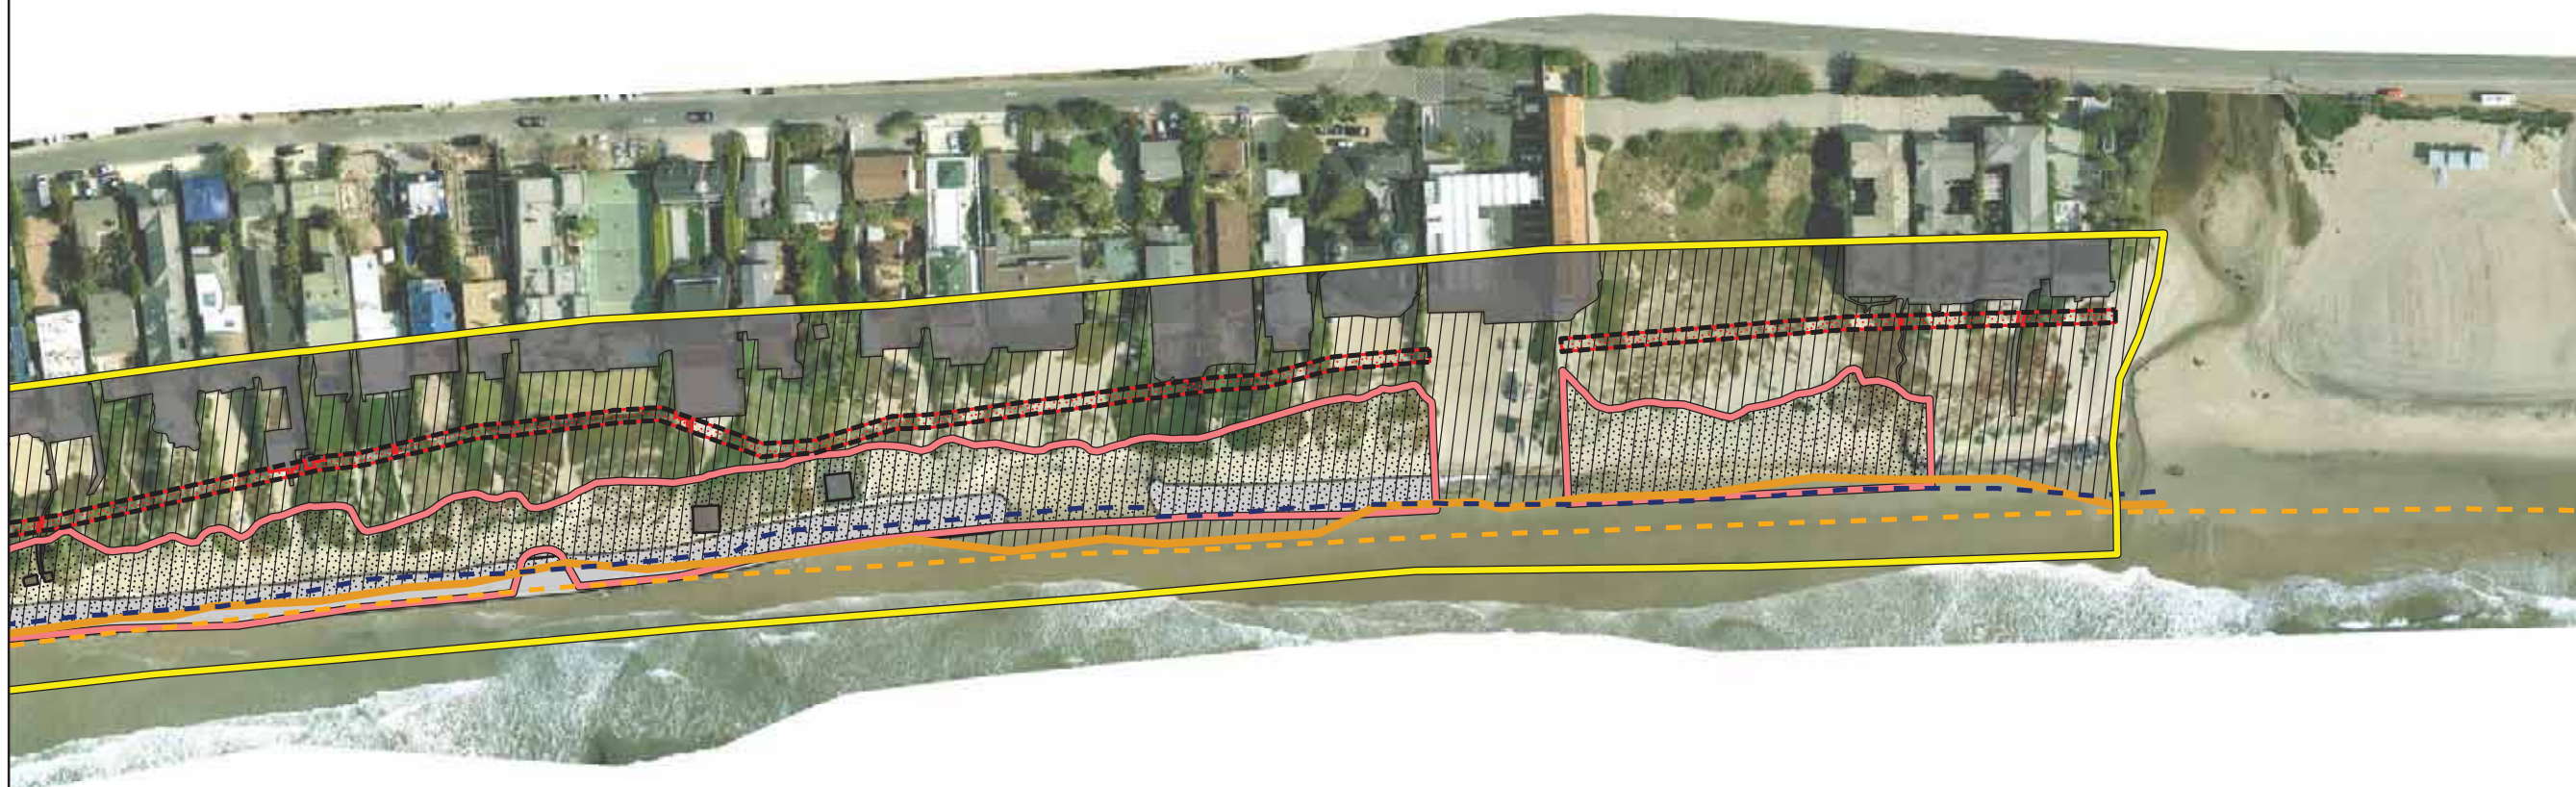
Potential Impacts to
Foredune Habitat
Under Alternative 3A
Relative to 2005
Baseline Conditions

- Study Area
- MHTL - JAN 19-20, 2010
- MHTL - OCT 15, 2009
- June 2005 Beach/Foredune Escarpment Line
- Development Footprint
- 2010 Emergency Rock Revetment
- Proposed Dune Restoration Footprint (7.71 acres)
- Alternative 3A Seawall Pull-back Location
- Remnant Foredune Habitat (12.23 acres)*
- Potential Impacts to Remnant Foredune Habitat****
- Temporary Impacts (4.41 acres)
- Permanent Impacts (0.92 acre)

* Remnant foredune habitat based on 2005 foredune extent shown in Figure 2.

** Temporary impacts are due to revetment removal or enhancement of existing degraded foredune habitat. Permanent impacts are due to installation of seawall and associated rock apron in existing degraded foredune habitat (2005 extent).

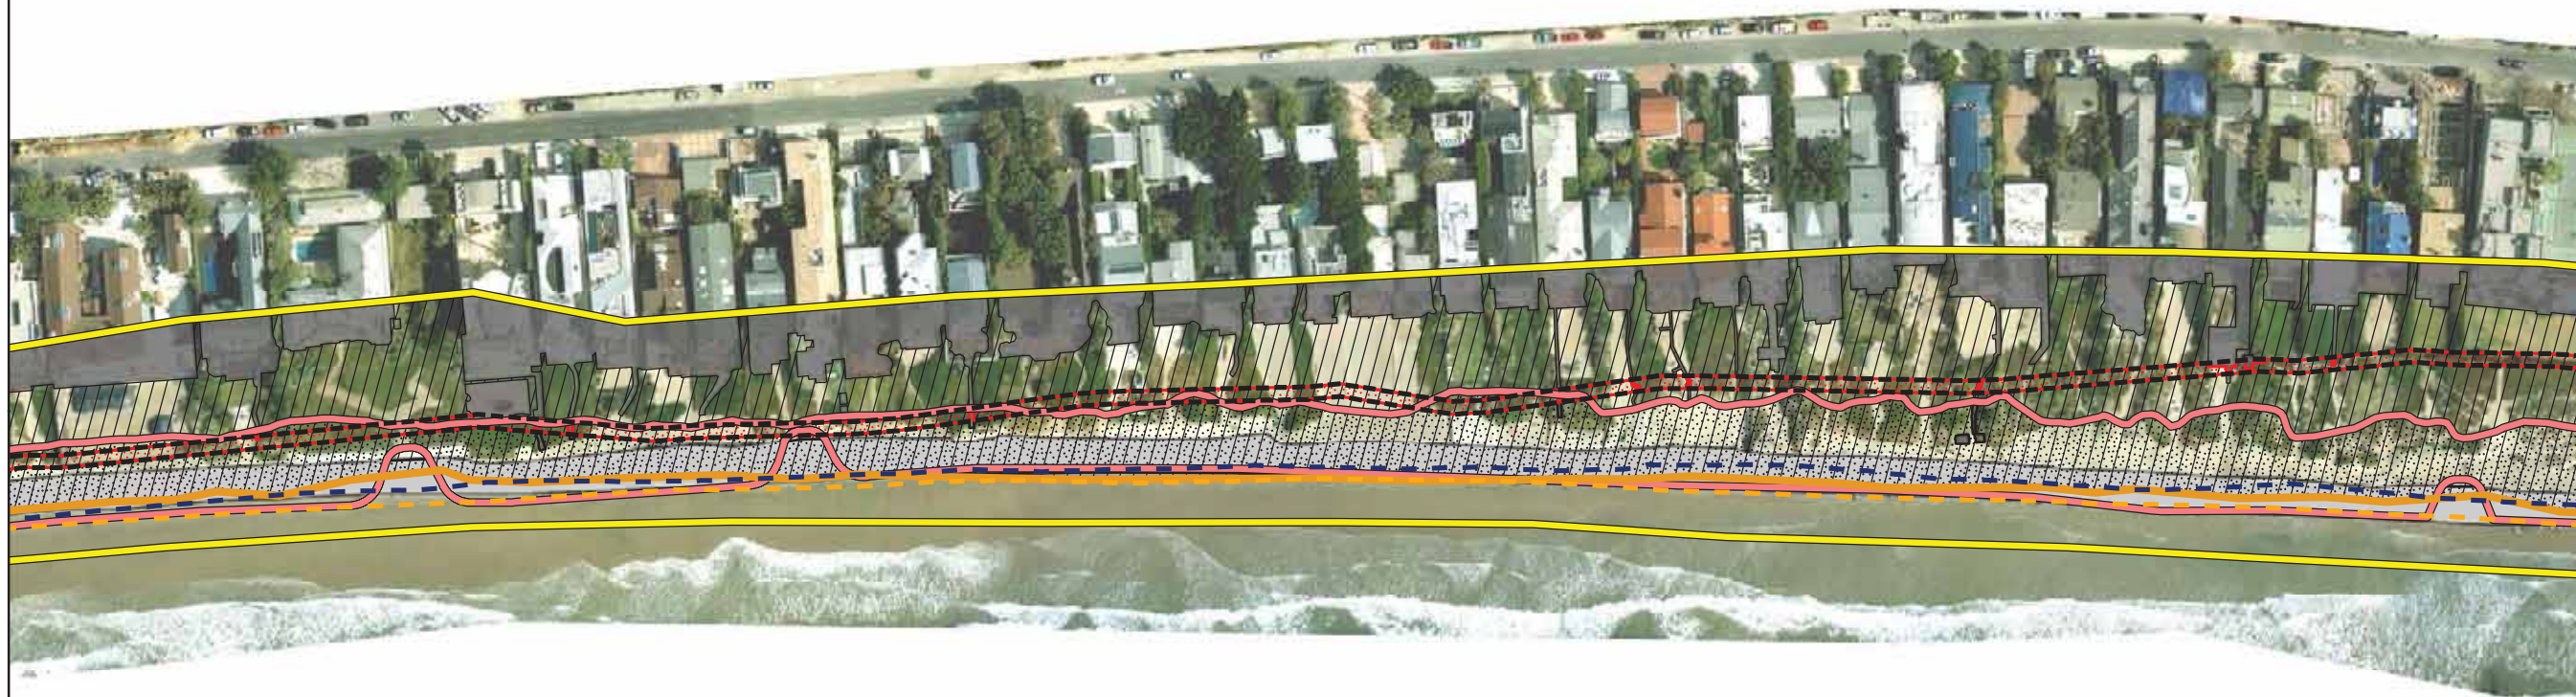
Potential Impacts to
Foredune Habitat
Under Alternative 3A
Relative to 2005
Baseline Conditions

* Remnant foredune habitat based on 2005 foredune extent shown in Figure 2.

** Temporary impacts are due to revetment removal or enhancement of existing degraded foredune habitat. Permanent impacts are due to installation of seawall and associated rock apron in existing degraded foredune habitat (2005 extent).

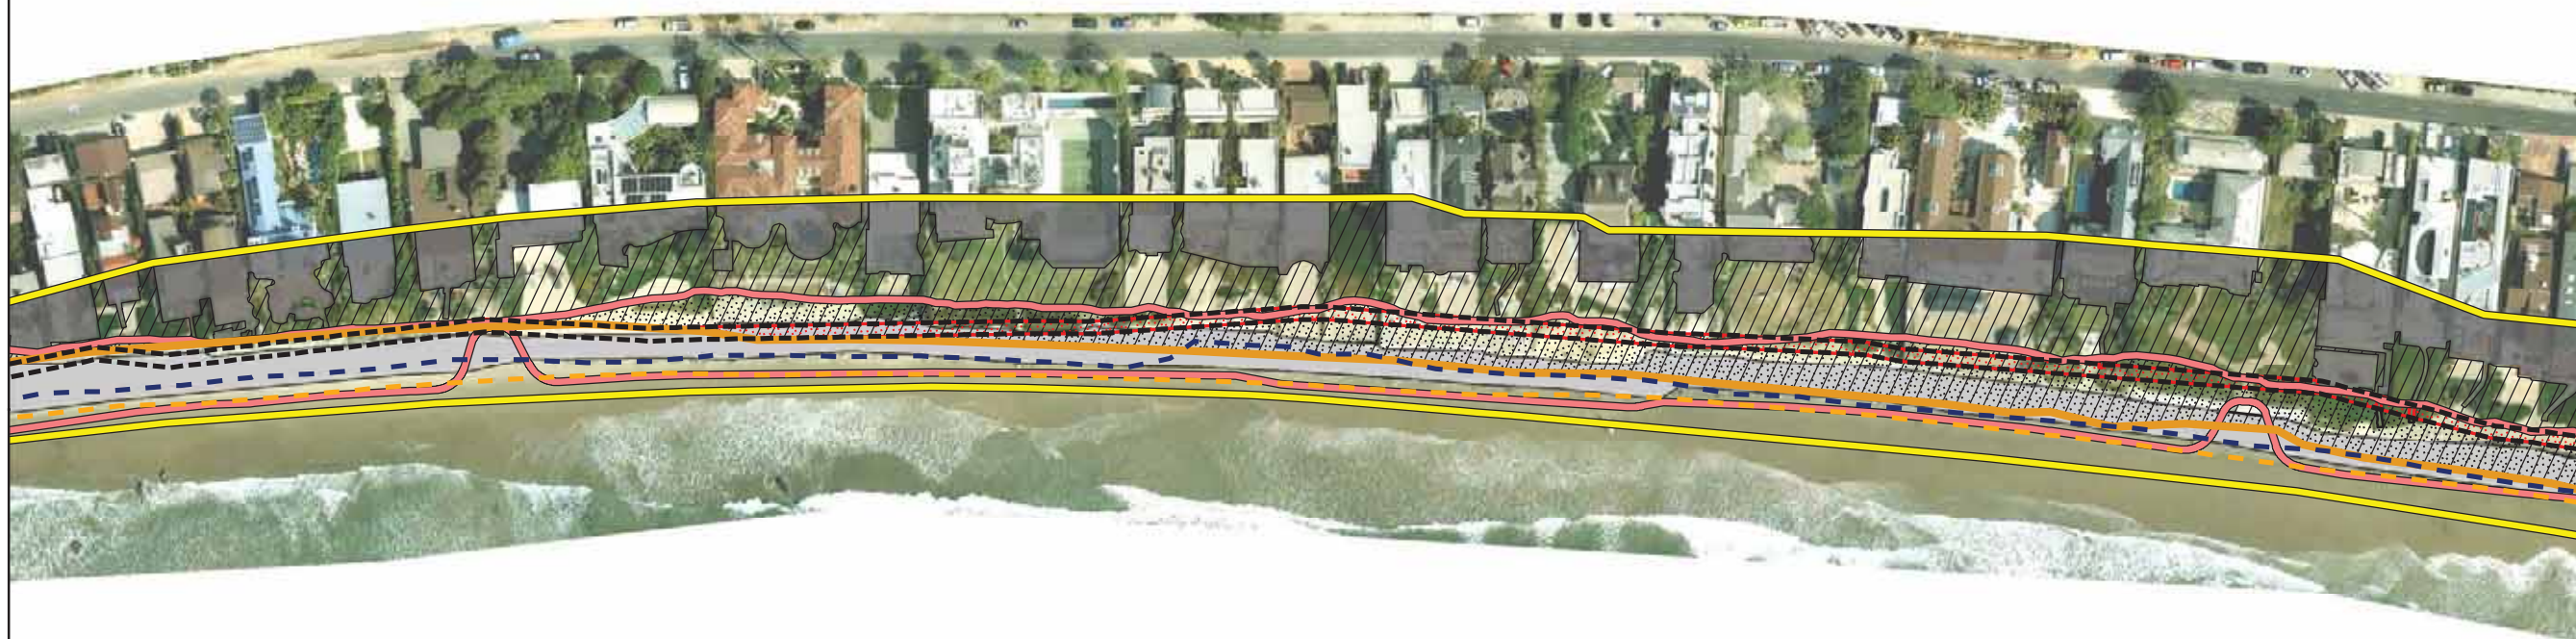
Potential Impacts to
Foredune Habitat
Under Alternative 3A
Relative to 2005
Baseline Conditions

* Remnant foredune habitat based on 2005 foredune extent shown in Figure 2.

** Temporary impacts are due to revetment removal or enhancement of existing degraded foredune habitat. Permanent impacts are due to installation of seawall and associated rock apron in existing degraded foredune habitat (2005 extent).

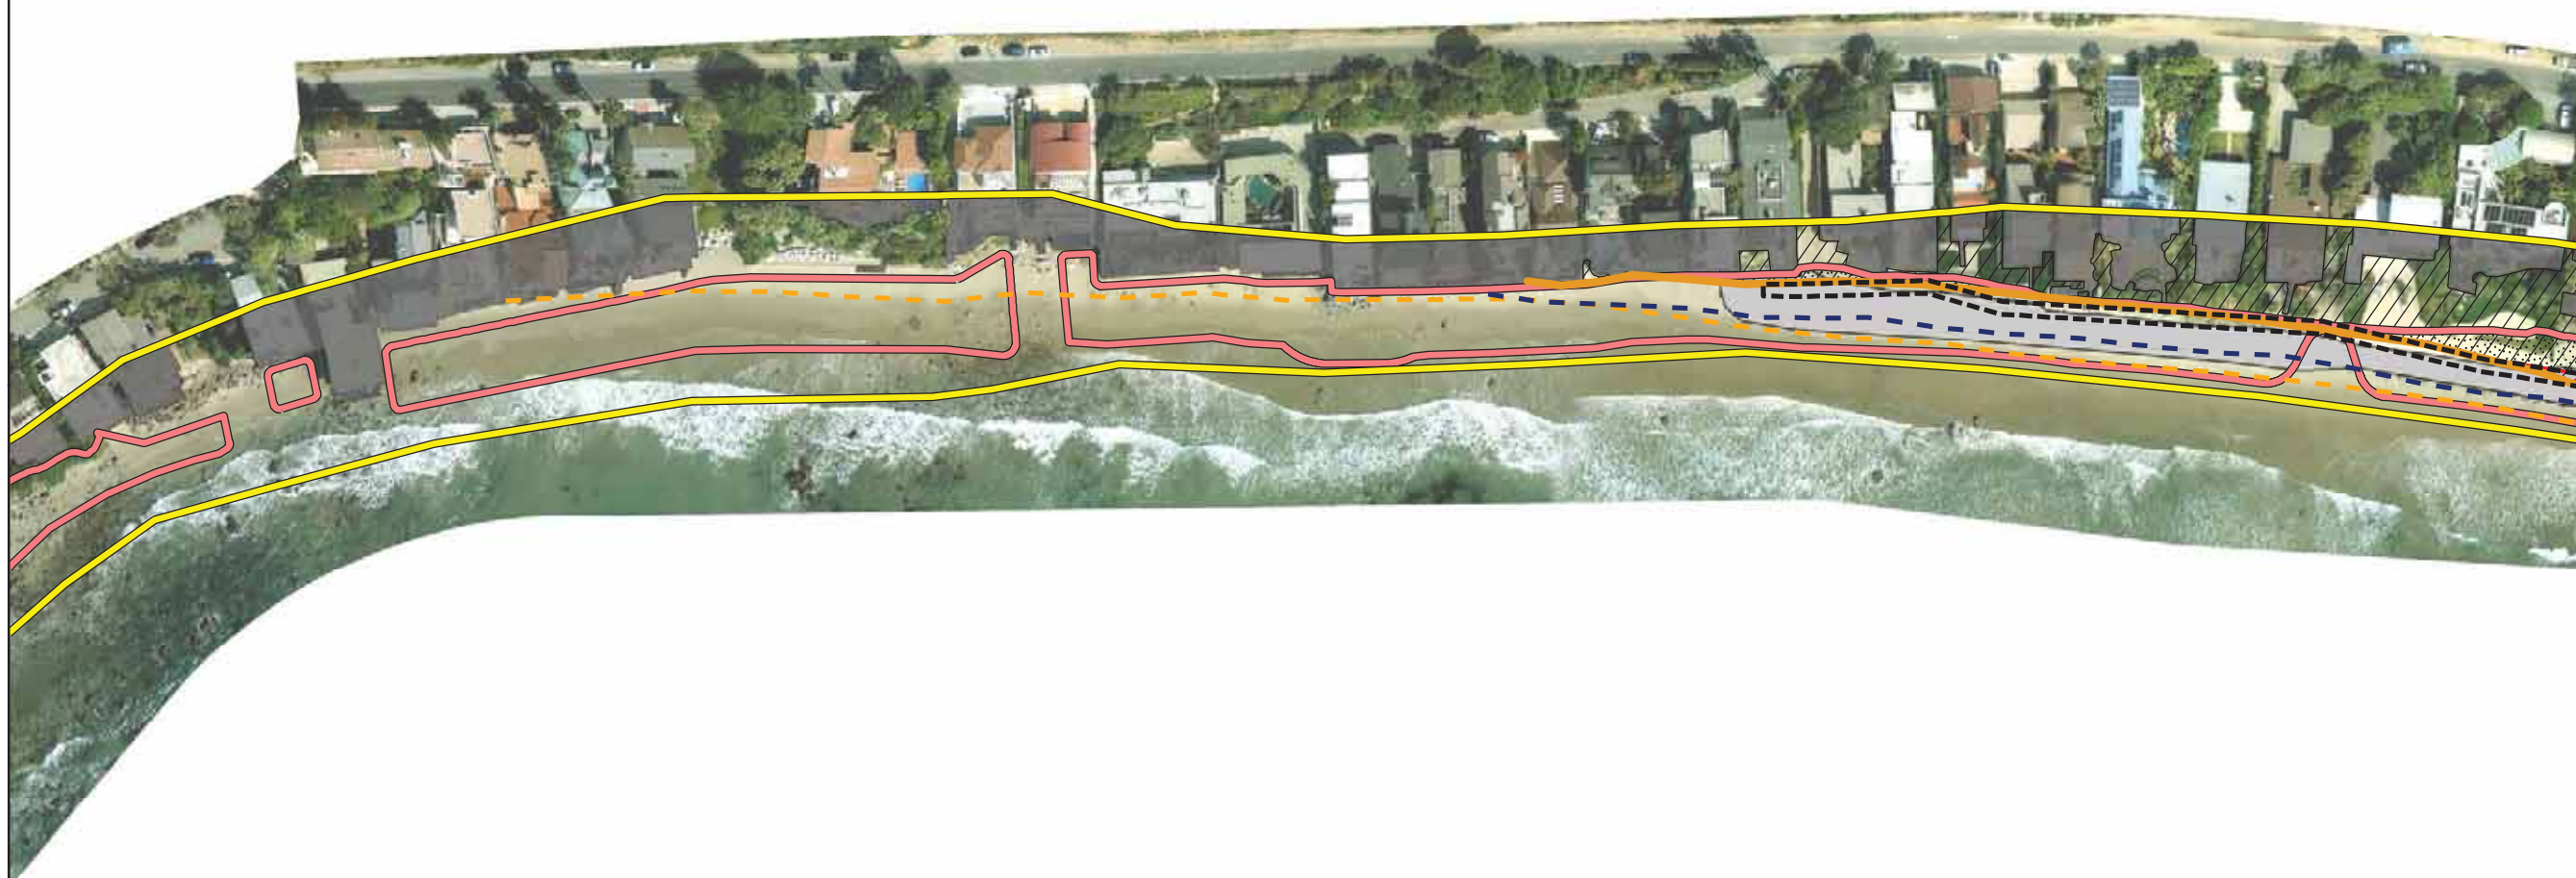
Potential Impacts to
Foredune Habitat
Under Alternative 3A
Relative to 2005
Baseline Conditions

- Study Area
- MHTL - JAN 19-20, 2010
- MHTL - OCT 15, 2009
- June 2005 Beach/Foredune Escarpment Line
- Development Footprint
- 2010 Emergency Rock Revetment
- Proposed Dune Restoration Footprint (7.71 acres)
- Alternative 3A Seawall Pull-back Location
- Remnant Foredune Habitat (12.23 acres)*
- Potential Impacts to Remnant Foredune Habitat****
- Temporary Impacts (4.41 acres)
- Permanent Impacts (0.92 acre)

* Remnant foredune habitat based on 2005 foredune extent shown in Figure 2.

** Temporary impacts are due to revetment removal or enhancement of existing degraded foredune habitat. Permanent impacts are due to installation of seawall and associated rock apron in existing degraded foredune habitat (2005 extent).

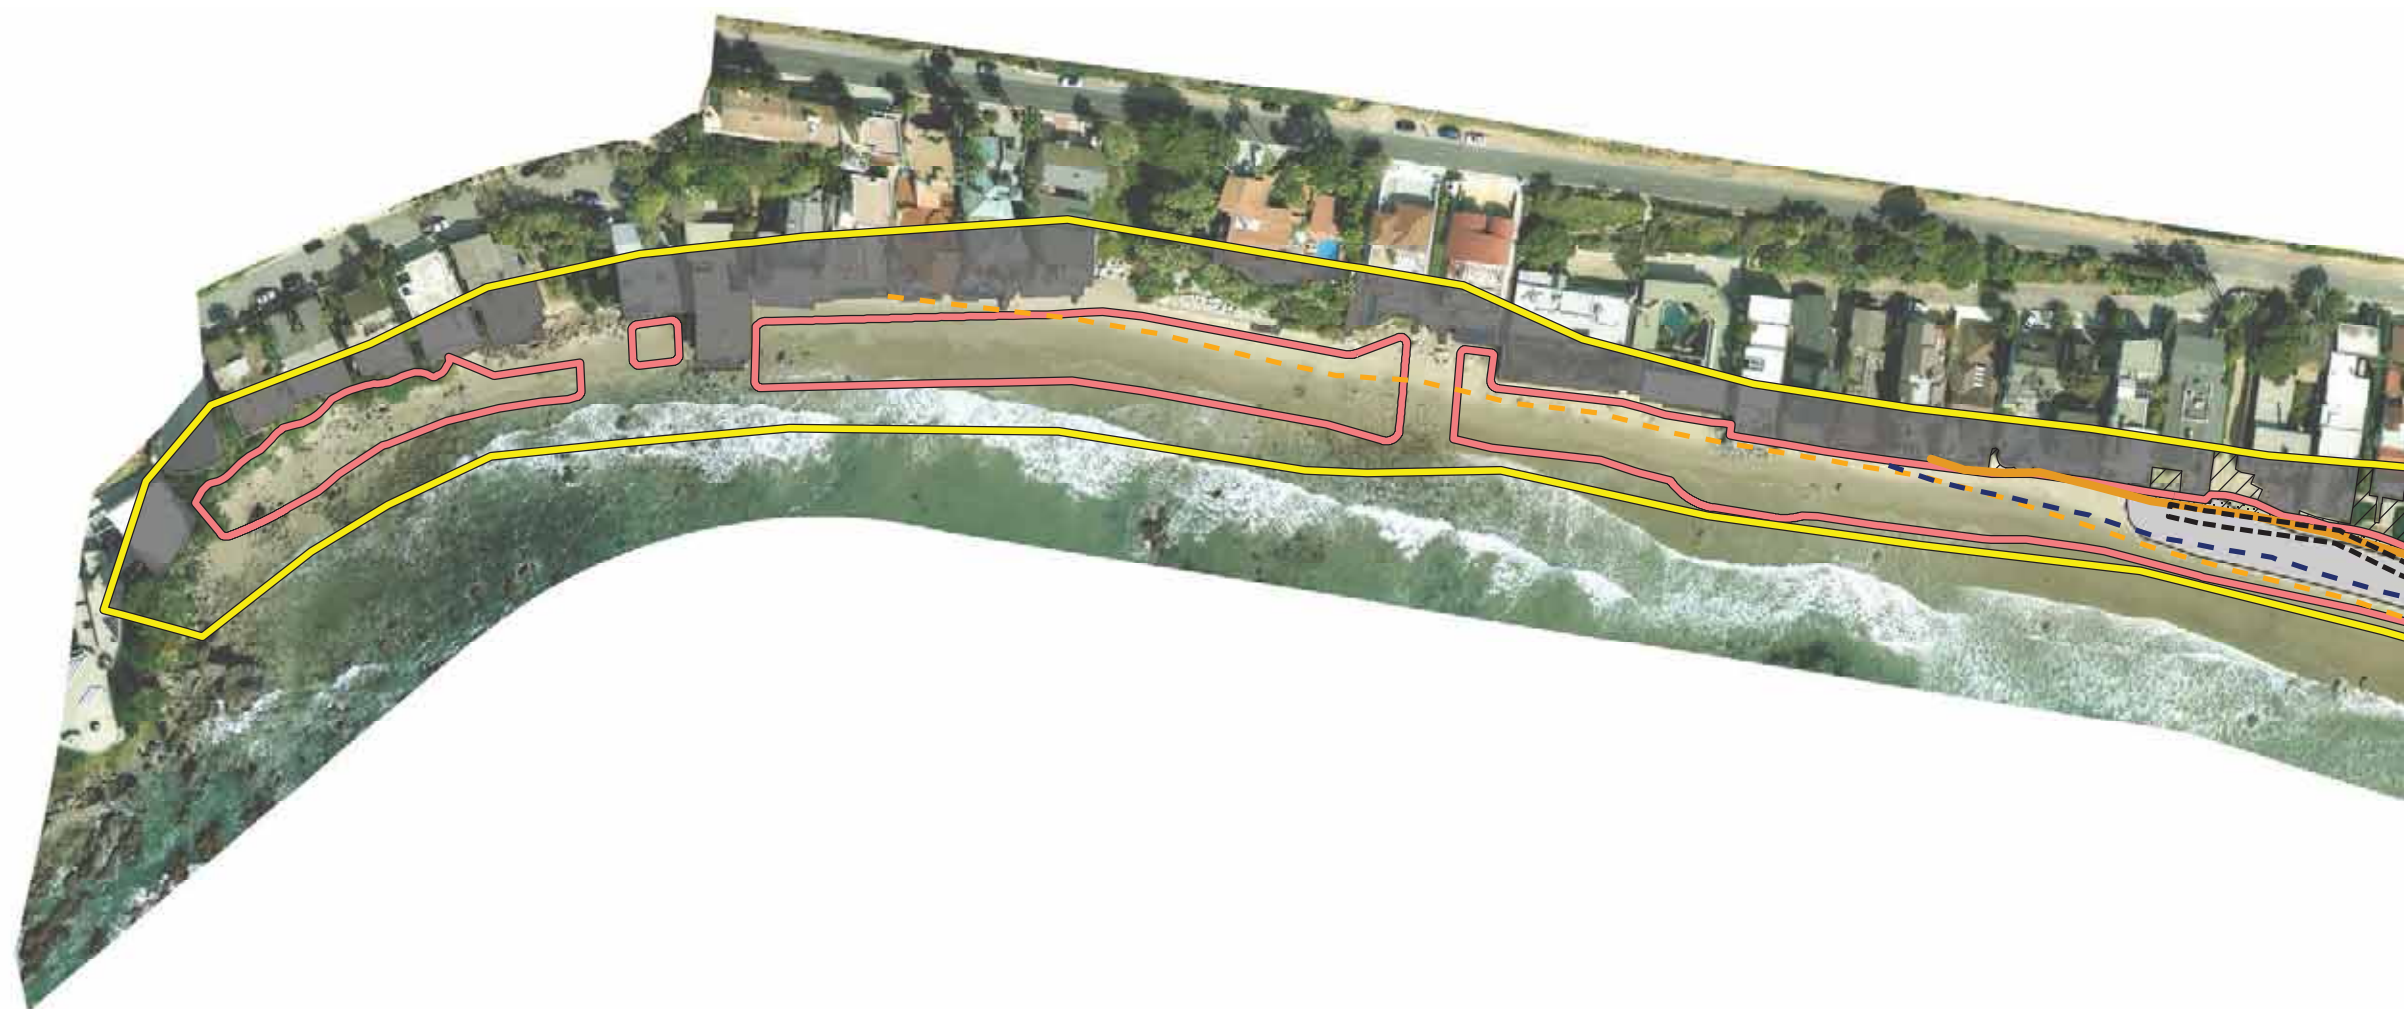
Potential Impacts to
Foredune Habitat
Under Alternative 3A
Relative to 2005
Baseline Conditions

- Study Area
- MHTL - JAN 19-20, 2010
- MHTL - OCT 15, 2009
- June 2005 Beach/Foredune Escarpment Line
- Development Footprint
- 2010 Emergency Rock Revetment
- Proposed Dune Restoration Footprint (7.71 acres)
- Alternative 3A Seawall Pull-back Location
- Remnant Foredune Habitat (12.23 acres)*
- Potential Impacts to Remnant Foredune Habitat****
- Temporary Impacts (4.41 acres)
- Permanent Impacts (0.92 acre)

* Remnant foredune habitat based on 2005 foredune extent shown in Figure 2.

** Temporary impacts are due to revetment removal or enhancement of existing degraded foredune habitat. Permanent impacts are due to installation of seawall and associated rock apron in existing degraded foredune habitat (2005 extent).

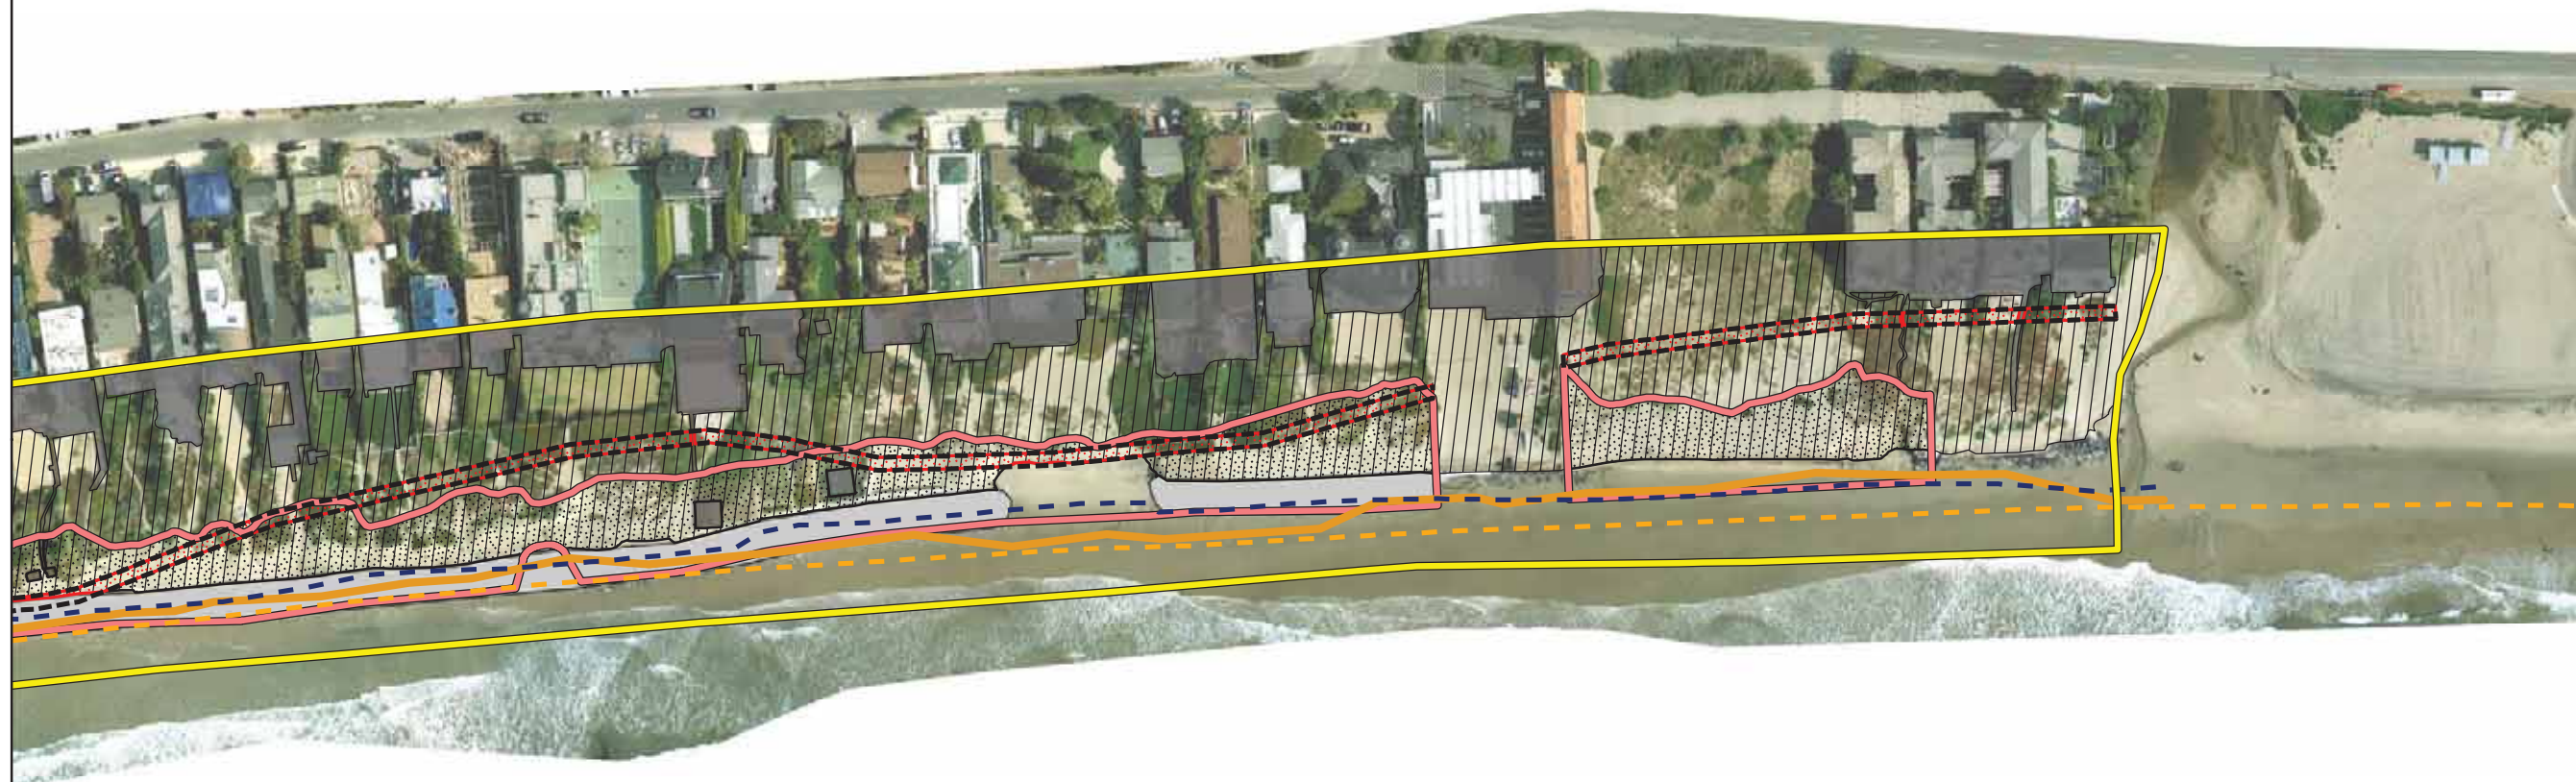
Potential Impacts to
Foredune Habitat
Under Alternative 3B
Relative to 2013
Existing Conditions

- Study Area
- MHTL - JAN 19-20, 2010
- MHTL - OCT 15, 2009
- June 2005 Beach/Foredune Escarpment Line
- Development Footprint
- 2010 Emergency Rock Revetment
- Proposed Dune Restoration Footprint (7.71 acres)
- Alternative 3B Seawall Pull-back Location
- Remnant Foredune Habitat (10.09 acres)*
- Potential Impacts to Remnant Foredune Habitat****
- Temporary Impacts (2.73 acres)
- Permanent Impacts (0.41 acre)

* Remnant foredune habitat remaining after installation of Pre-2010 Shoreline Protection Structures and 2010 Emergency Rock Revetment, including areas of pocket cove formation where revetment materials were not installed or were installed but failed.
 ** Temporary impacts are due to enhancement of existing degraded foredune habitat. Permanent impacts are due to installation of seawall and associated rock apron in existing degraded foredune habitat (2010 extent).
