Memorandum

Subject: Broad Beach Foredune Impact Analysis

This memorandum provides an assessment of the impacts to foredune habitat that may have occurred or that could occur as a result of previous and proposed shoreline stabilization efforts at Broad Beach. This material is intended to support the application for a California Coastal Commission (“CCC”) Coastal Development Permit (“CDP”) for the proposed Broad Beach Restoration Project located in Malibu, Los Angeles County, California (“Study Area”; Figure 1). The information included here is based on inferred historical conditions, observed current conditions, and predicted future conditions at Broad Beach. As noted in the previous CDP submittals for the project, detailed records of historical habitat conditions and shoreline stabilization efforts at Broad Beach are lacking, and much information had to be inferred from historic aerial imagery, a sporadic record of photographs from the site, and comparisons with similar habitats in the region. As such, the analysis presented here is subject to a number of caveats which are presented in the following sections. The analysis follows in six parts, each of which contains (1) an assess

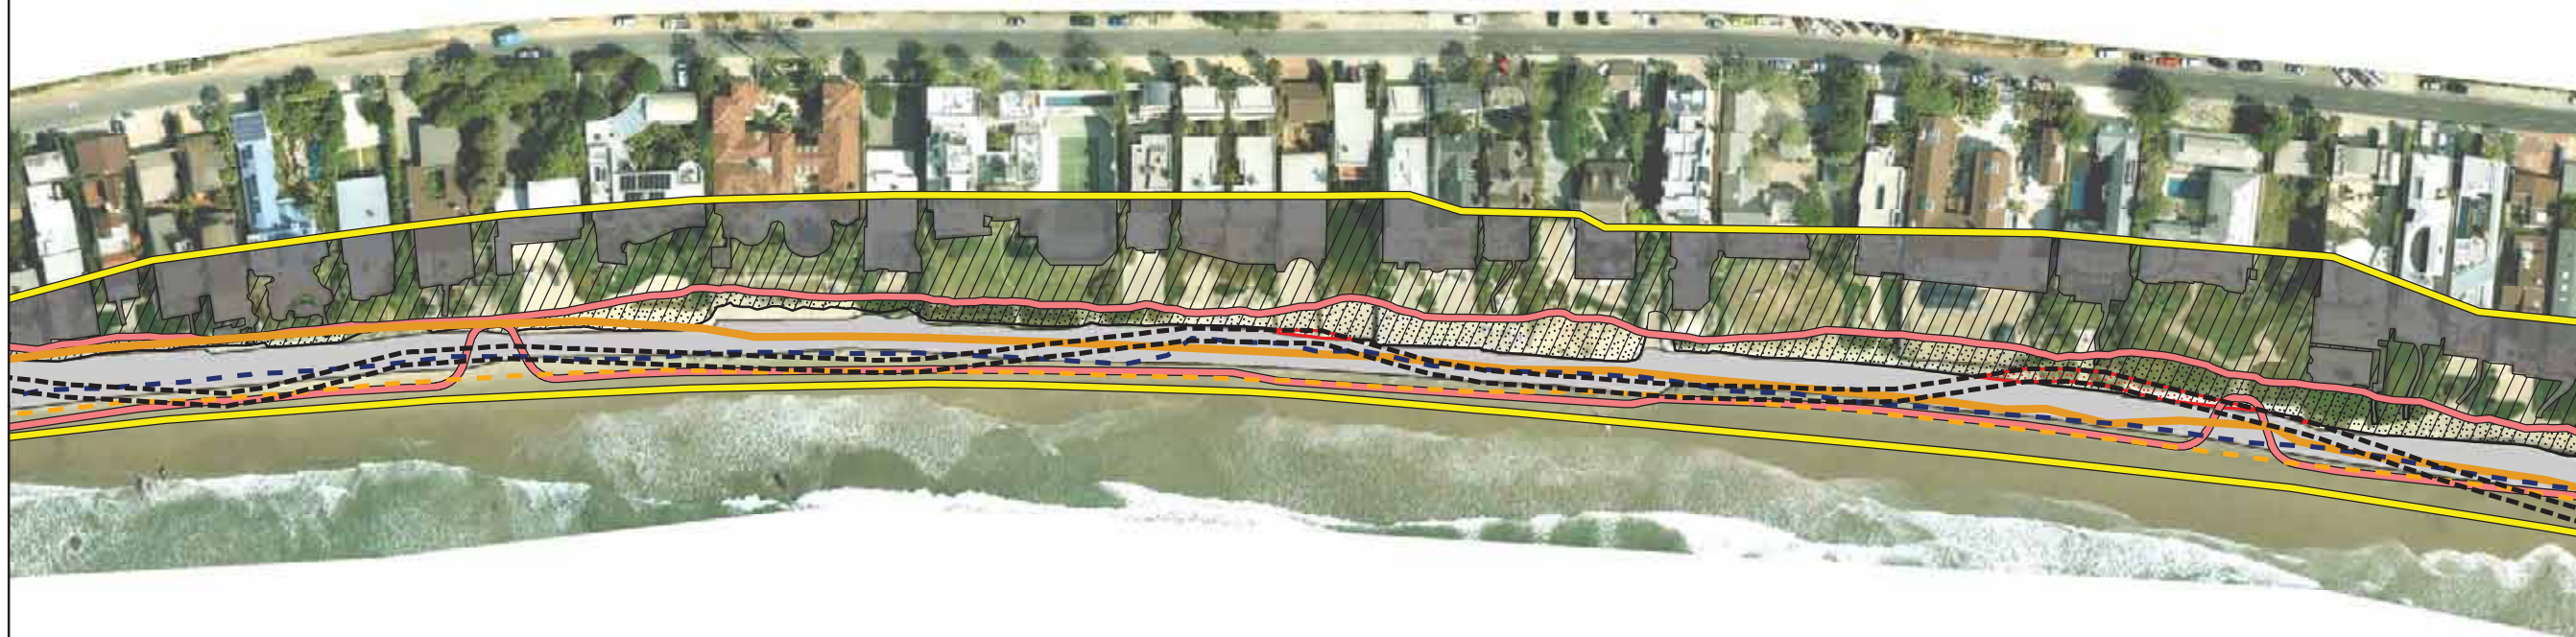
Potential Impacts to
Foredune Habitat
Under Alternative 3B
Relative to 2013
Existing Conditions

* Remnant foredune habitat remaining after installation of Pre-2010 Shoreline Protection Structures and 2010 Emergency Rock Revetment, including areas of pocket cove formation where revetment materials were not installed or were installed but failed.

** Temporary impacts are due to enhancement of existing degraded foredune habitat. Permanent impacts are due to installation of seawall and associated rock apron in existing degraded foredune habitat (2010 extent).

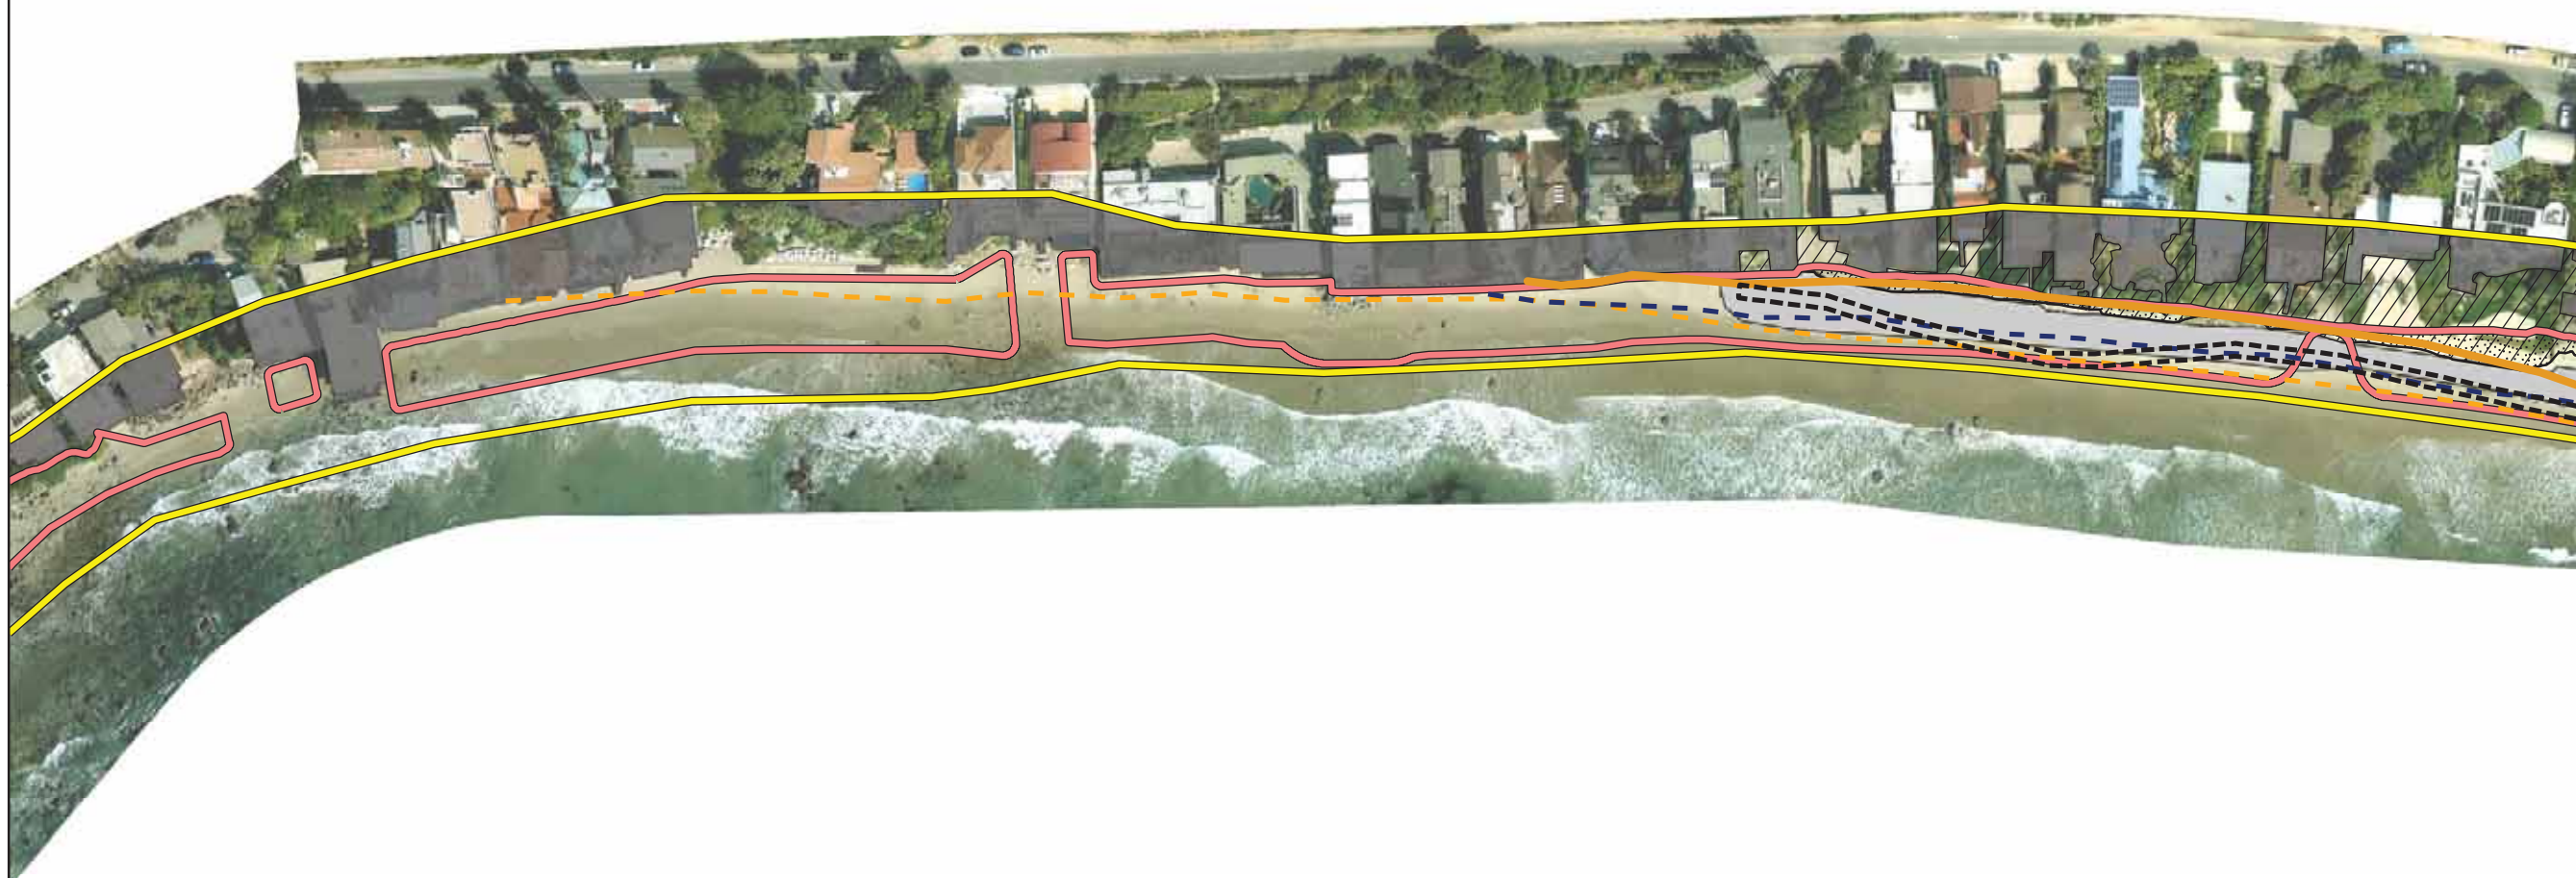
Potential Impacts to
Foredune Habitat
Under Alternative 3B
Relative to 2013
Existing Conditions

- Study Area
- MHTL - JAN 19-20, 2010
- MHTL - OCT 15, 2009
- June 2005 Beach/Foredune Escarpment Line
- Development Footprint
- 2010 Emergency Rock Revetment
- Proposed Dune Restoration Footprint (7.71 acres)
- Alternative 3B Seawall Pull-back Location
- Remnant Foredune Habitat (10.09 acres)*
- Potential Impacts to Remnant Foredune Habitat****
- Temporary Impacts (2.73 acres)
- Permanent Impacts (0.41 acre)

* Remnant foredune habitat remaining after installation of Pre-2010 Shoreline Protection Structures and 2010 Emergency Rock Revetment, including areas of pocket cove formation where revetment materials were not installed or were installed but failed.
 ** Temporary impacts are due to enhancement of existing degraded foredune habitat. Permanent impacts are due to installation of seawall and associated rock apron in existing degraded foredune habitat (2010 extent).

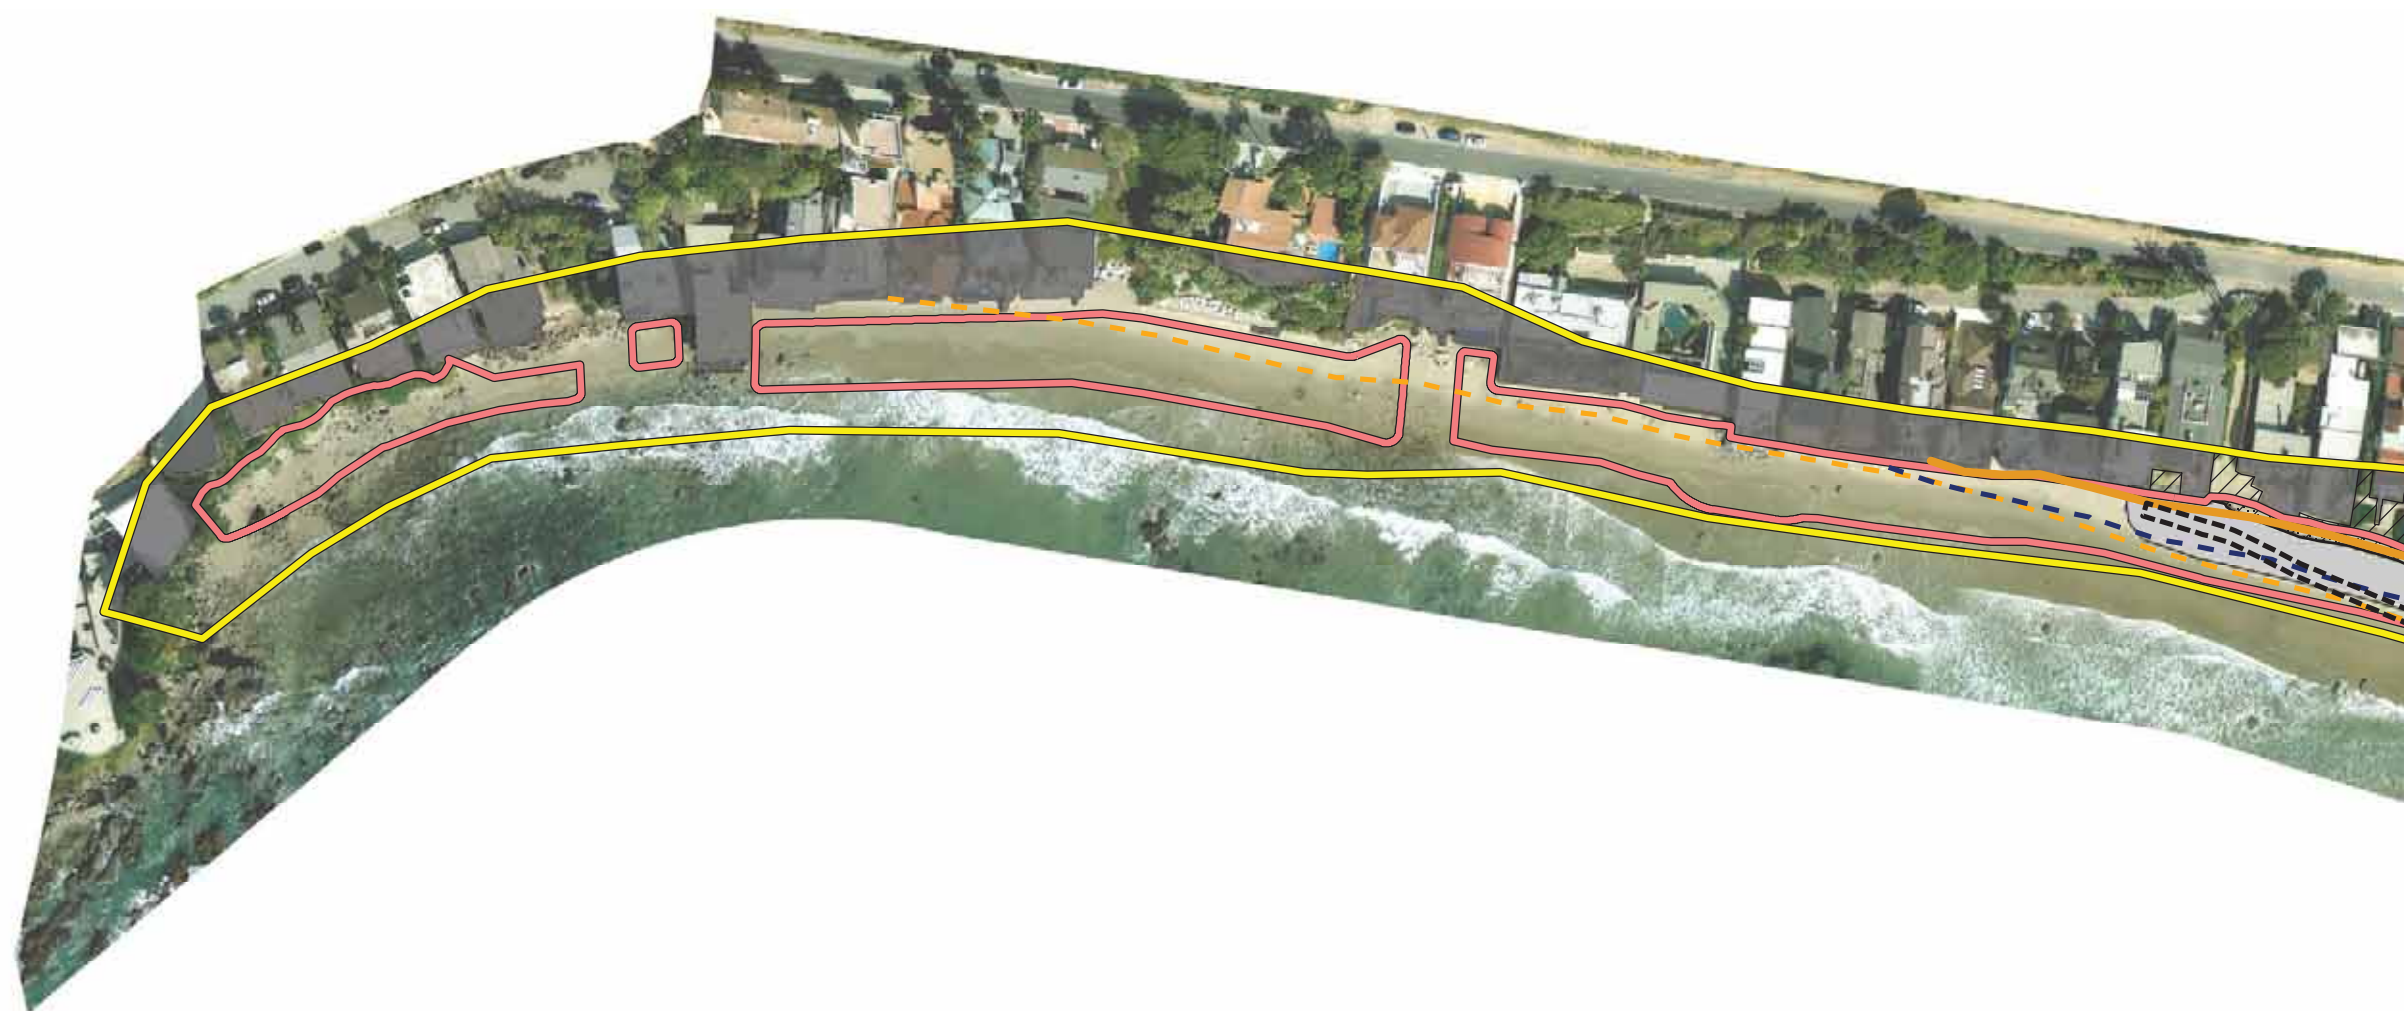
Potential Impacts to
Foredune Habitat
Under Alternative 3B
Relative to 2013
Existing Conditions

* Remnant foredune habitat remaining after installation of Pre-2010 Shoreline Protection Structures and 2010 Emergency Rock Revetment, including areas of pocket cove formation where revetment materials were not installed or were installed but failed.
 ** Temporary impacts are due to enhancement of existing degraded foredune habitat. Permanent impacts are due to installation of seawall and associated rock apron in existing degraded foredune habitat (2010 extent).

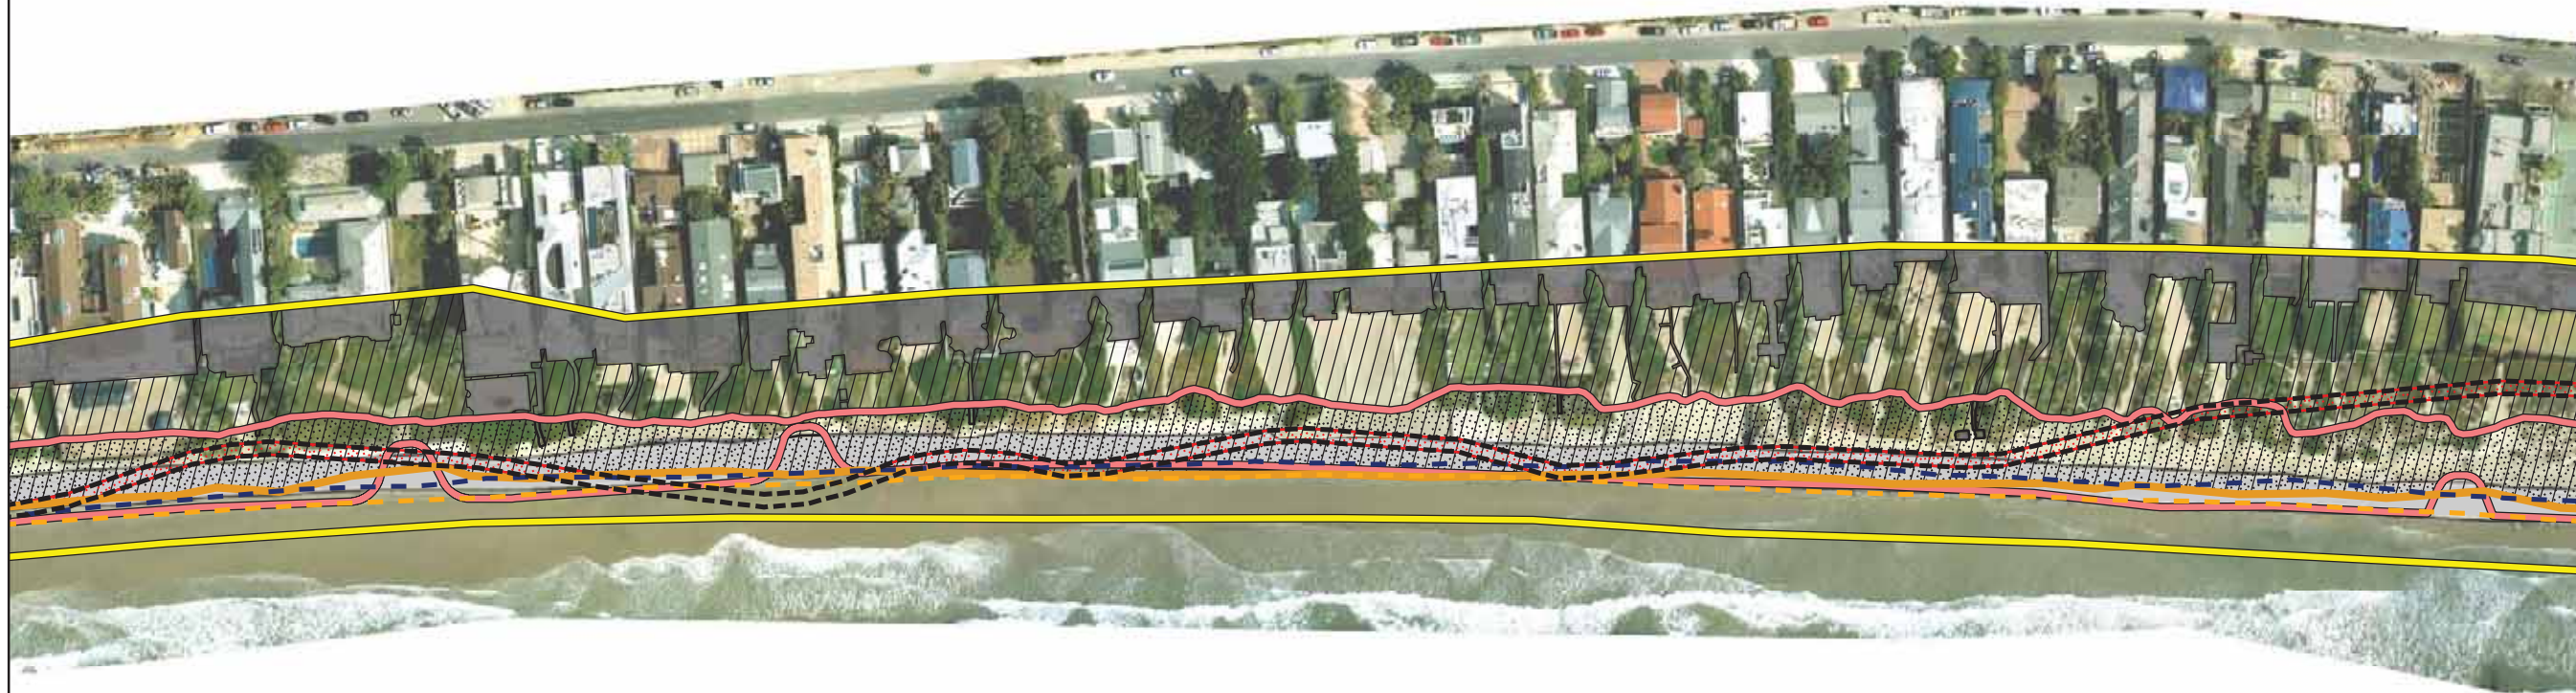
Potential Impacts to
Foredune Habitat
Under Alternative 3B
Relative to 2005
Baseline Conditions

- Study Area
- MHTL - JAN 19-20, 2010
- MHTL - OCT 15, 2009
- June 2005 Beach/Foredune Escarpment Line
- Development Footprint
- 2010 Emergency Rock Revetment
- Proposed Dune Restoration Footprint (7.71 acres)
- Alternative 3B Seawall Pull-back Location
- Remnant Foredune Habitat (12.23 acres)*
- Potential Impacts to Remnant Foredune Habitat****
- Temporary Impacts (4.29 acres)
- Permanent Impacts (0.70 acre)

* Remnant foredune habitat based on 2005 foredune extent shown in Figure 2.

** Temporary impacts are due to revetment removal or enhancement of existing degraded foredune habitat. Permanent impacts are due to installation of seawall and associated rock apron in existing degraded foredune habitat (2005 extent).

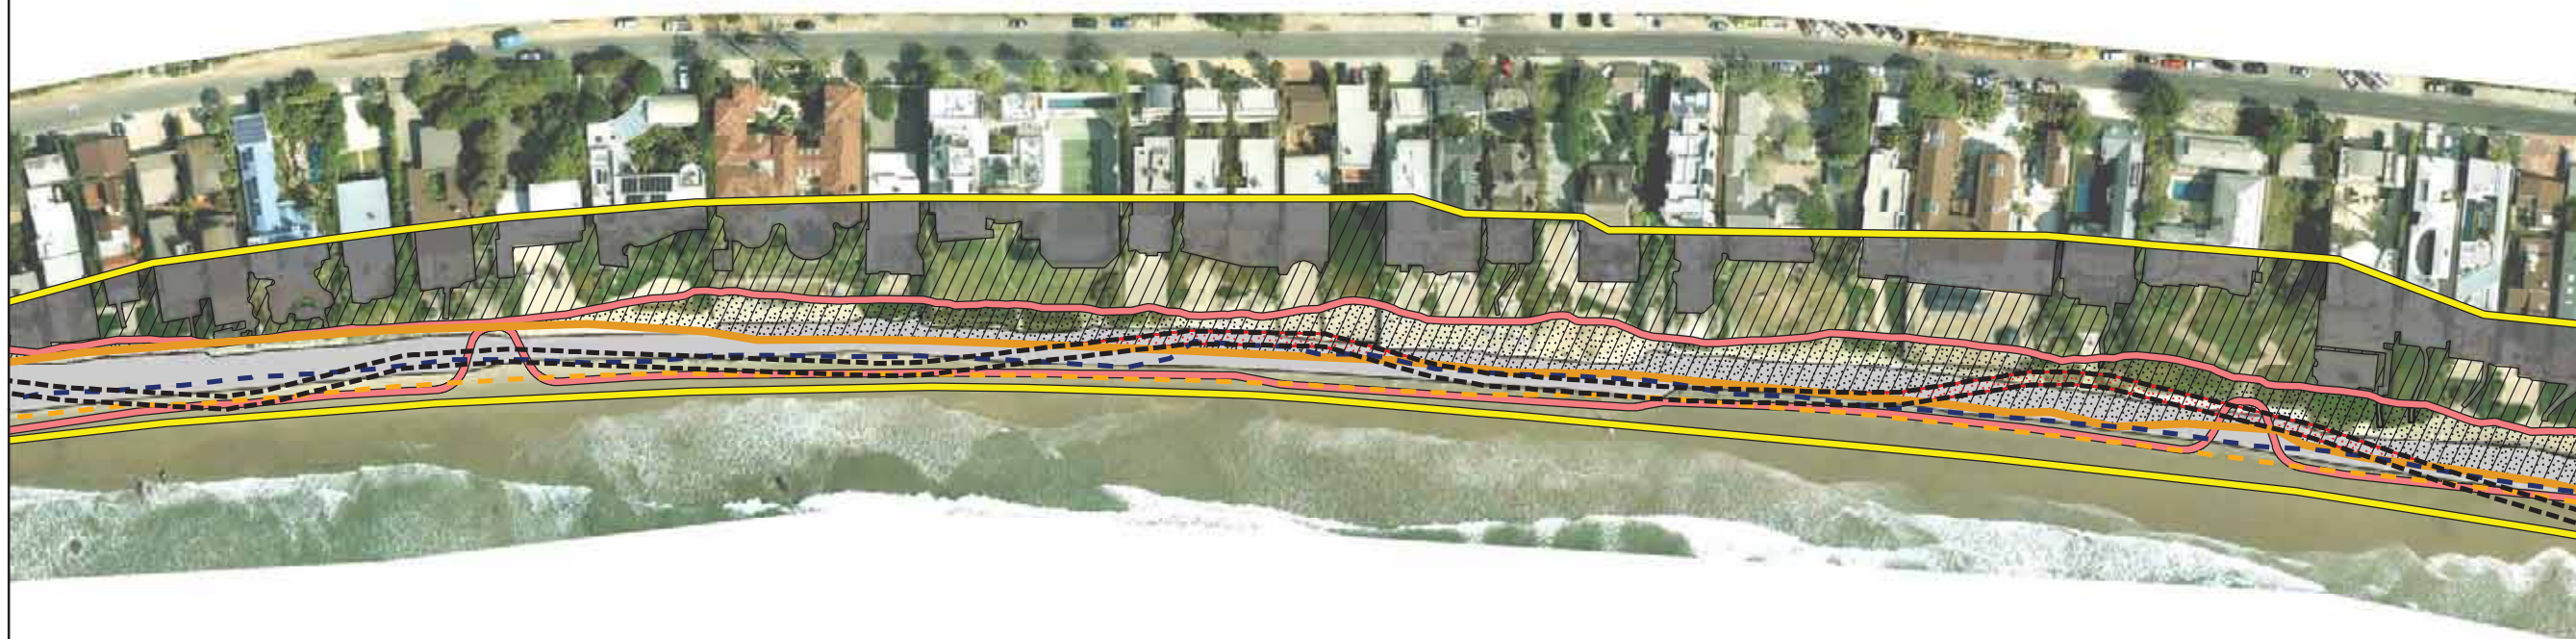
Figure 13-2c.

Potential Impacts to
Foredune Habitat
Under Alternative 3B
Relative to 2005
Baseline Conditions

** Temporary impacts are due to revetment removal or enhancement of existing degraded foredune habitat. Permanent impacts are due to installation of seawall and associated rock apron in existing degraded foredune habitat (2005 extent).

For the assessment of impacts relative to the 2005 baseline condition, WRA assumed that the area landward of the 2005 beach/dune escarpment line shown in Figure 2 represents existing foredune habitat at the site. Using the 2005 baseline extent of foredune habitat, WRA assumed that areas of revetment removal and areas of foredune enhancement (excluding areas occupied by the seawall) represent temporary impacts to foredune habitat and that areas where the seawall and associated rock apron represent permanent impacts to foredune habitat. These impacts are shown in Figure 13-2 and include 4.29 acres of temporary impacts and 0.7 acres of permanent impacts.

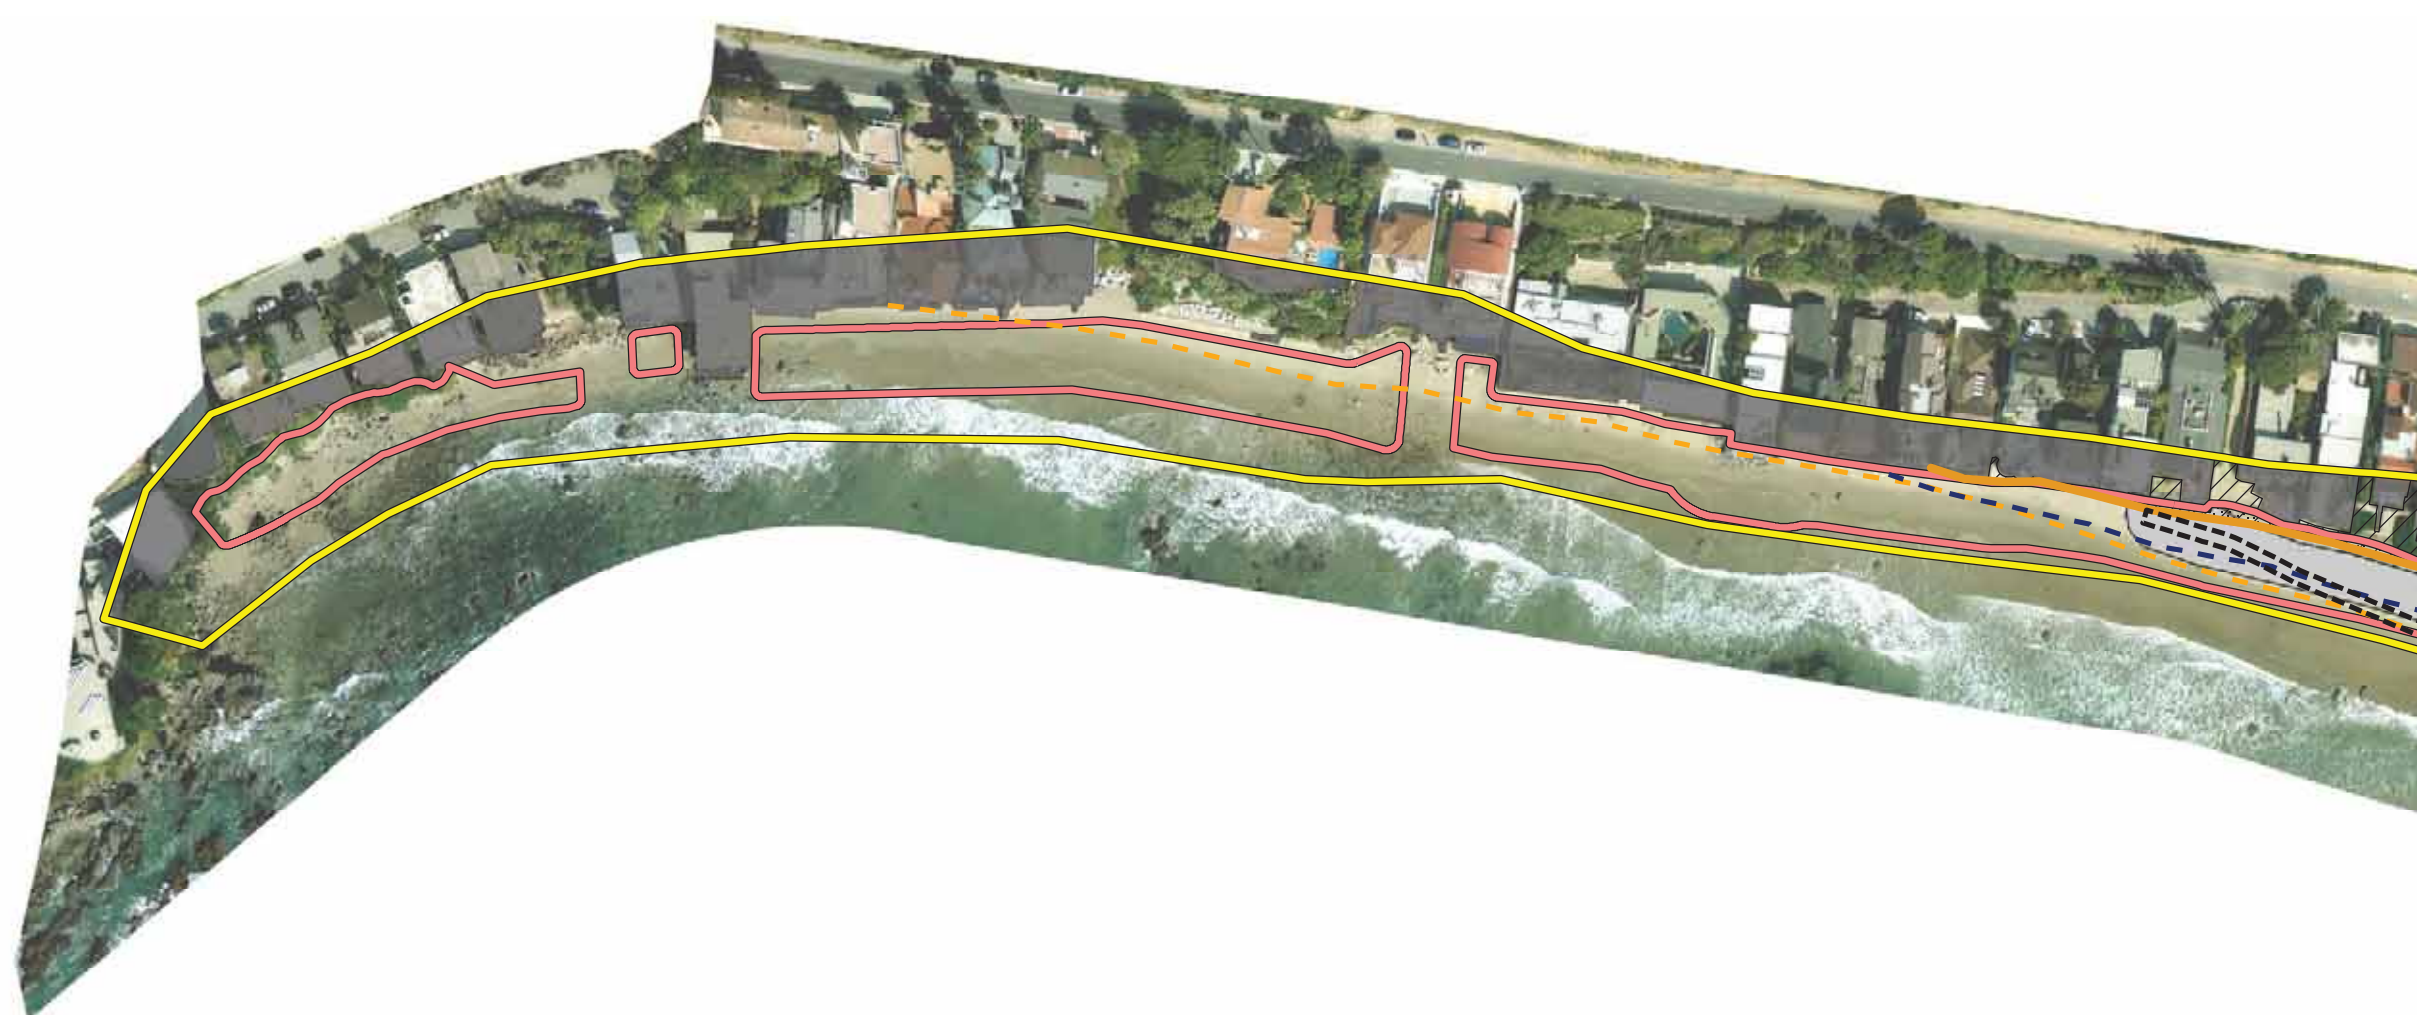
Figure 13-2e.

Potential Impacts to
Foredune Habitat
Under Alternative 3B
Relative to 2005
Baseline Conditions

** Temporary impacts are due to revetment removal or enhancement of existing degraded foredune habitat. Permanent impacts are due to installation of seawall and associated rock apron in existing degraded foredune habitat (2005 extent).

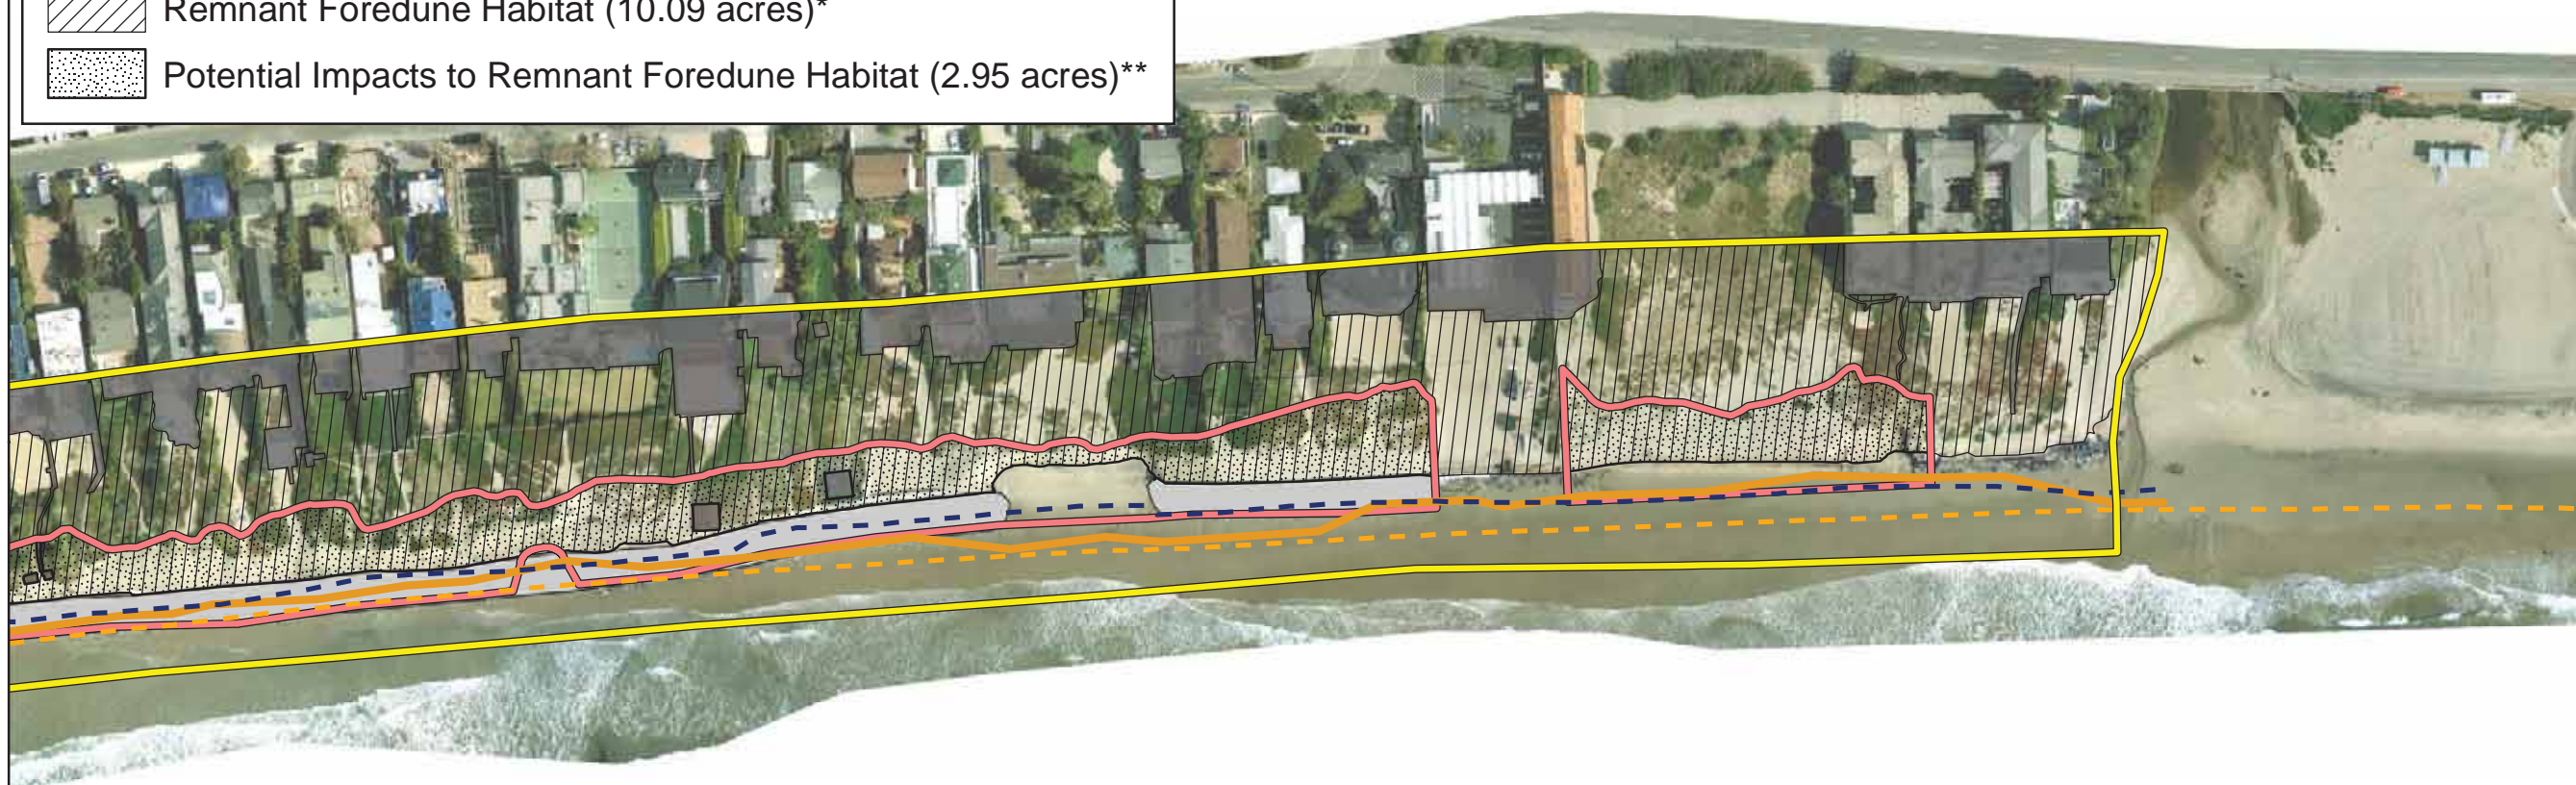
Potential Impacts to
Foredune Habitat
Under Alternative 4
Relative to 2013
Existing Conditions

** Potential impacts are due to enhancement of existing degraded foredune habitat and are temporary in nature.

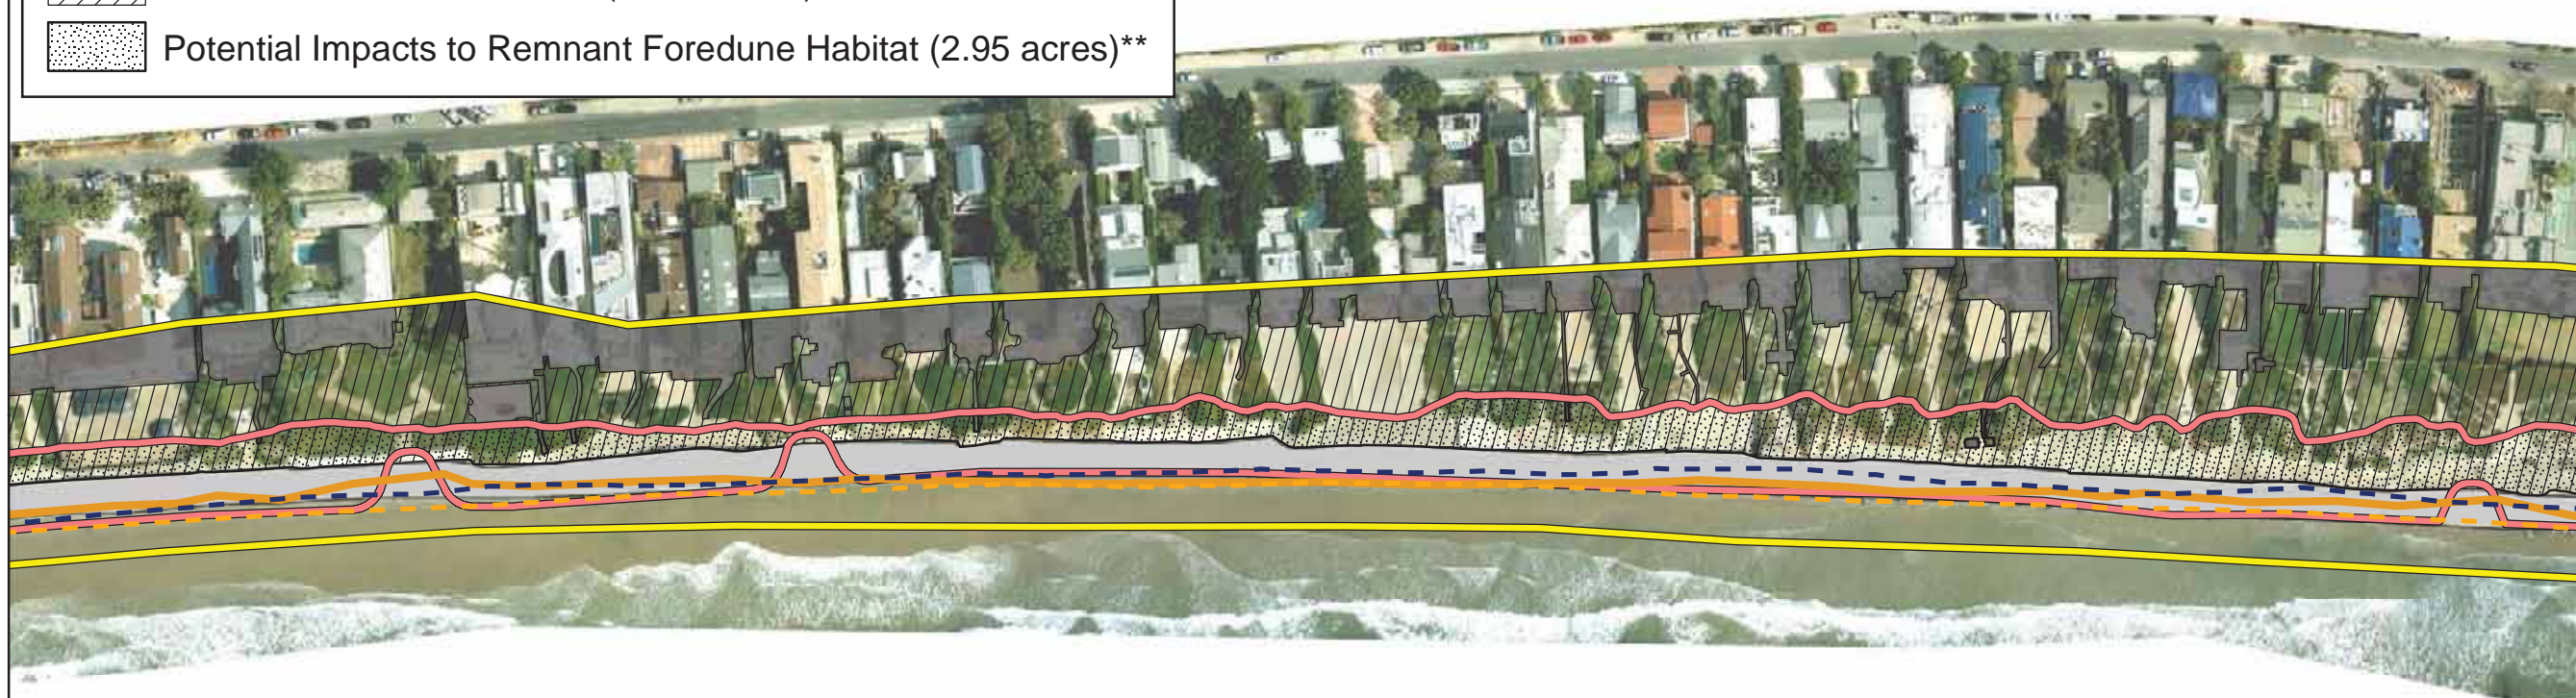
Potential Impacts to
Foredune Habitat
Under Alternative 4
Relative to 2013
Existing Conditions

** Potential impacts are due to enhancement of existing degraded foredune habitat and are temporary in nature.

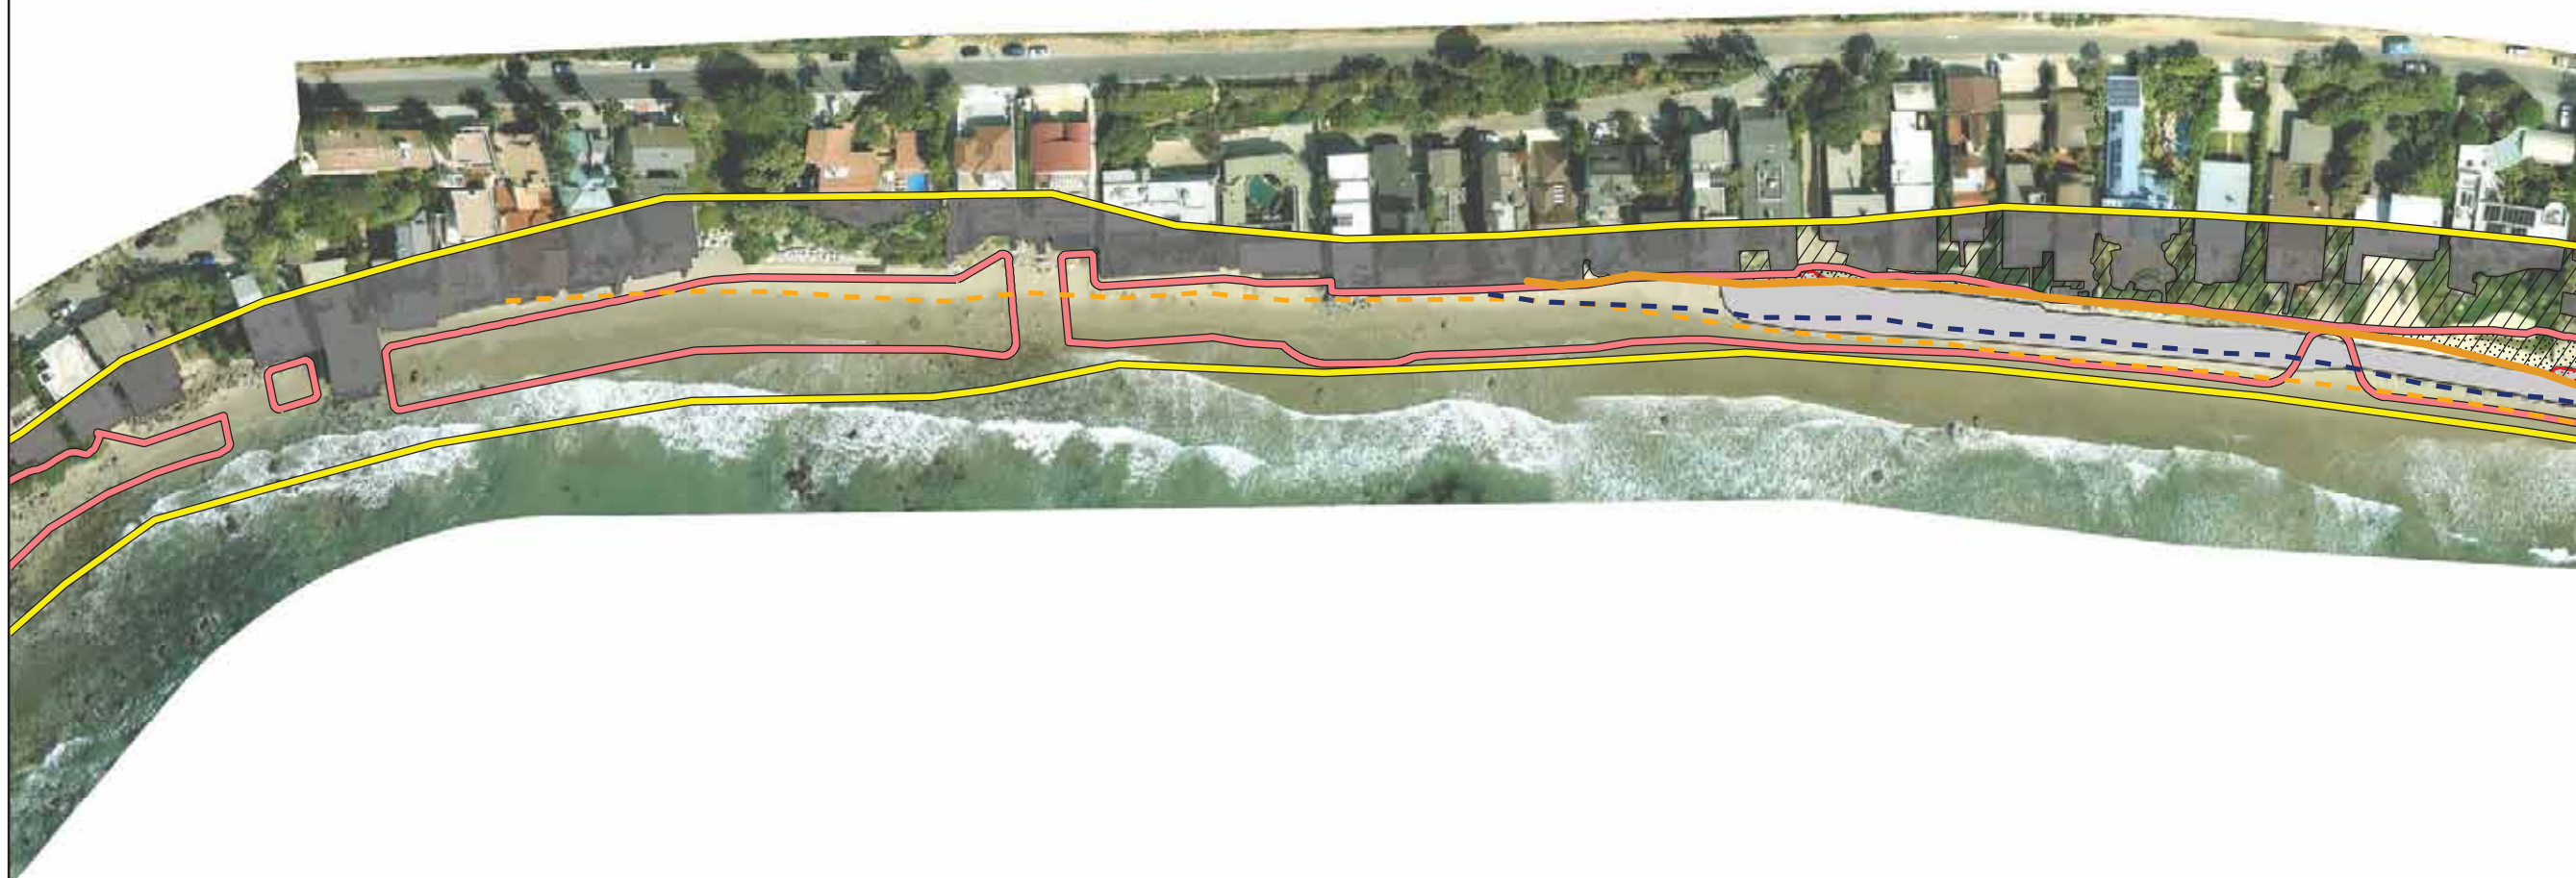
Figure 14-2d.

Potential Impacts to
Foredune Habitat
Under Alternative 4
Relative to 2005
Baseline Conditions

** Temporary impacts are due to enhancement of existing degraded foredune habitat. Permanent impacts are due to retention of the rock revetment in the project design.

For the assessment of impacts relative to the 2005 baseline condition, WRA assumed that the area landward of the 2005 beach/dune escarpment line shown in Figure 2 represents existing foredune habitat at the site. Using the 2005 baseline extent of foredune habitat, WRA assumed that areas of foredune enhancement represent temporary impacts to foredune habitat and that areas in which the 2010 revetment will be retained represent permanent impacts to foredune habitat. These impacts are shown in Figure 14-2 and include 3.23 acres of temporary impacts and 1.57 acres of permanent impacts.

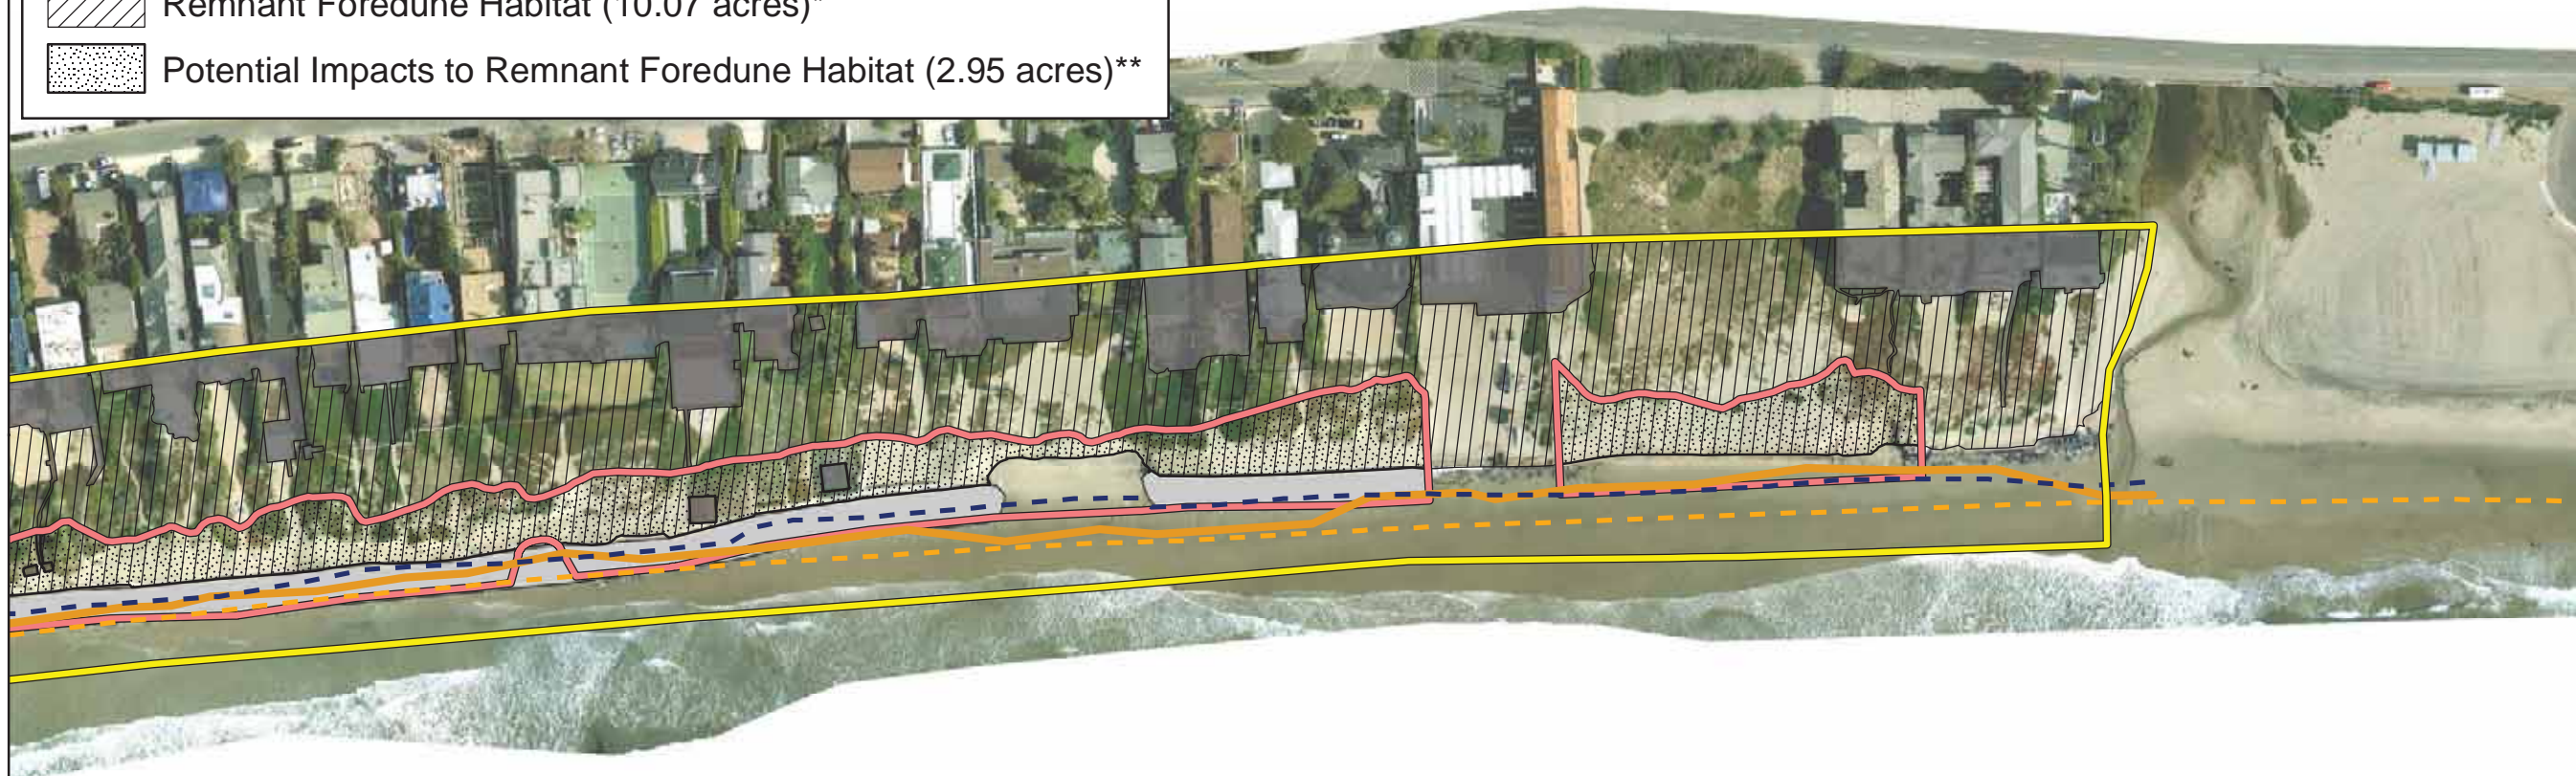
Potential Impacts to
Foredune Habitat
Under Alternative 5
Relative to 2013
Existing Conditions

** Potential impacts are due to enhancement of existing degraded foredune habitat and are temporary in nature.
