Memorandum

Subject: Broad Beach Foredune Impact Analysis

This memorandum provides an assessment of the impacts to foredune habitat that may have occurred or that could occur as a result of previous and proposed shoreline stabilization efforts at Broad Beach. This material is intended to support the application for a California Coastal Commission (“CCC”) Coastal Development Permit (“CDP”) for the proposed Broad Beach Restoration Project located in Malibu, Los Angeles County, California (“Study Area”; Figure 1). The information included here is based on inferred historical conditions, observed current conditions, and predicted future conditions at Broad Beach. As noted in the previous CDP submittals for the project, detailed records of historical habitat conditions and shoreline stabilization efforts at Broad Beach are lacking, and much information had to be inferred from historic aerial imagery, a sporadic record of photographs from the site, and comparisons with similar habitats in the region. As such, the analysis presented here is subject to a number of caveats which are presented in the following sections. The analysis follows in six parts, each of which contains (1) an assess

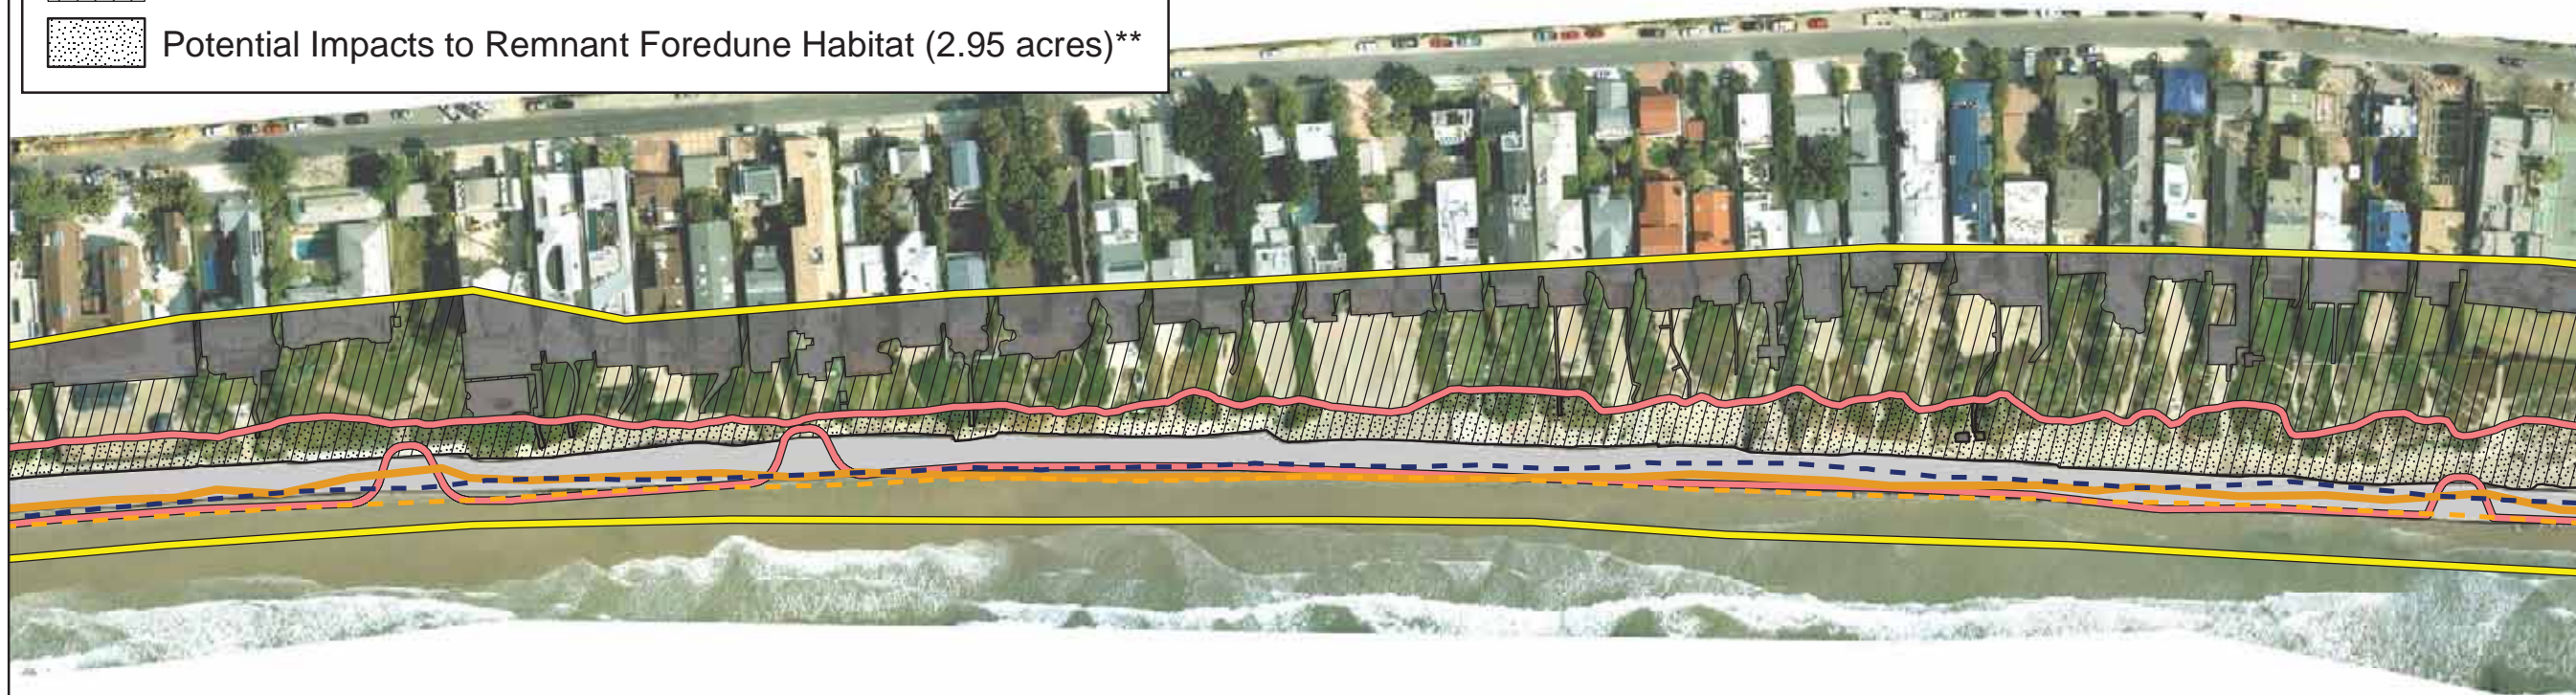
Potential Impacts to
Foredune Habitat
Under Alternative 5
Relative to 2013
Existing Conditions

** Potential impacts are due to enhancement of existing degraded foredune habitat and are temporary in nature.

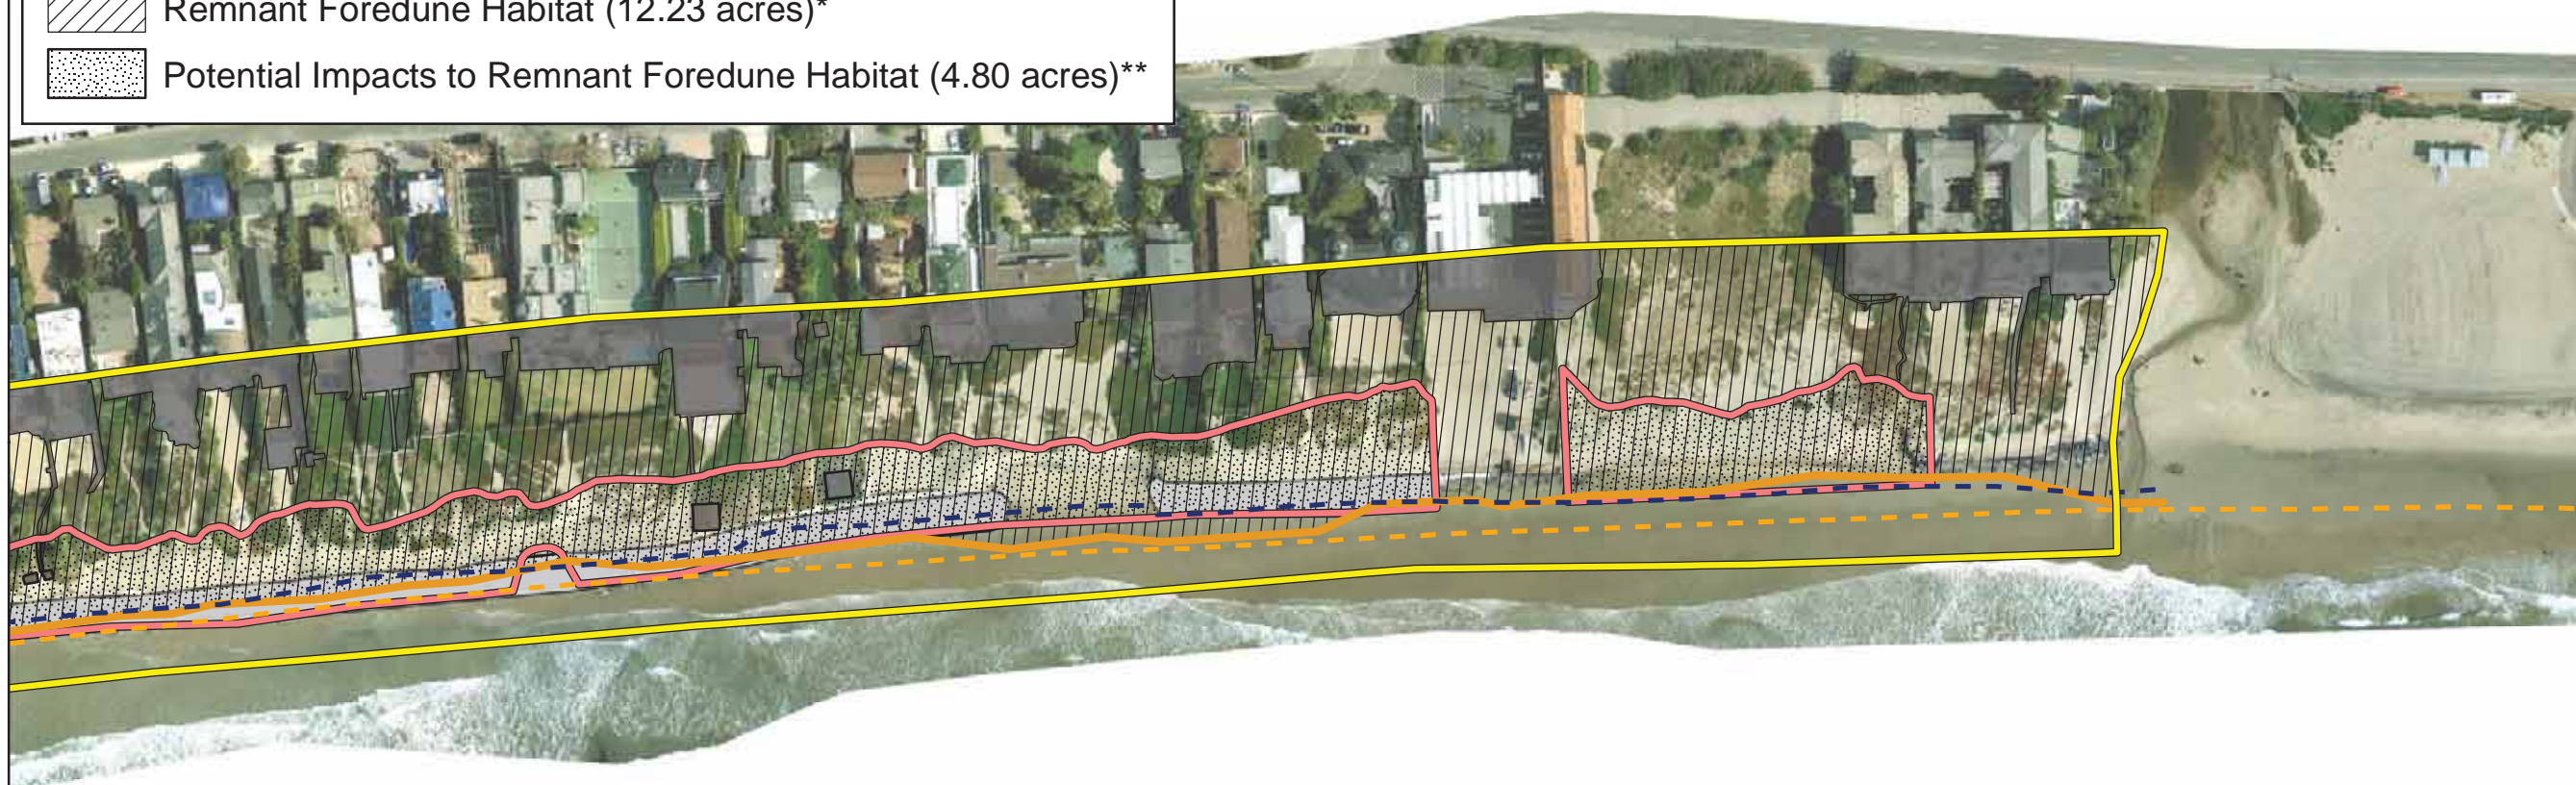
Potential Impacts to
Foredune Habitat
Under Alternative 5
Relative to 2005
Baseline Conditions

** Potential impacts are due to revetment removal or enhancement of existing degraded foredune habitat and are temporary in nature.

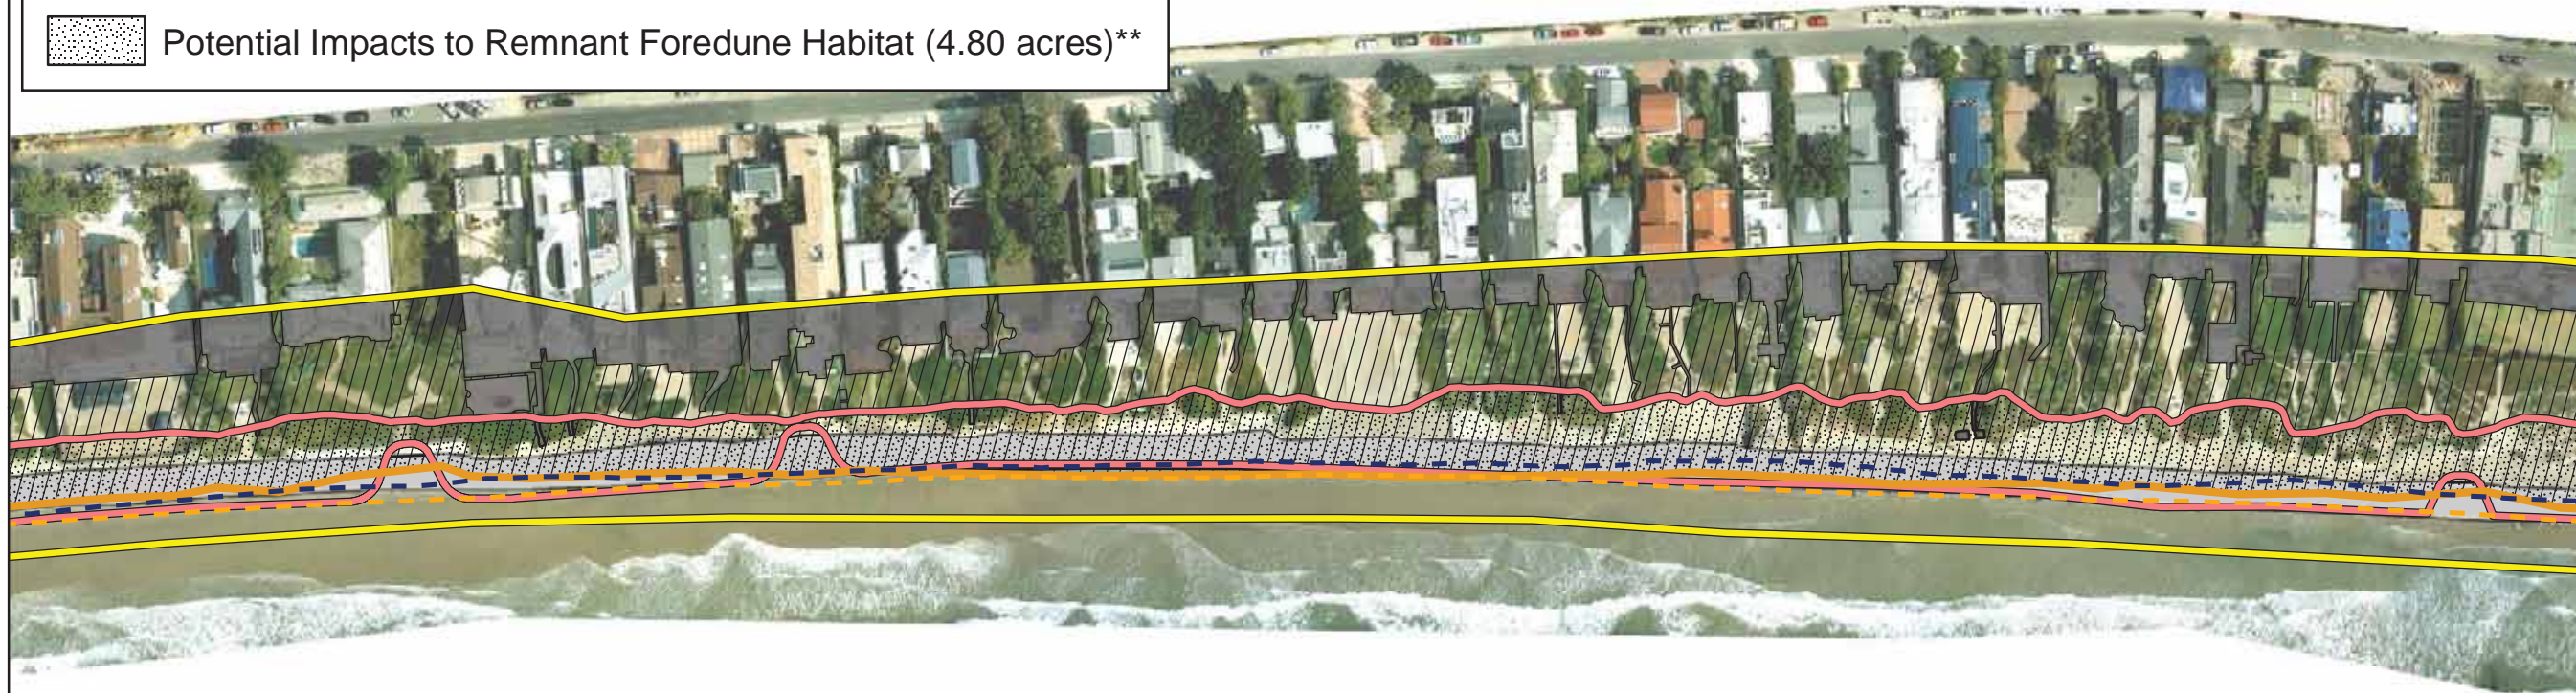
Potential Impacts to
Foredune Habitat
Under Alternative 5
Relative to 2005
Baseline Conditions

** Potential impacts are due to revetment removal or enhancement of existing degraded foredune habitat and are temporary in nature.

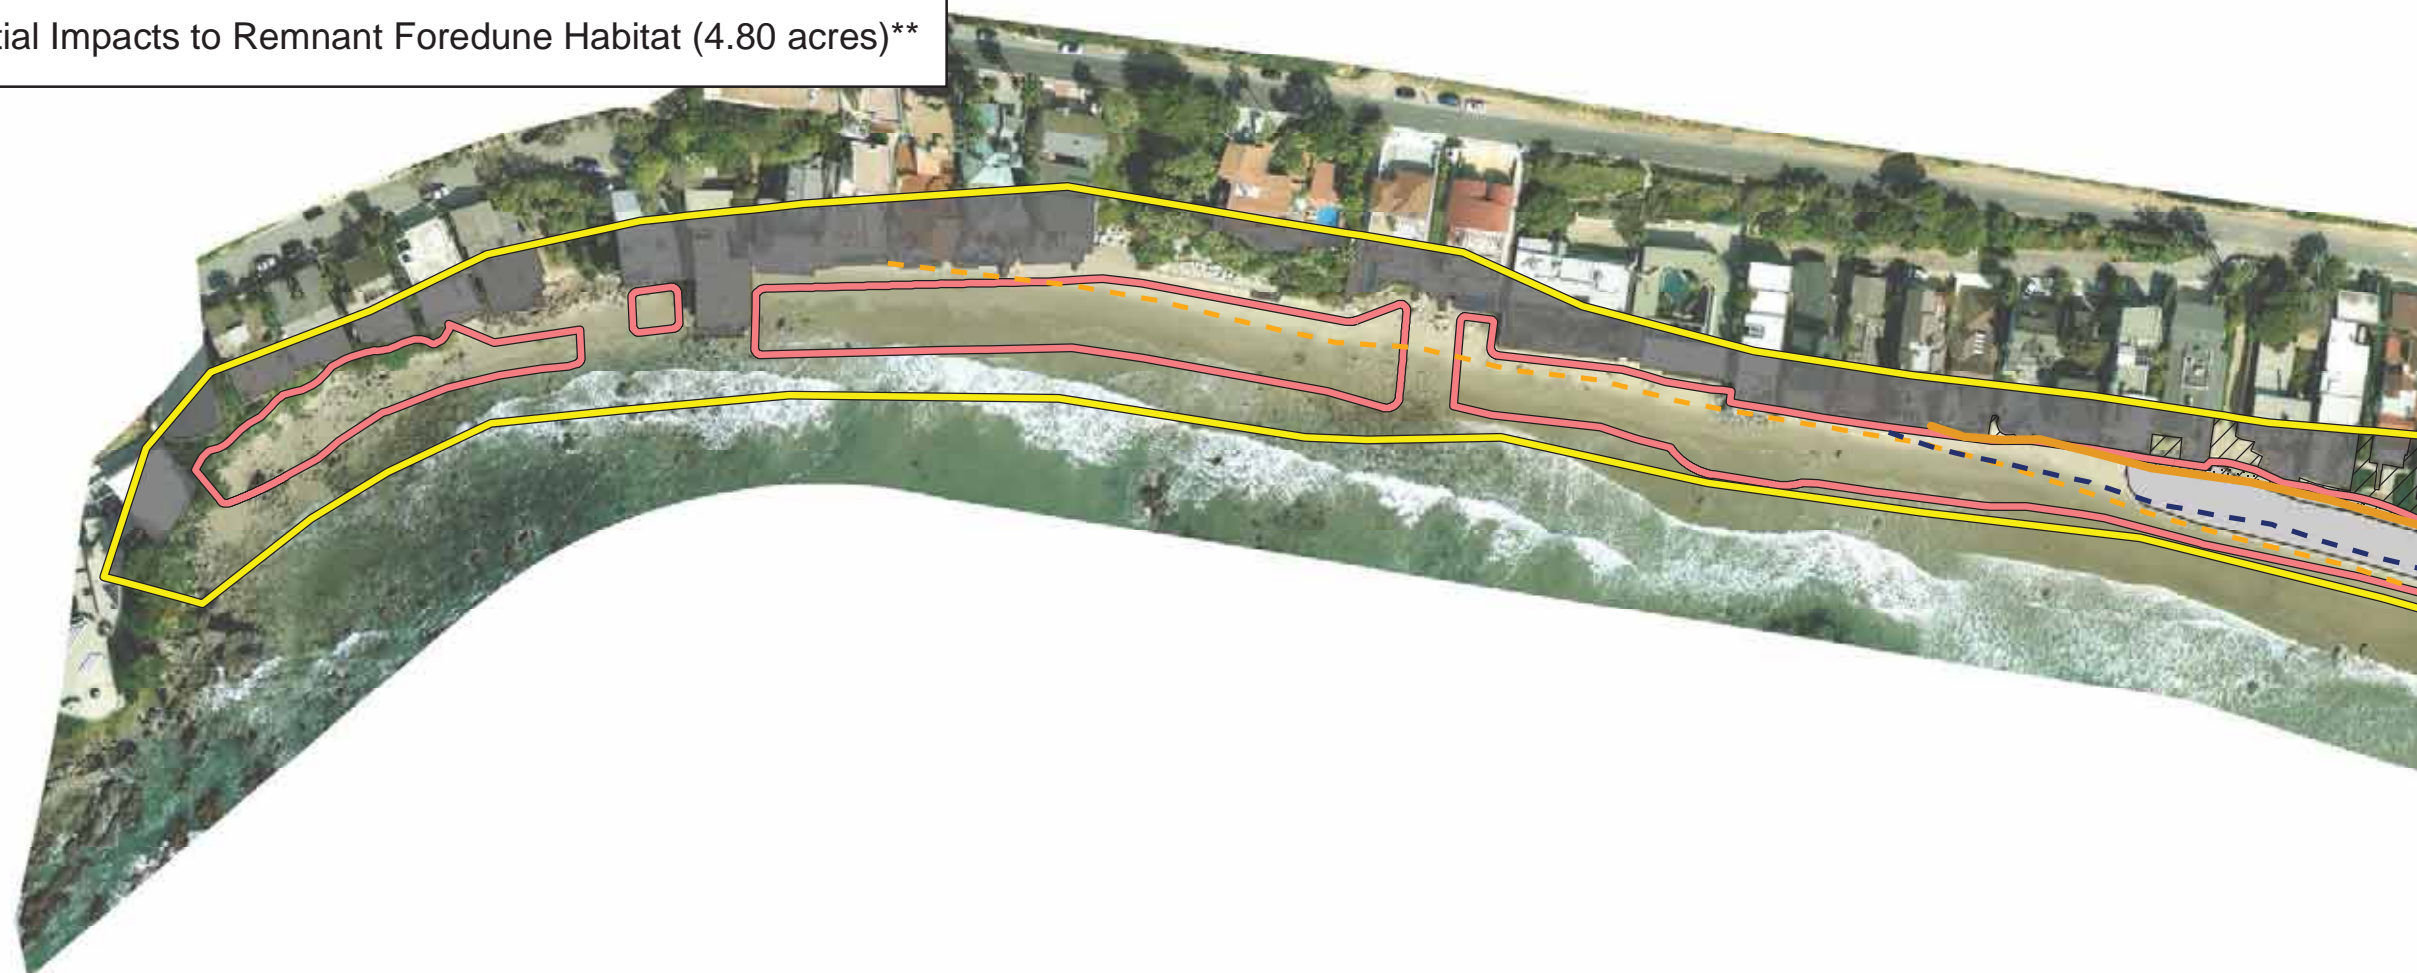
Potential Impacts to
Foredune Habitat
Under Alternative 5
Relative to 2005
Baseline Conditions

** Potential impacts are due to revetment removal or enhancement of existing degraded foredune habitat and are temporary in nature.

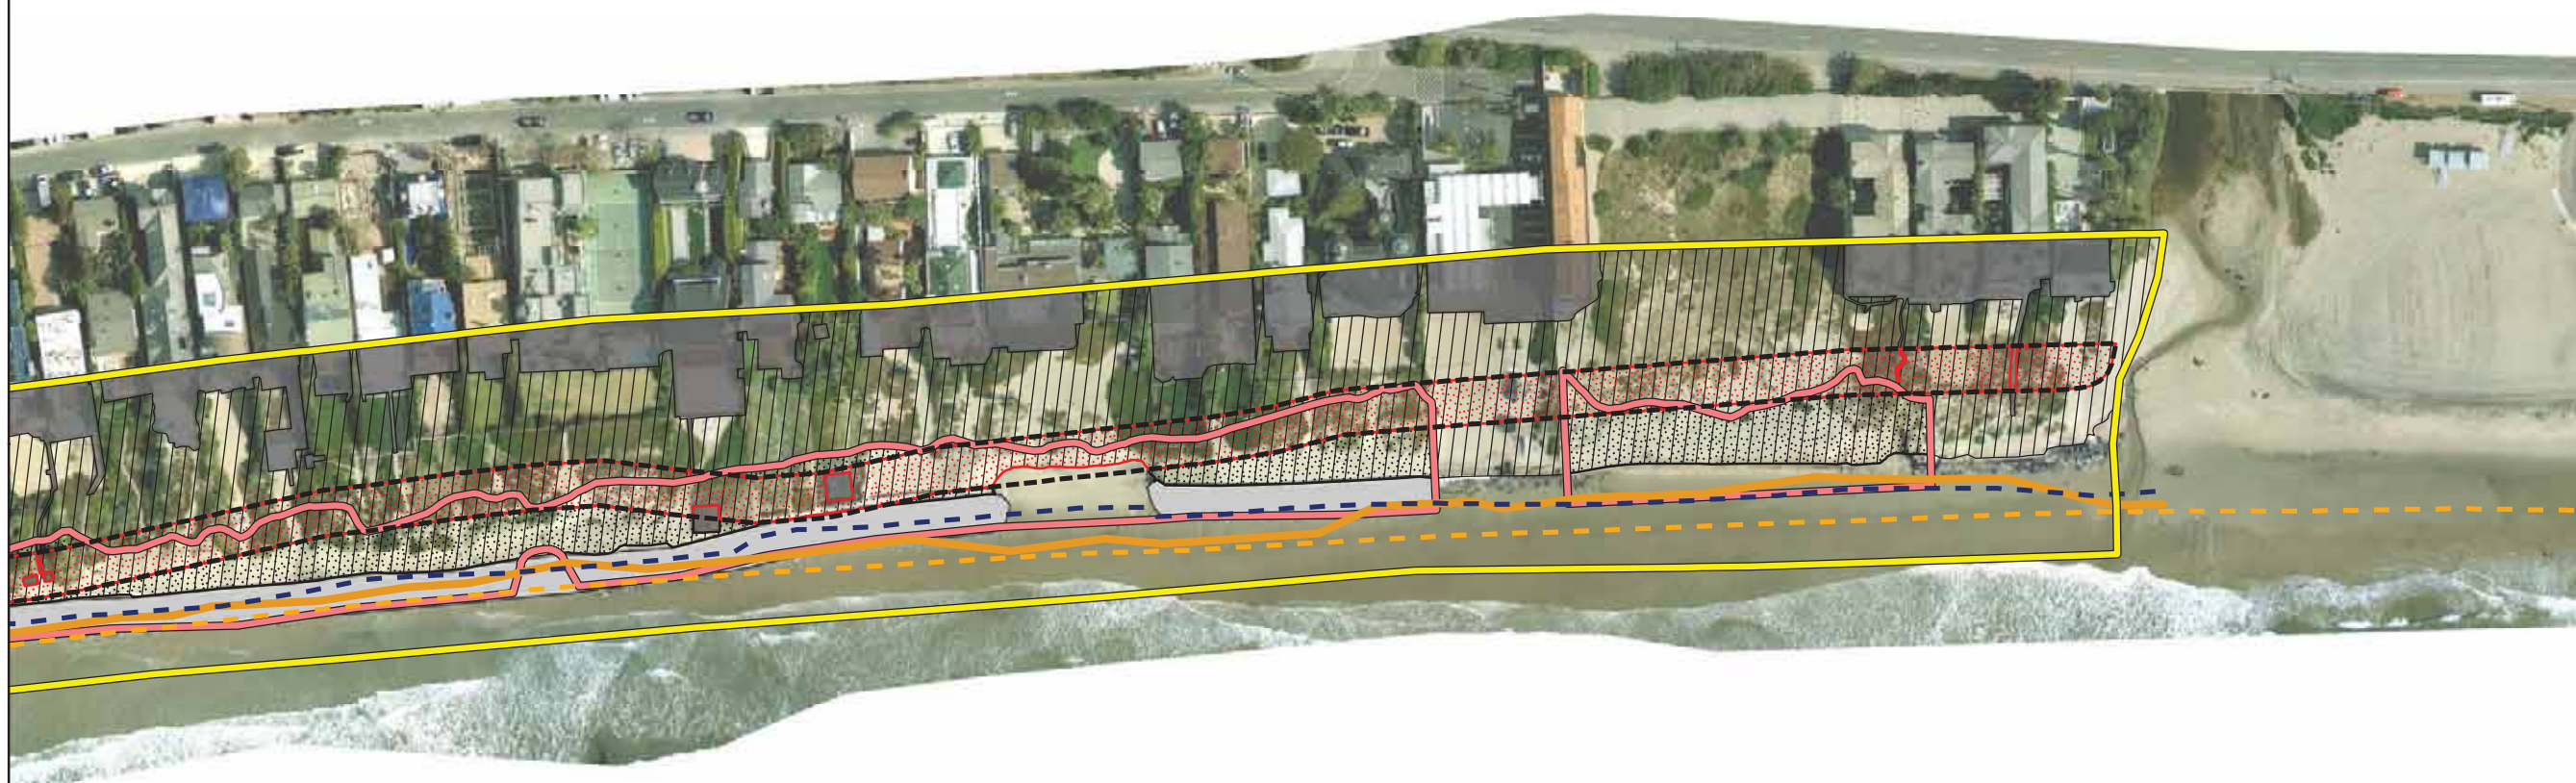
Potential Impacts to
Foredune Habitat
Under Alternative 6A
Relative to 2013
Existing Conditions

** Temporary impacts are due to enhancement of existing degraded foredune habitat. Permanent impacts are due to relocation of revetment.

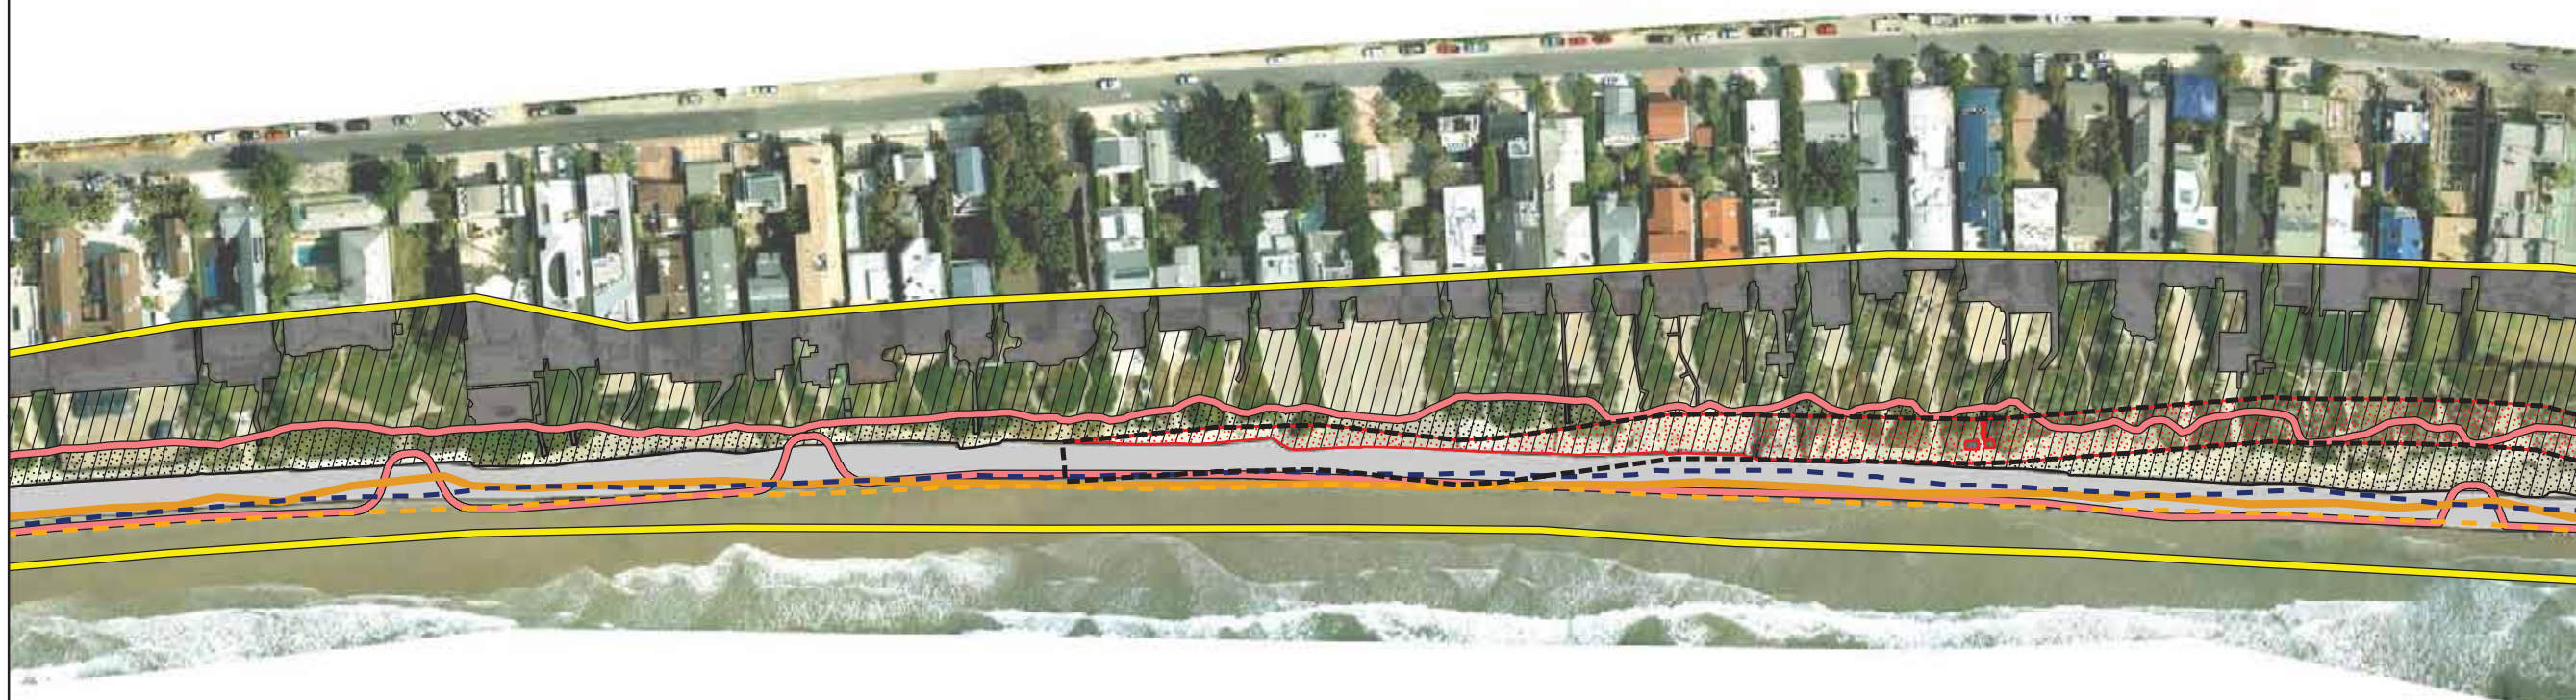
Potential Impacts to
Foredune Habitat
Under Alternative 6A
Relative to 2013
Existing Conditions

** Temporary impacts are due to enhancement of existing degraded foredune habitat. Permanent impacts are due to relocation of revetment.

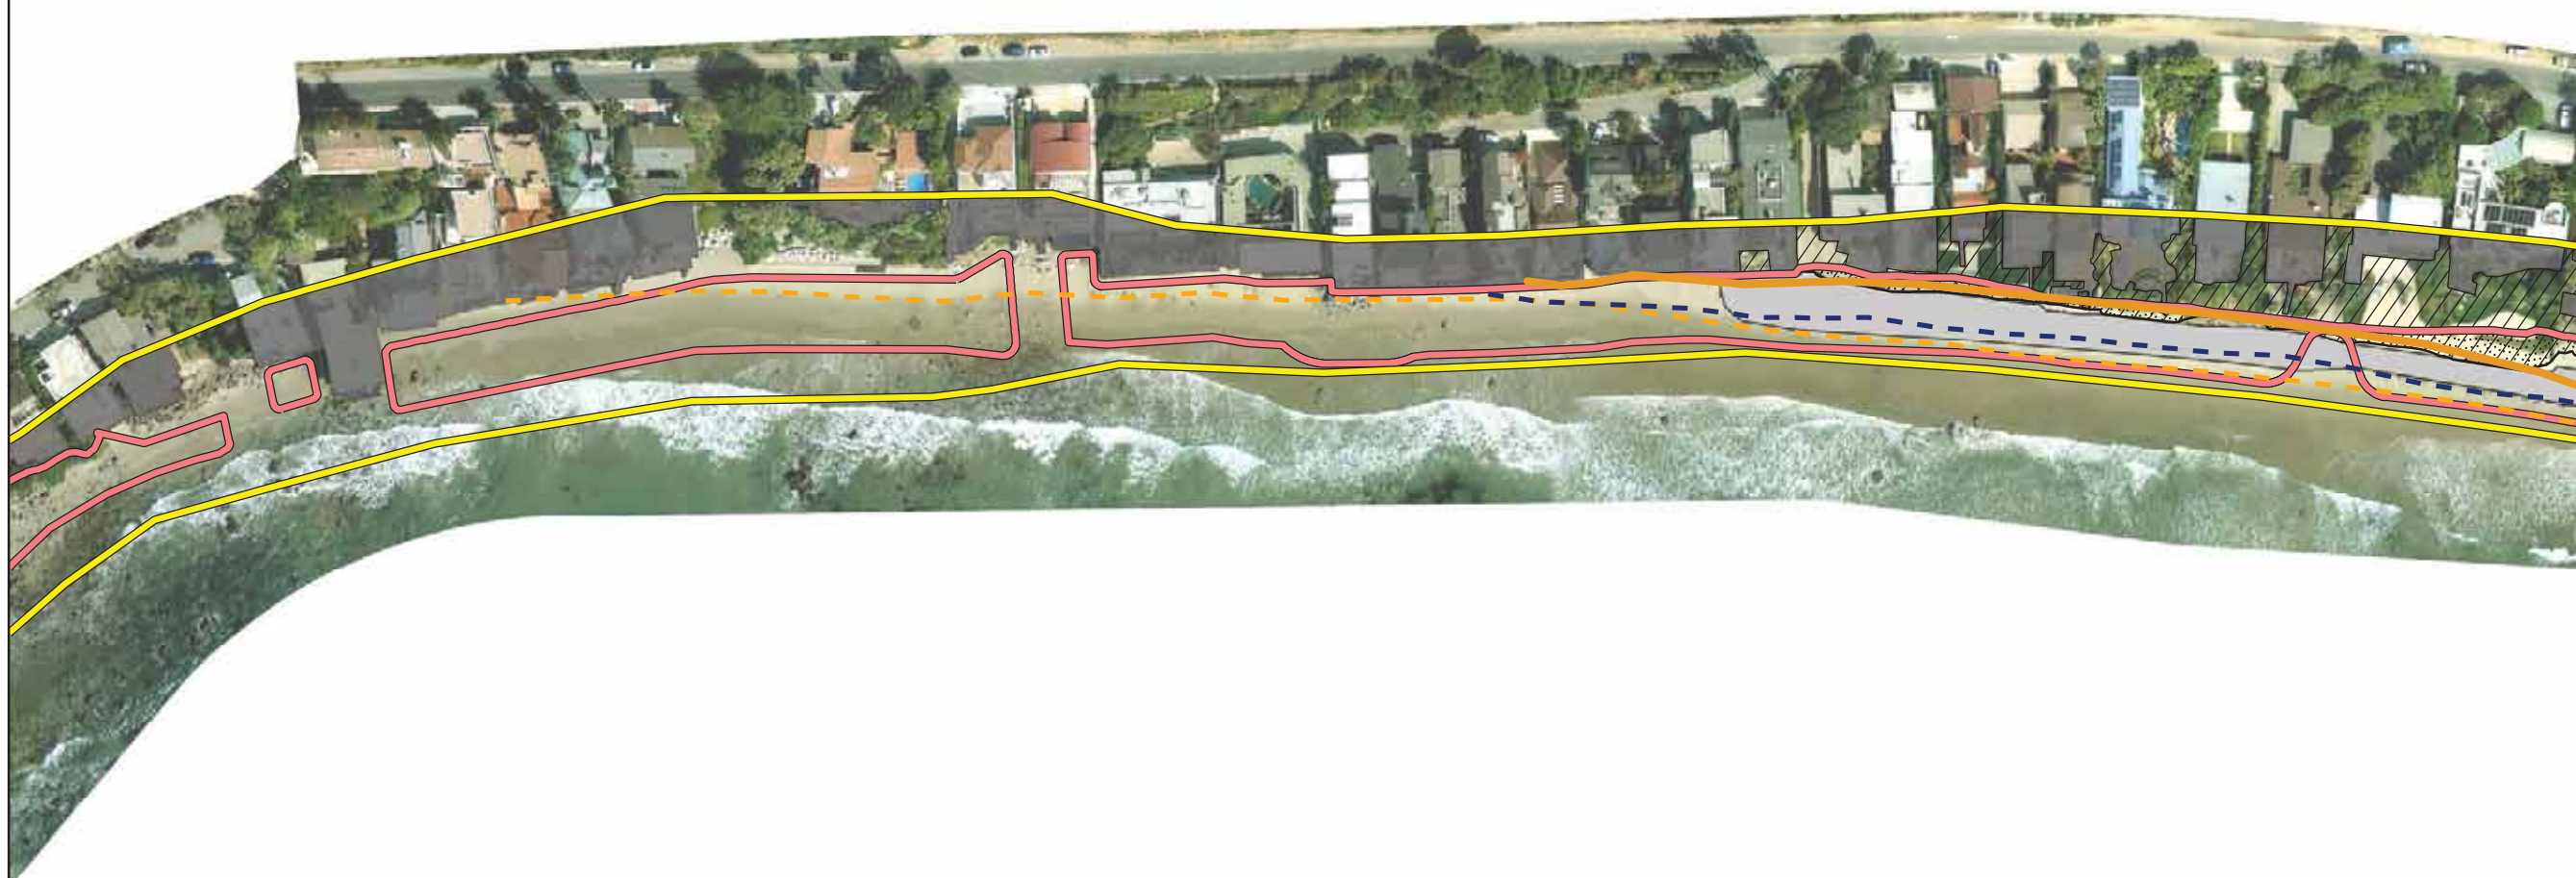
Potential Impacts to
Foredune Habitat
Under Alternative 6A
Relative to 2013
Existing Conditions

** Temporary impacts are due to enhancement of existing degraded foredune habitat. Permanent impacts are due to relocation of revetment.

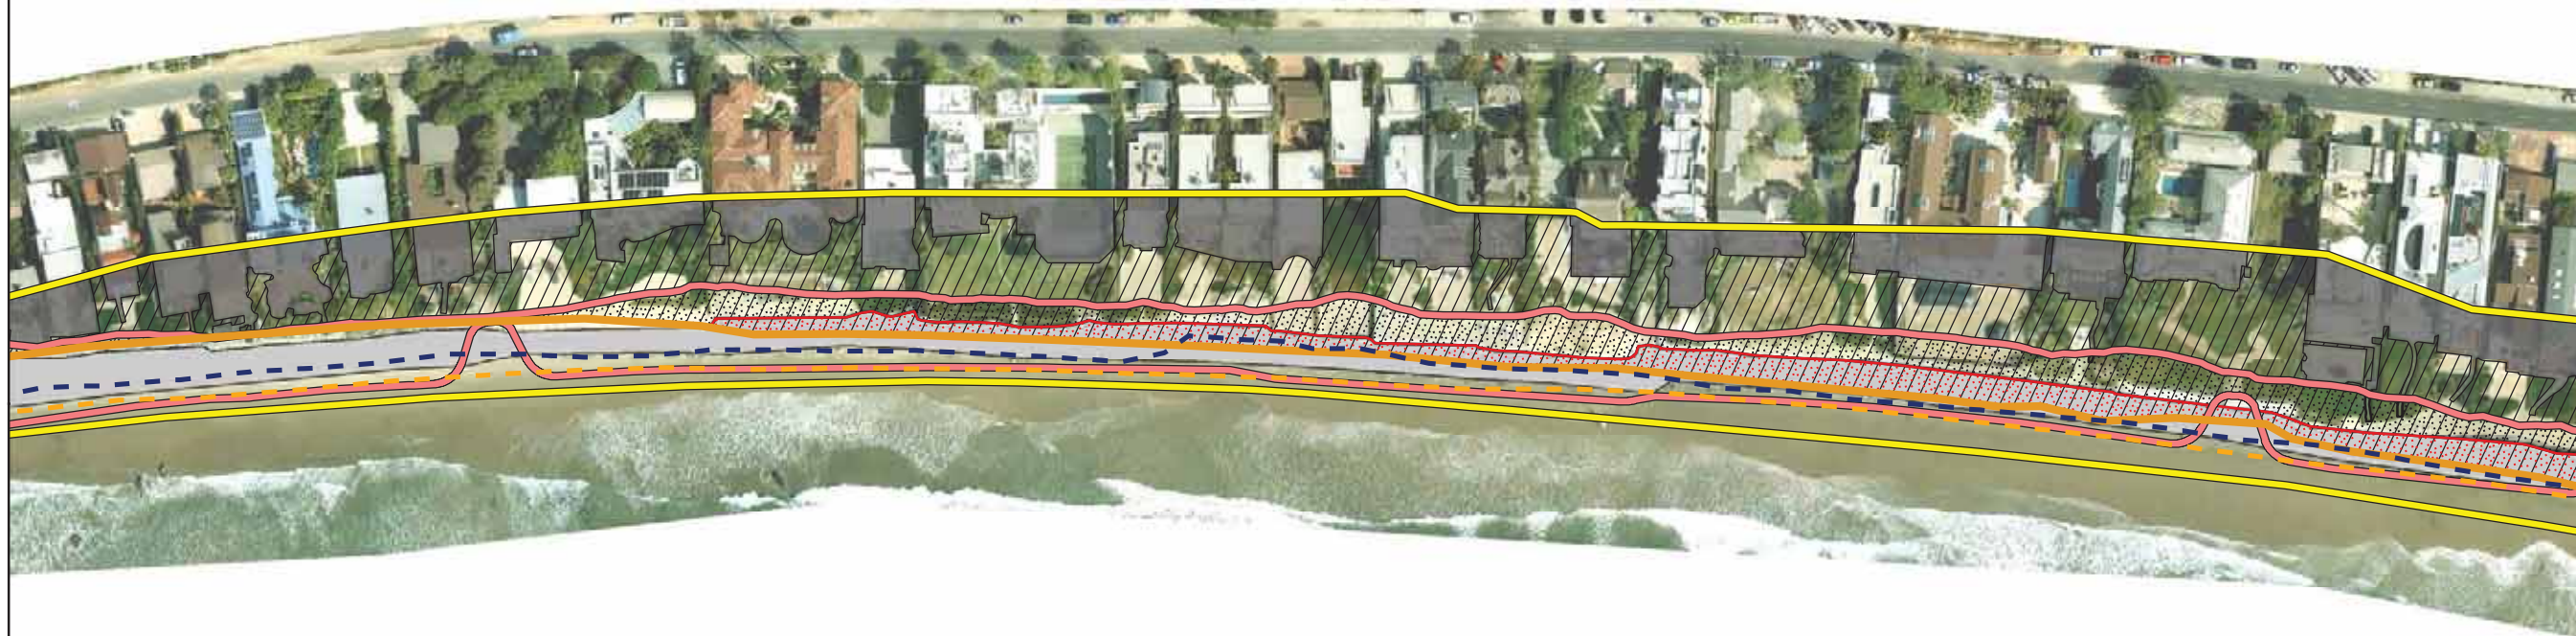
Figure 16-2c.

Potential Impacts to
Foredune Habitat
Under Alternative 6A
Relative to 2005
Baseline Conditions

** Temporary impacts are due to revetment removal or enhancement of existing degraded foredune habitat. Permanent impacts are due to retained and relocated sections of revetment.

For the assessment of impacts relative to the 2005 baseline condition, WRA assumed that the area landward of the 2005 beach/dune escarpment line shown in Figure 2 represents existing foredune habitat at the site. Using the 2005 baseline extent of foredune habitat, WRA assumed that areas of foredune enhancement and revetment removal represent temporary impacts to foredune habitat and that areas of retained or relocated revetment represent permanent impacts. These impacts are shown in Figure 16-2 and include 2.86 acres of temporary impacts and 2.58 acres of permanent impacts.

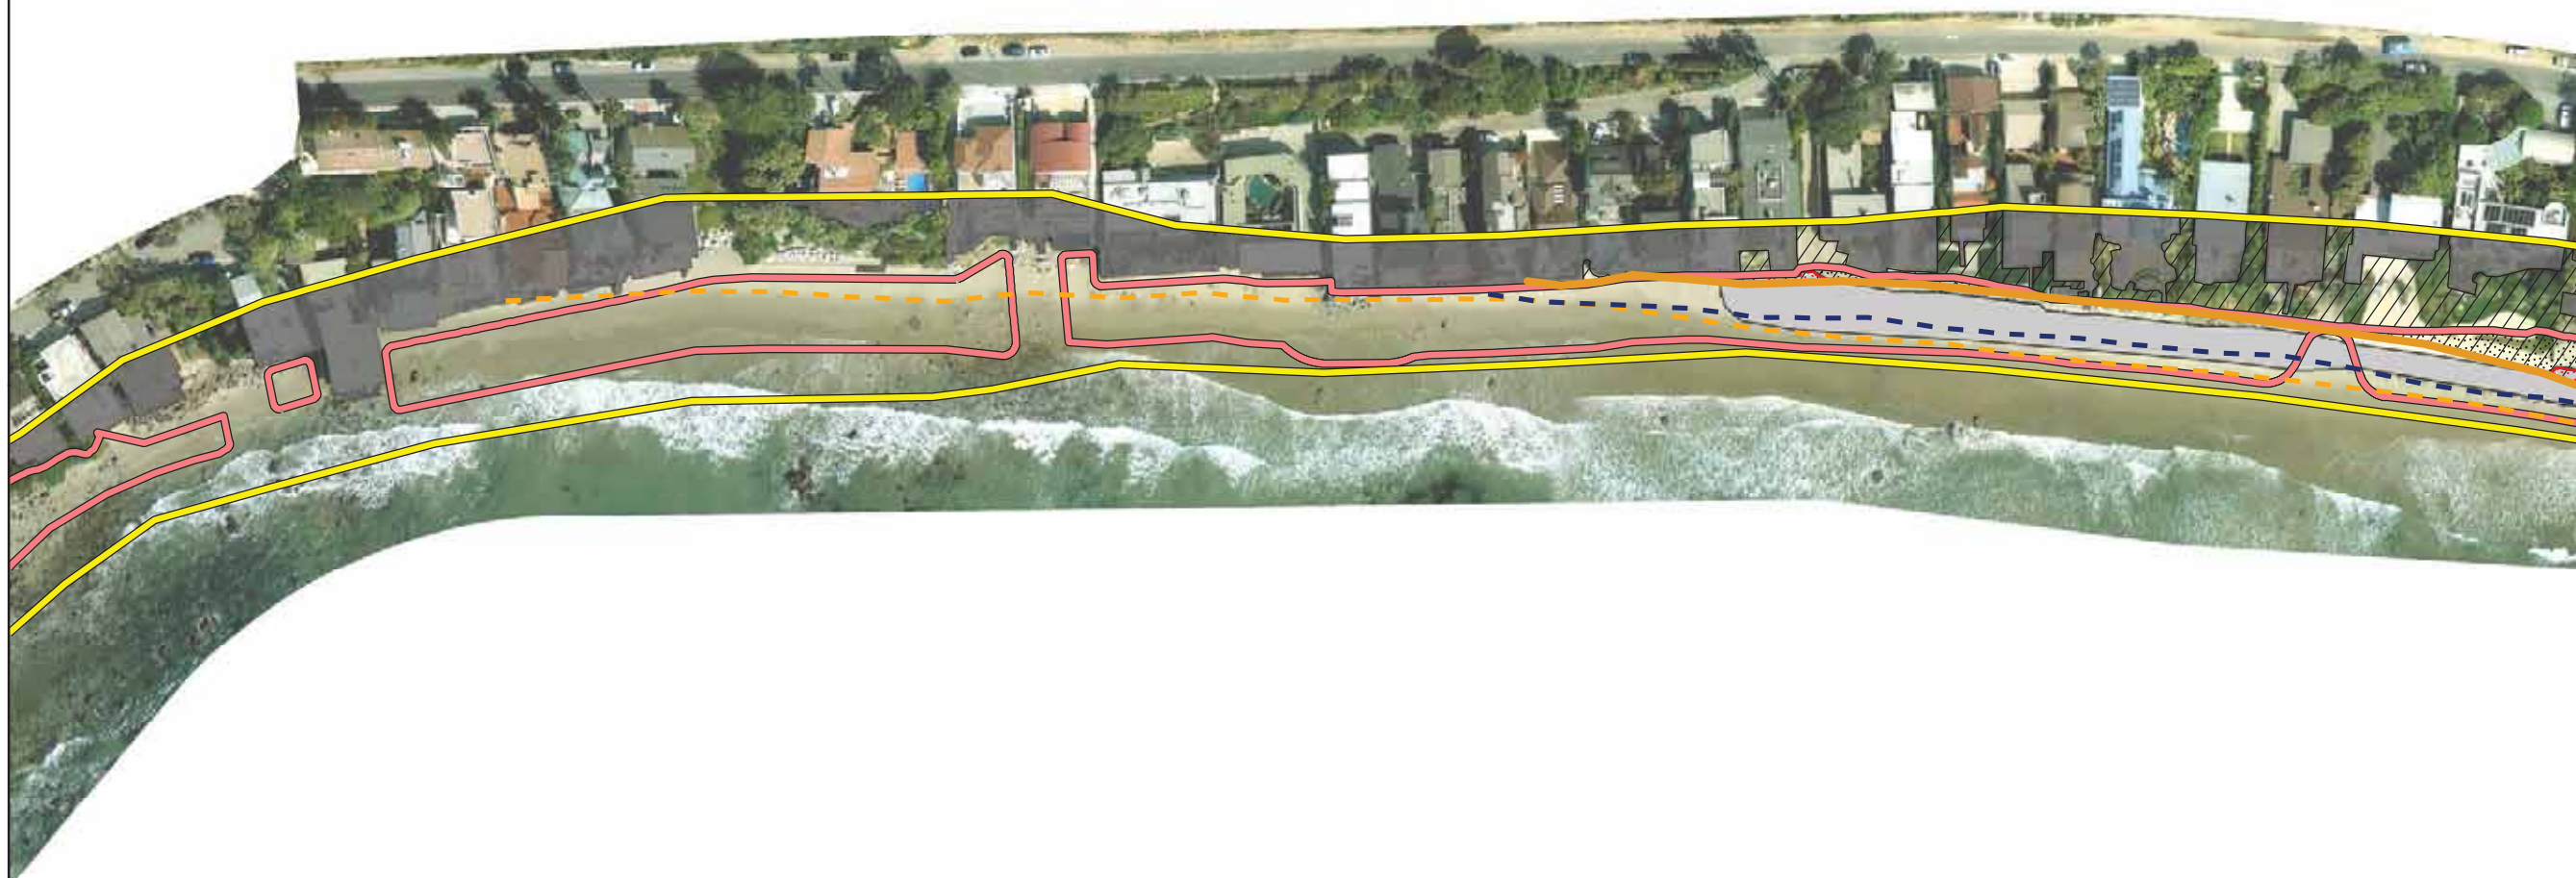
Figure 16-2d.

Potential Impacts to
Foredune Habitat
Under Alternative 6A
Relative to 2005
Baseline Conditions

** Temporary impacts are due to revetment removal or enhancement of existing degraded foredune habitat. Permanent impacts are due to retained and relocated sections of revetment.

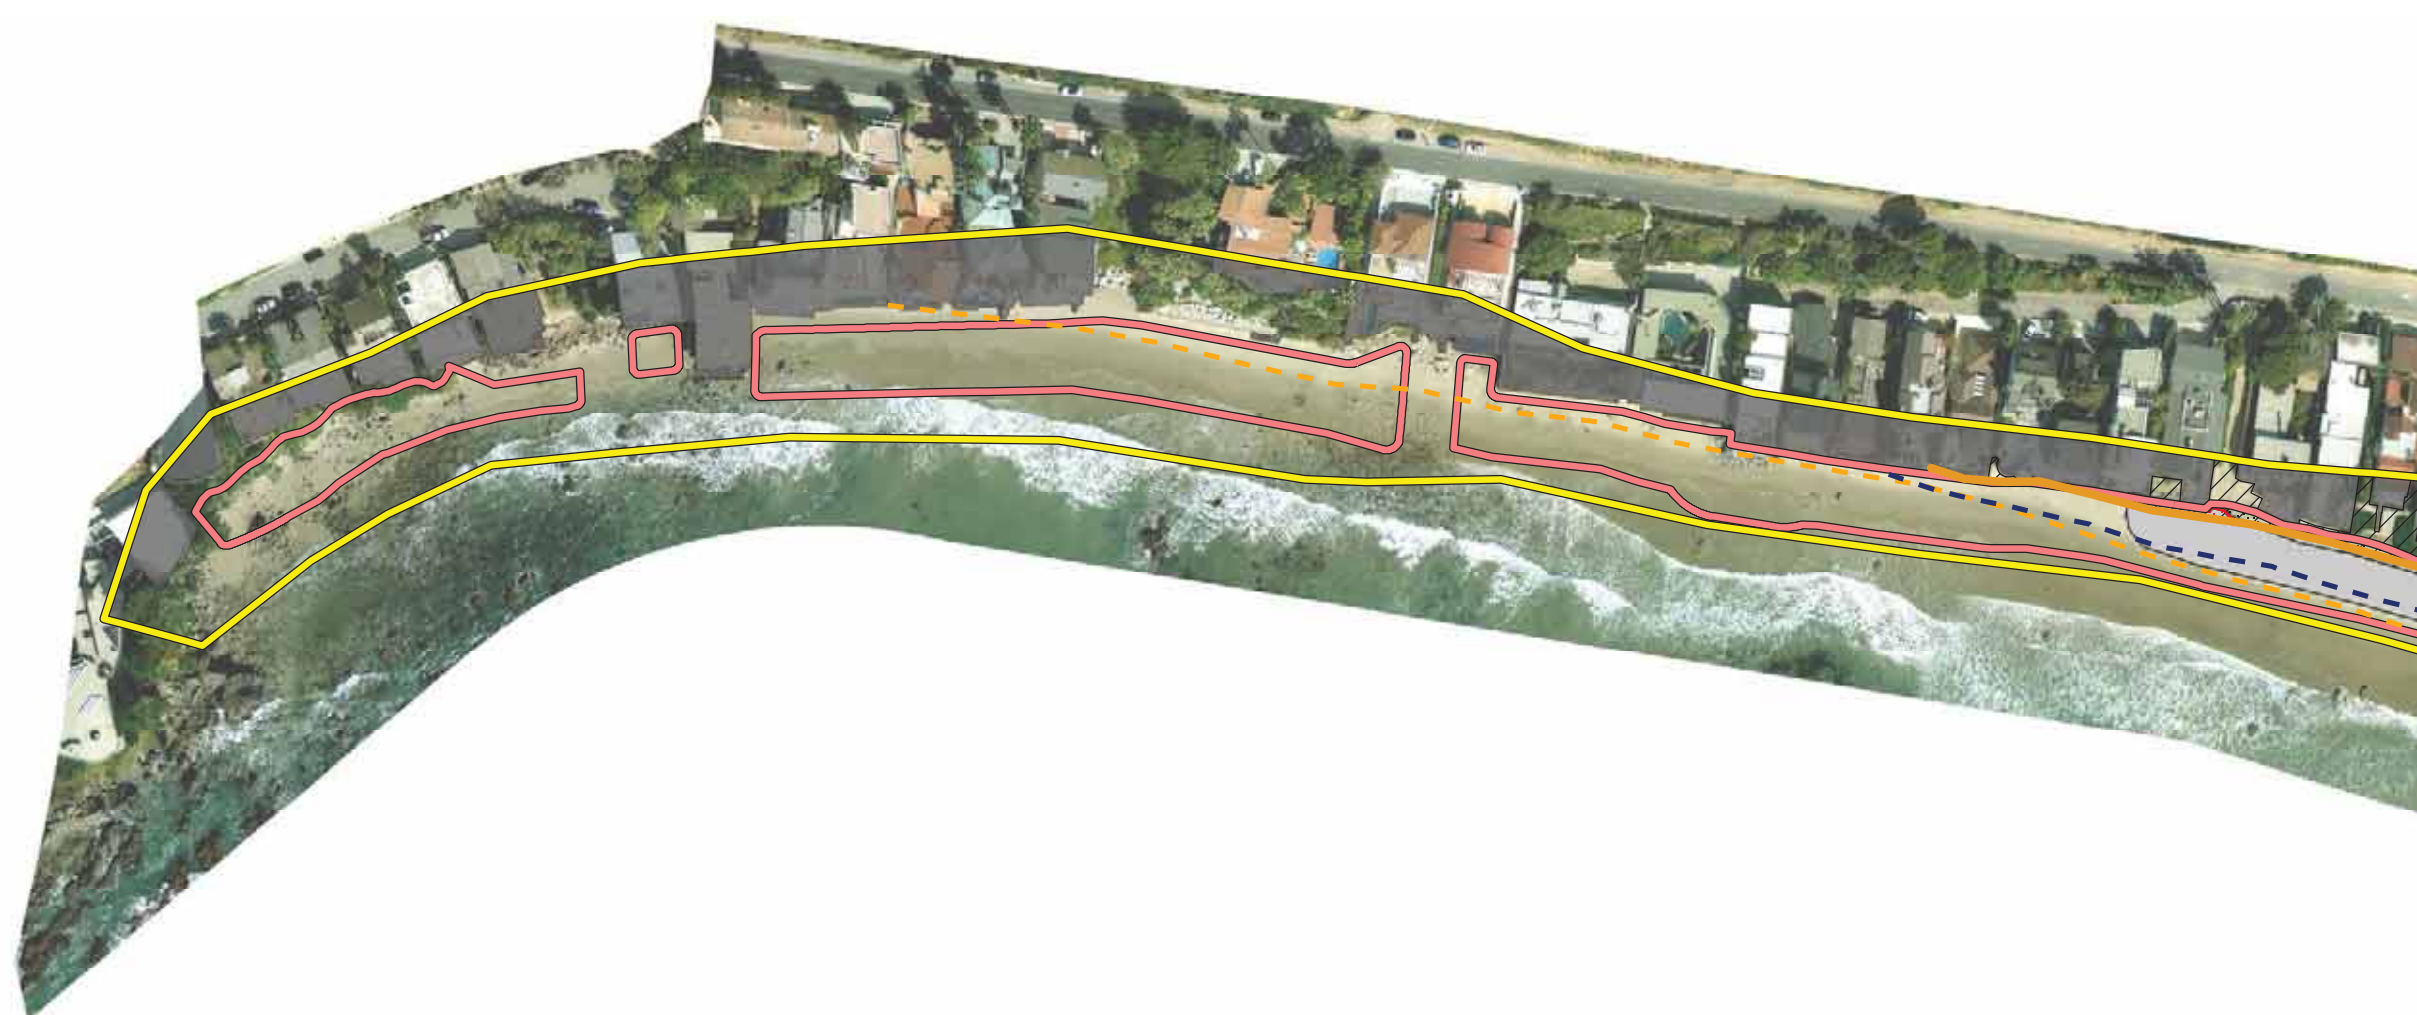
Figure 16-2e.

Potential Impacts to
Foredune Habitat
Under Alternative 6A
Relative to 2005
Baseline Conditions

** Temporary impacts are due to revetment removal or enhancement of existing degraded foredune habitat. Permanent impacts are due to retained and relocated sections of revetment.
