Memorandum

Subject: Broad Beach Foredune Impact Analysis

This memorandum provides an assessment of the impacts to foredune habitat that may have occurred or that could occur as a result of previous and proposed shoreline stabilization efforts at Broad Beach. This material is intended to support the application for a California Coastal Commission (“CCC”) Coastal Development Permit (“CDP”) for the proposed Broad Beach Restoration Project located in Malibu, Los Angeles County, California (“Study Area”; Figure 1). The information included here is based on inferred historical conditions, observed current conditions, and predicted future conditions at Broad Beach. As noted in the previous CDP submittals for the project, detailed records of historical habitat conditions and shoreline stabilization efforts at Broad Beach are lacking, and much information had to be inferred from historic aerial imagery, a sporadic record of photographs from the site, and comparisons with similar habitats in the region. As such, the analysis presented here is subject to a number of caveats which are presented in the following sections. The analysis follows in six parts, each of which contains (1) an assess

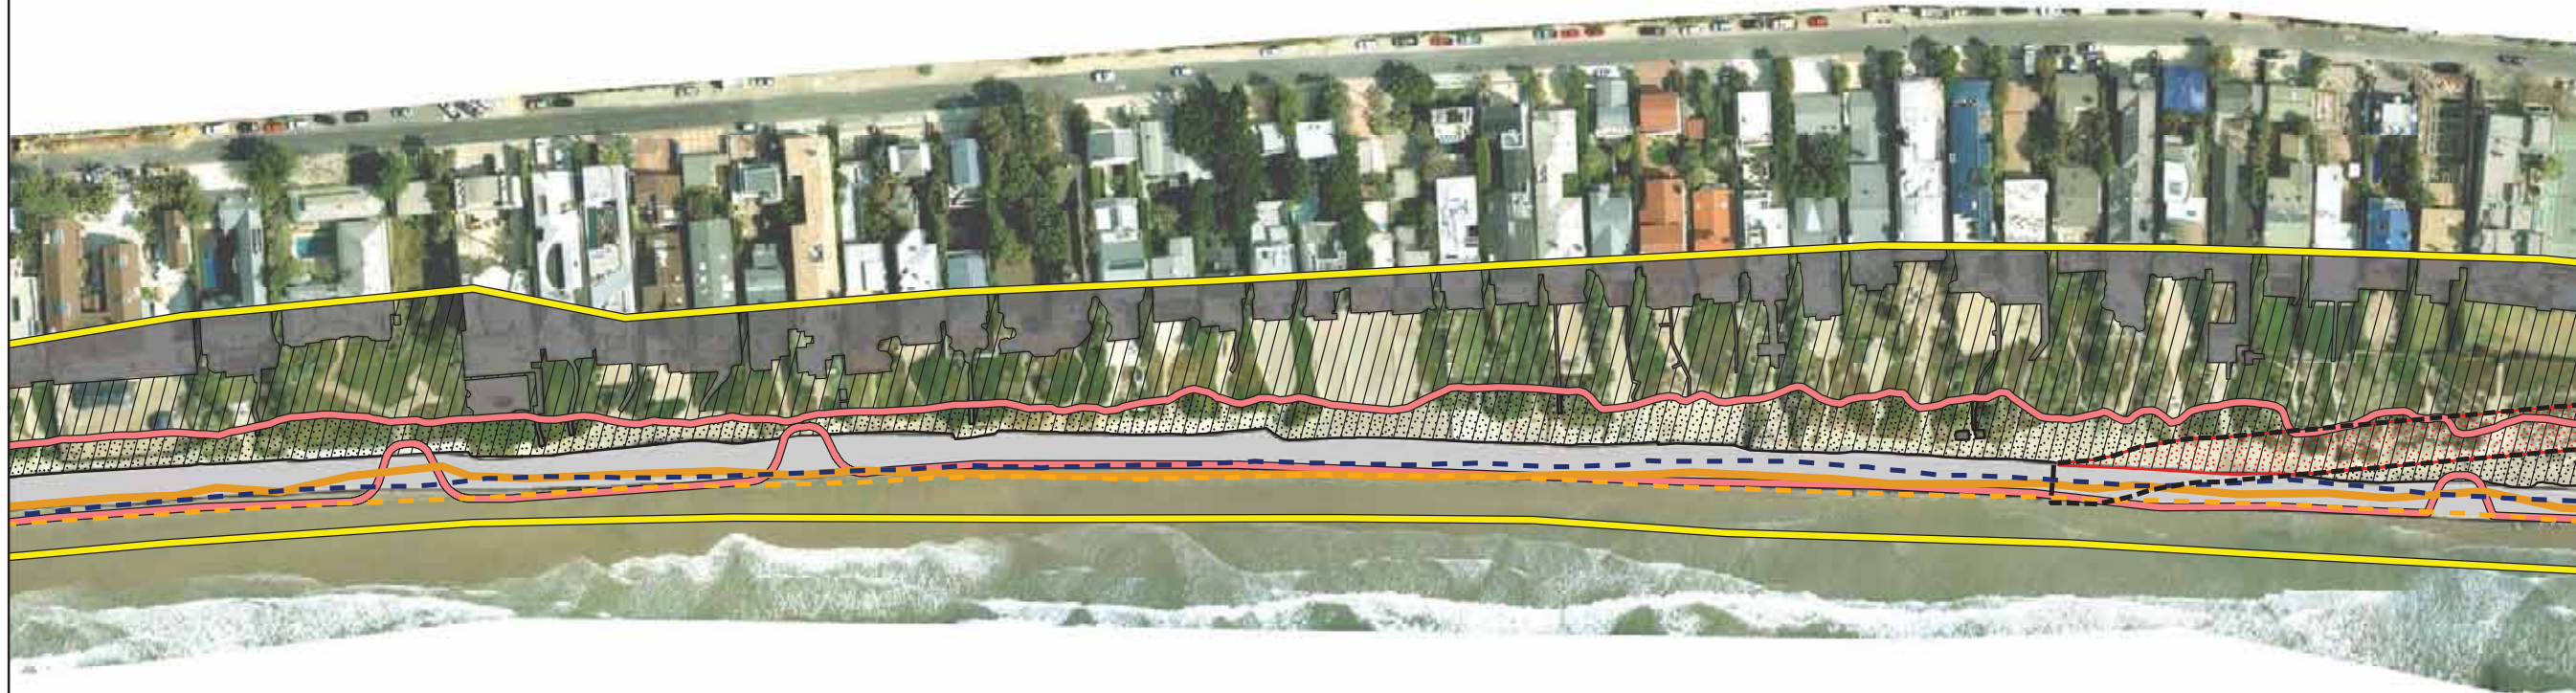
Figure 17-1b.

Potential Impacts to
Foredune Habitat
Under Alternative 6B
Relative to 2013
Existing Conditions

** Temporary impacts are due to enhancement of existing degraded foredune habitat. Permanent impacts are due to relocation of revetment.

For the chronological assessment of foredune impacts, WRA used the existing foredune extent shown in Figure 5 and assumed that potential impacts associated with this alternative include permanent impacts where the revetment will be relocated inland of its existing location as well as temporary impacts in the location of the proposed foredune enhancement. Because no foredune habitat currently occurs seaward of the existing revetment, the proposed foredune creation in these areas would not result in impacts to foredune habitat. The potential impacts to foredune habitat associated with this alternative are shown in Figure 17-1 and include 0.91 acres of permanent impacts associated with the relocated revetment and 2.48 acres of temporary impacts associated with the proposed foredune enhancement.

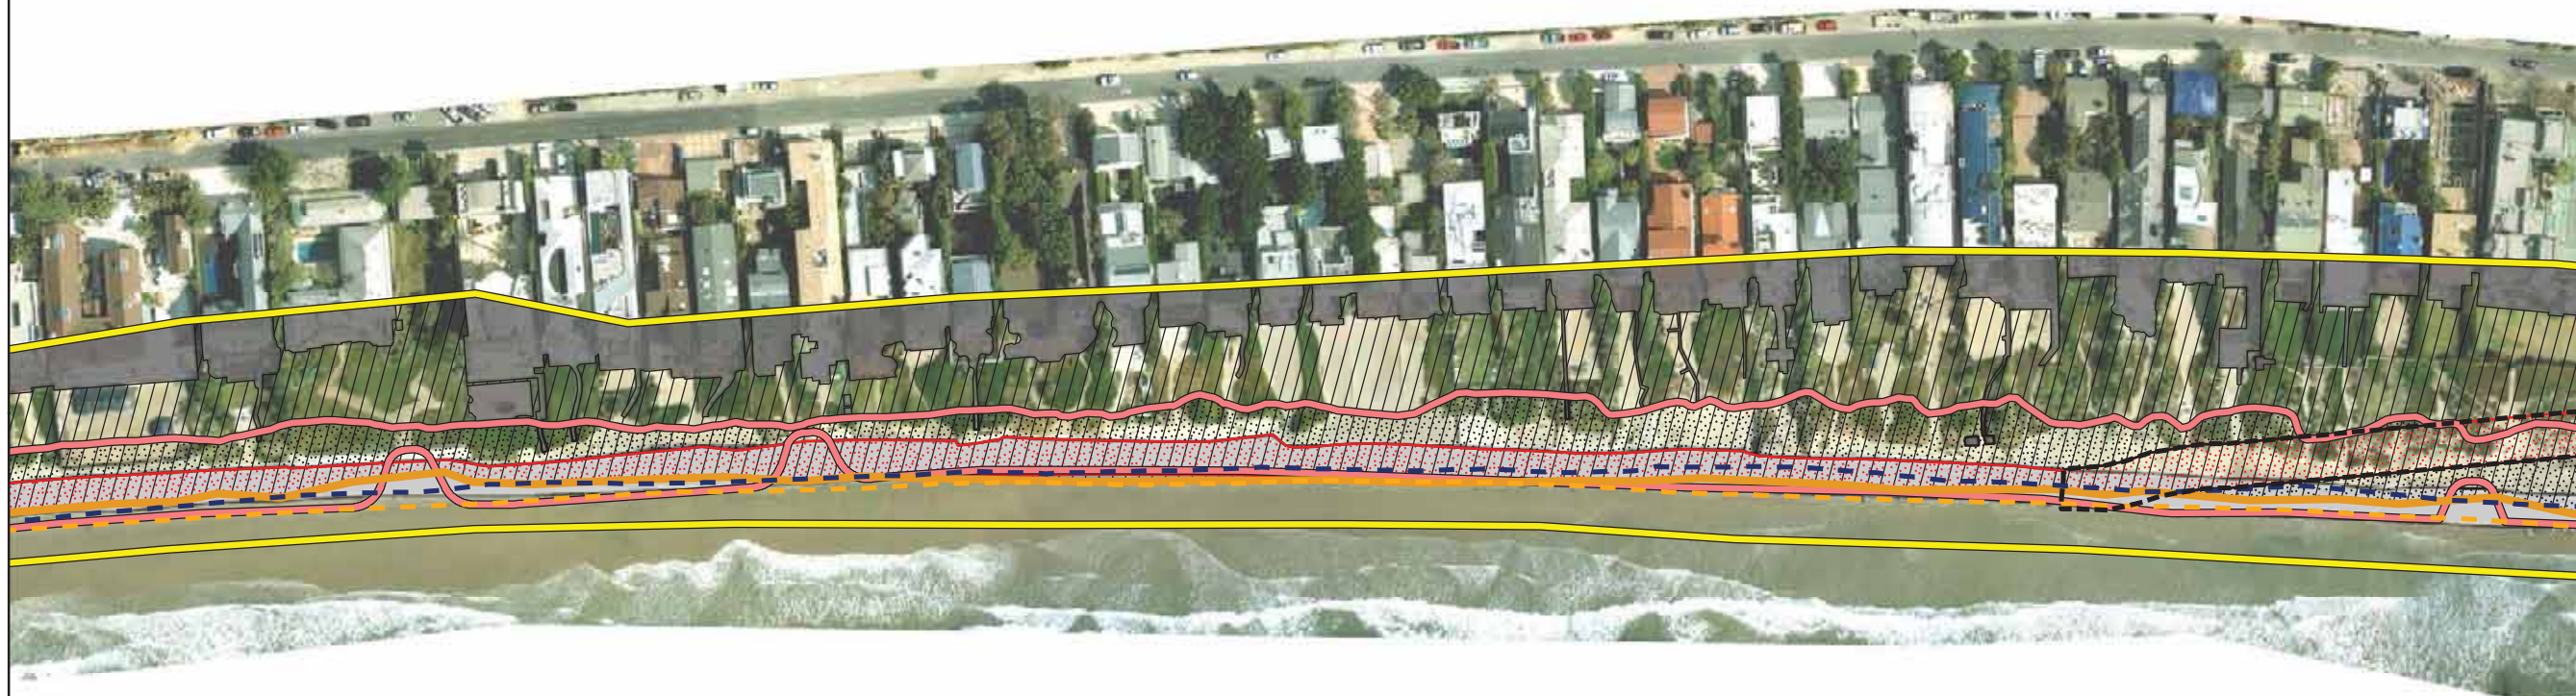
Figure 17-2b.

**Temporary impacts are due to revetment removal or enhancement of existing degraded foredune habitat. Permanent impacts are due to retained and relocated sections of revetment.

For the assessment of impacts relative to the 2005 baseline condition, WRA assumed that the area landward of the 2005 beach/dune escarpment line shown in Figure 2 represents existing foredune habitat at the site. Using the 2005 baseline extent of foredune habitat, WRA assumed that areas of foredune enhancement and revetment removal represent temporary impacts to foredune habitat and that areas of retained or relocated revetment represent permanent impacts. These impacts are shown in Figure 17-2 and include 2.86 acres of temporary impacts and 2.39 acres of permanent impacts.

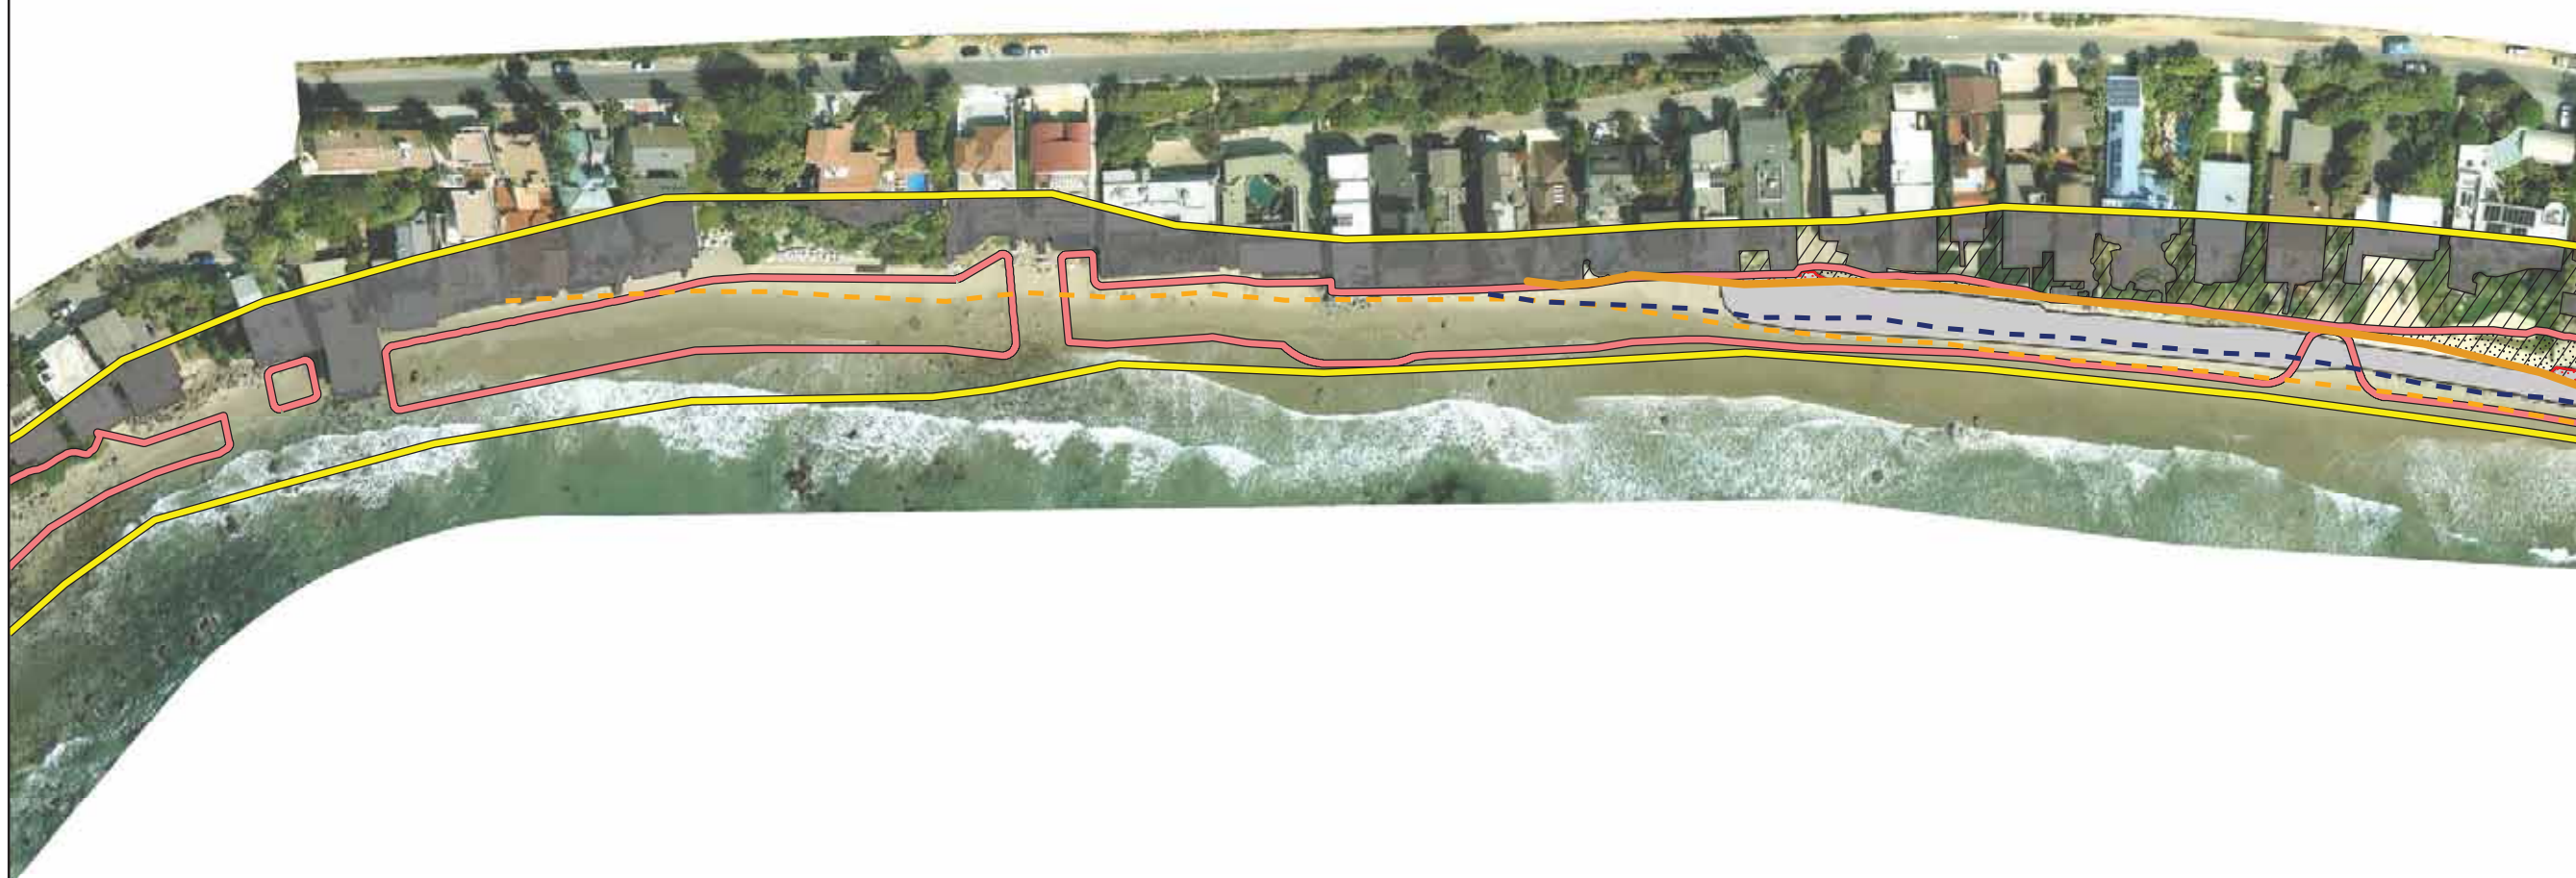
Figure 17-2e.

* Remnant foredune habitat based on 2005 foredune extent shown in Figure 2.

**Temporary impacts are due to revetment removal or enhancement of existing degraded foredune habitat. Permanent impacts are due to retained and relocated sections of revetment.

Potential Impacts to
Foredune Habitat
Under Alternative 6B
Relative to 2005
Baseline Conditions
